Recall Bulletin

PRODUCT SAFETY RECALL

SUBJECT: Front Passenger Air Bag Inflator Module

MODELS: 2003-2005 Pontiac Vibe
Currently Registered or Previously Registered in Alabama, Florida, Georgia, Hawaii, Louisiana, Mississippi, Texas, Guam, Puerto Rico, Saipan, U.S. Samoa or U.S. Virgin Islands

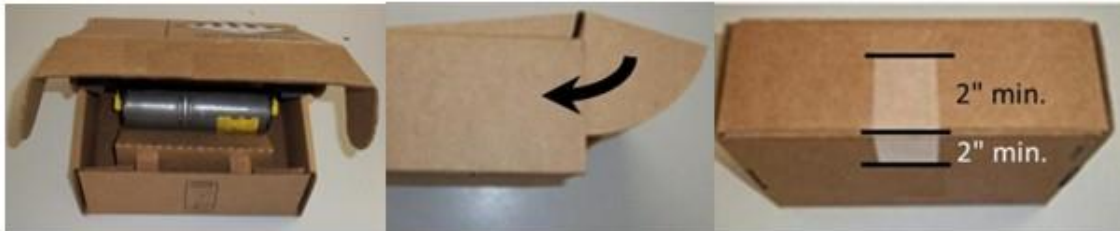
2. Closure Instructions: Close the top box flap, per box closure instructions located on front panel of box. Use a 2" wide x 4" long piece of clear packing tape to seal the box as shown below.
