**PRODUCT CAMPAIGN BULLETIN**

**APPLICABILITY:** 2003-2005 Subaru Legacy and Outback  
 2003-2005 Subaru Baja  
 2004-2005 Subaru Impreza  
 (including WRX and STI)

**NUMBER:** WQP-51  
**DATE:** January 2015  
**NHTSA ID:** 14V-763

**SUBJECT:** Regional Front Passenger Air Bag Inflator Replacement

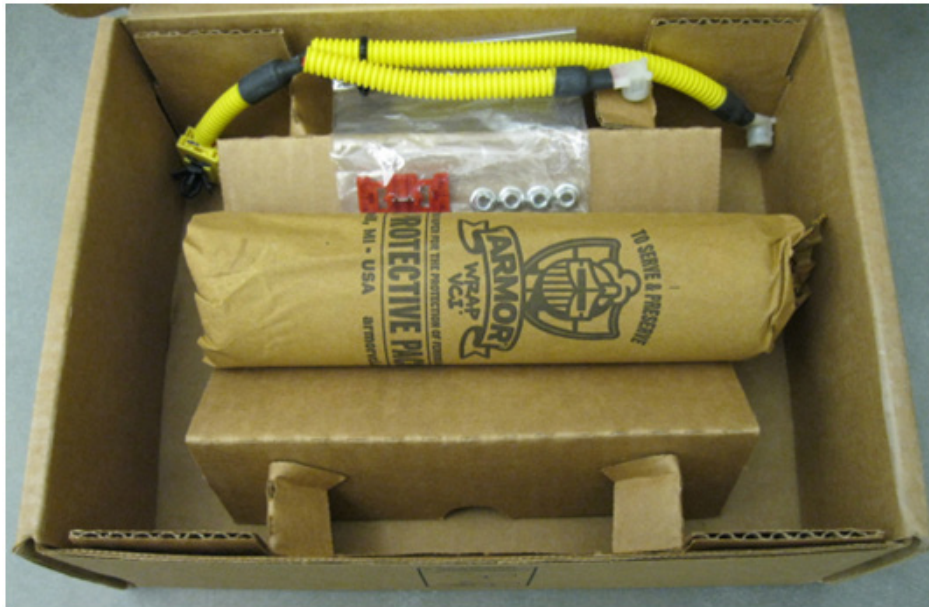
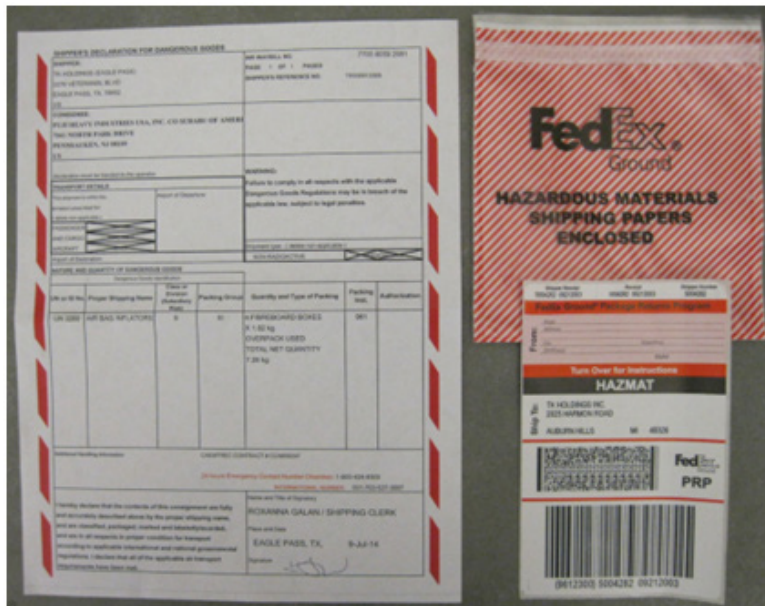
- Open the Kit Box and confirm all the necessary components are included:
  - 4 Self-Locking nuts
  - New Inflator (yellow tape applied to one end to identify it as the replacement part)
  - New Inflator Harness
  - Electro-Tap (red shorting crimp connector)
  - Shipping Declaration document, FedEx document pouch and return shipping label

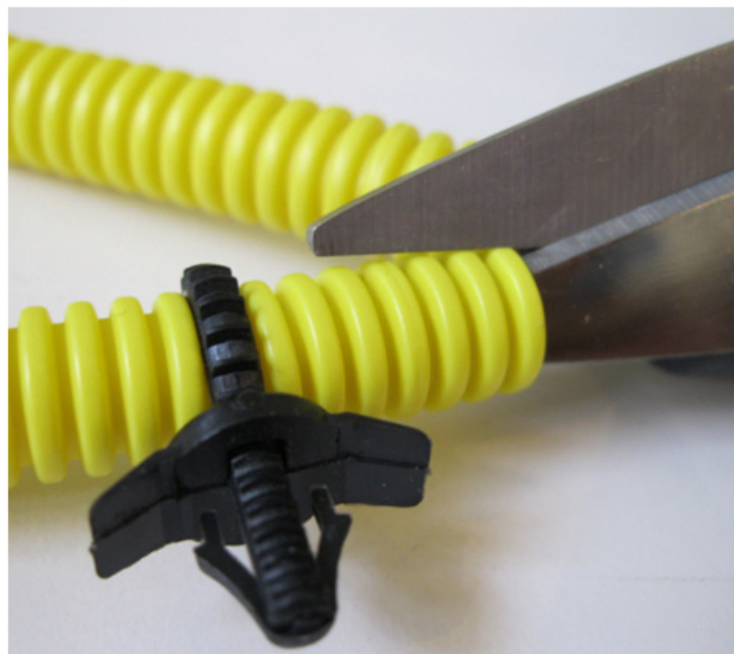
**STEP 3- CAREFULLY** cut the yellow harness cover (approximately 1 1/2 inches) enough to expose the 2 yellow wires inside and provide enough room to install the Electro-Tap (shorting) connector using a scissor or wire cutter (no knives or razors). **TAKE YOUR TIME AND BE CAREFUL TO NOT CUT THE 2 YELLOW WIRES!**

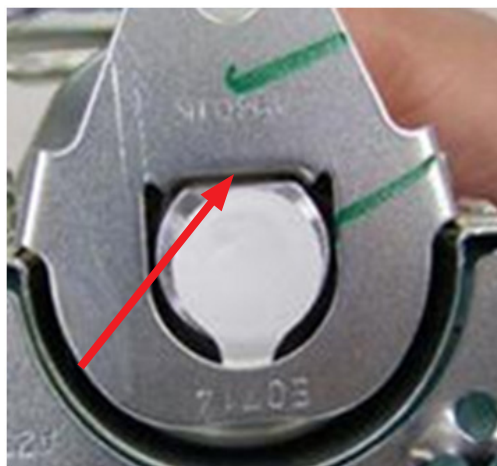
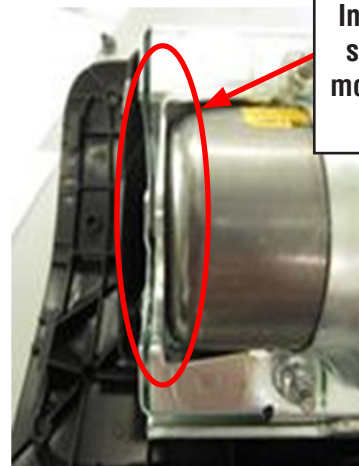
**Inflator properly seated against mounting bracket (NO GAP)**

**STEP 9-** Install the new inflator into the mounting bracket so the yellow taped end aligns with the removed stopper plate. Make sure the “D-shaped” portion of the inflator harness connector boss aligns with the “D-shaped” portion of the hole in the end of the mounting bracket as shown below. When properly installed, the end of the inflator will be seated tight against the mounting bracket. Do not peel the white harness connection dust cover at this time.

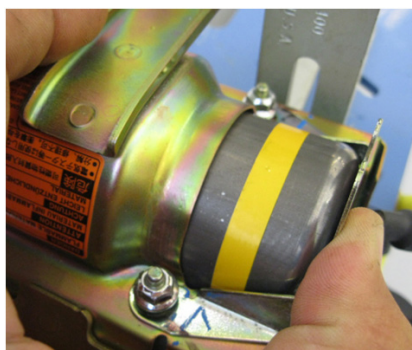
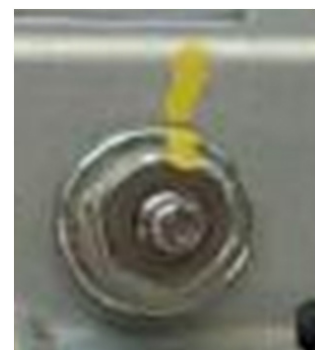
**STEP 10-** As shown below, install but **do not fully tighten** 2 of the NEW self-locking nuts while holding the stopper plate tight against the inflator. Remove the nuts still installed on the mounting bracket and replace them with 2 NEW self-locking nuts. Once all 4 NEW nuts are in place, **torque to 31 - 38 inch pounds in the sequence shown below**. Use a marker to mark the nuts after torquing to indicate they have been fully tightened.

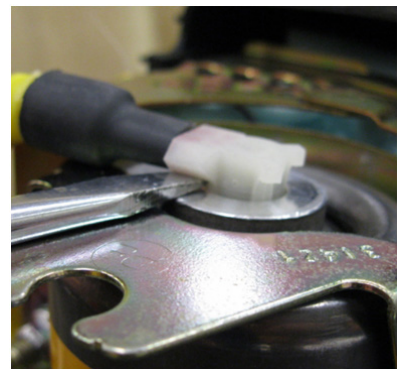
Locking Groove

Peel off the white dust cover from the round connector boss end of the inflator **ONLY**. **CAREFULLY** align the pins with the female terminals of the harness connector (2 red wires) as shown in the sequence below. **IMPORTANT: NEVER PEEL BOTH THE WHITE DUST COVERS OFF AT THE SAME TIME!** Once pin alignment is confirmed, push down firmly to engage the connector’s 3 locking tangs into the locking groove inside the connector boss. Confirm the connector is locked by prying up **LIGHTLY** with a small flat-blade screwdriver. Repeat the procedure on the D-shaped connector boss end (2 yellow wires). Reinstall the black wiring harness retaining clip into the mounting bracket to complete the airbag reassembly.

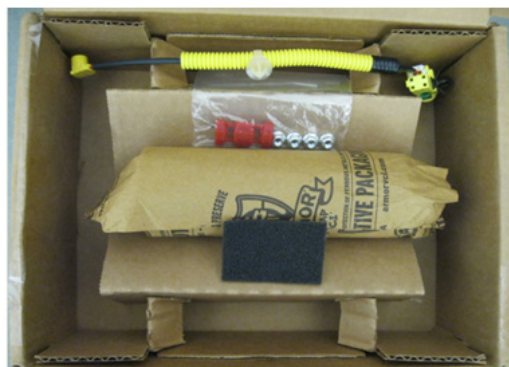
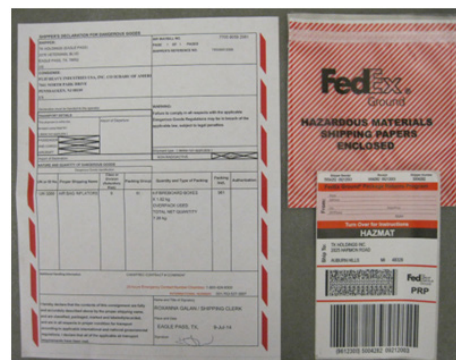
- Open the Kit Box and confirm all the necessary components are included:
  - 4 Self-Locking nuts
  - New Inflator (yellow tape applied to one end to identify it as the replacement part)
  - New Inflator Harness
  - Electro-Tap (red shorting crimp connector)
  - 1 ½” X 2 ¼” piece of self-adhesive Sponge Tape
  - Shipping Declaration document, FedEx document pouch and return shipping label

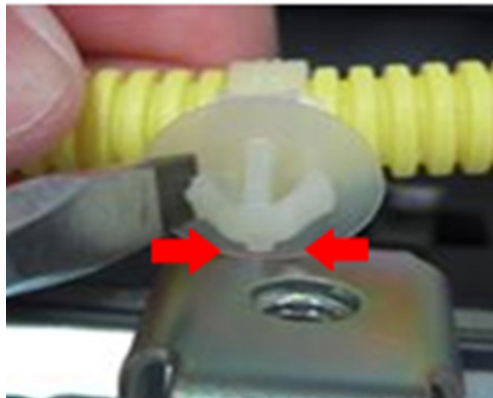
**STEP 2-** Peel the Sponge Tape and remove the harness clip from the retainer bracket by pushing the tangs inward with a flat-blade screwdriver as shown below. Always remove any Sponge Tape adhesive residue from the airbag mounting bracket using mild solvent on a clean shop cloth. **CAUTION:** Never use any silicone-based products for this purpose.

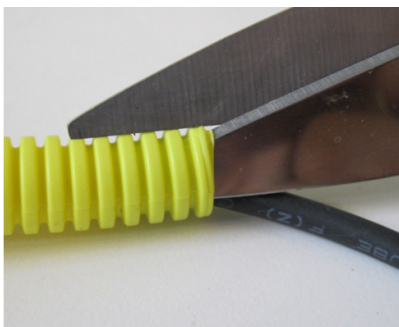
**STEP 3- CAREFULLY** cut the yellow harness cover enough (approximately 2 inches) to expose the 2 red or yellow wires inside and provide enough room to install the Electro-Tap (shorting) connector using a wire cutter or scissor (no knives or razors). **TAKE YOUR TIME AND BE CAREFUL TO NOT CUT THE 2 WIRES!**

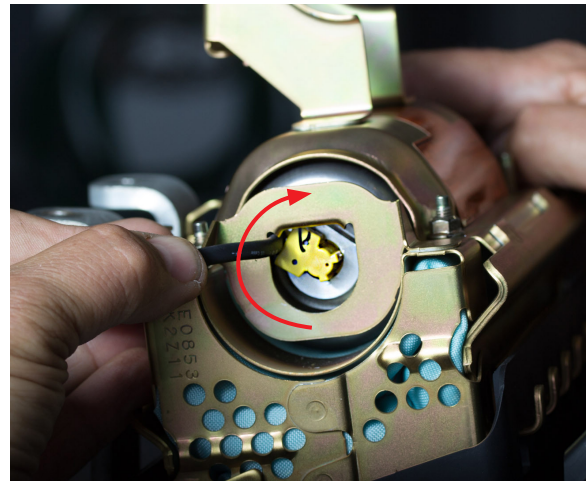
**STEP 7-** With the stopper plate removed and the other 2 self-locking nuts loosened, unseat the inflator off the mounting bracket end plate then rotate it slightly **CLOCKWISE** to make it easier to remove as shown in the photo to the right. Slide the inflator out of its mounting while feeding the cut off portion of the wiring harness through the “D-Shaped” hole in the end of the mounting bracket.

Place the removed original air bag inflator in the “cradle” of the Kit Box insert.

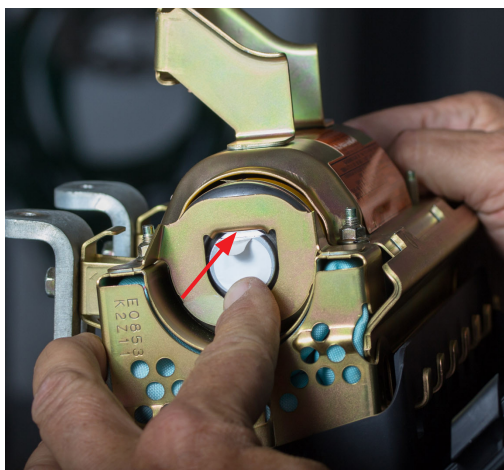
**Inflator properly seated against mounting bracket (NO GAP)**

**STEP 9-** Install the new inflator into the mounting bracket with the harness connector end going in first toward the mounting bracket. Make sure the “D-shaped” portion of the inflator harness connector boss aligns with the “D-shaped” portion of the hole in the end of the mounting bracket as shown below. When properly installed, the end of the inflator will be seated tight against the mounting bracket. Do not peel the white harness connection dust cover at this time.

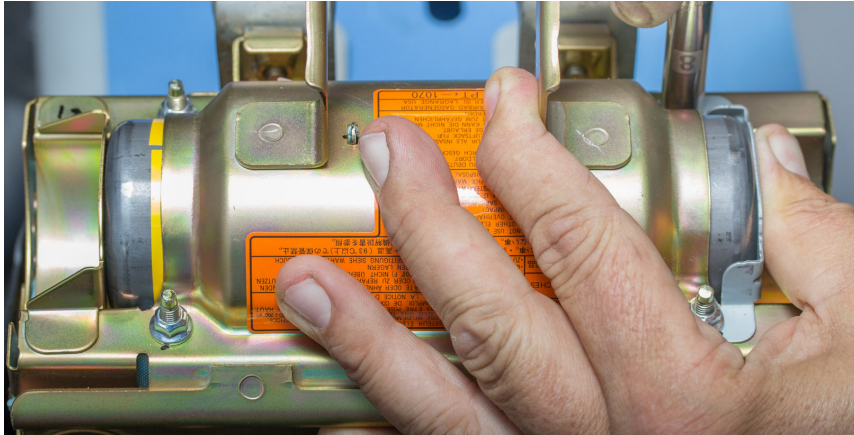
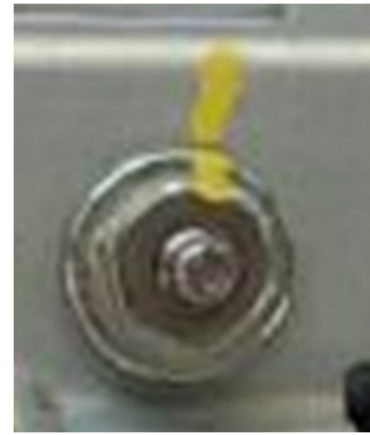
**STEP 10-** As shown below, install but do not fully tighten 2 of the NEW self-locking nuts while holding the stopper plate tight against the inflator. Remove the nuts still installed on the mounting bracket and replace them with 2 NEW self-locking nuts. Once all 4 NEW nuts are in place, torque to 31 - 38 inch pounds in the sequence shown below. Use a marker to mark the nuts after torquing indicating they have been fully tightened.

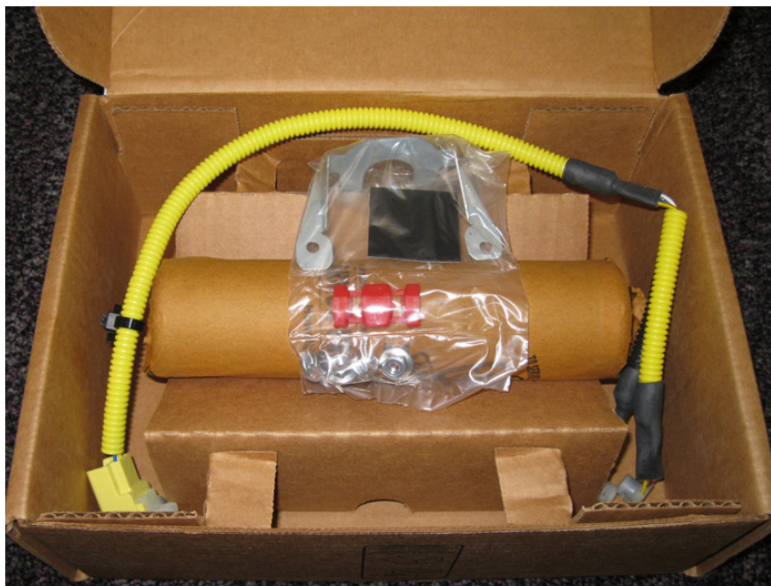
- 4 Self-Locking nuts
- New Inflator (yellow tape applied to one end to identify it as the replacement part)
- New Inflator Harness
- Electro-Tap (red shorting crimp connector)
- New Stopper Plate with D-Shaped hole
- Self-Adhesive Foam Protector
- Shipping Declaration document, FedEx document pouch and return shipping label

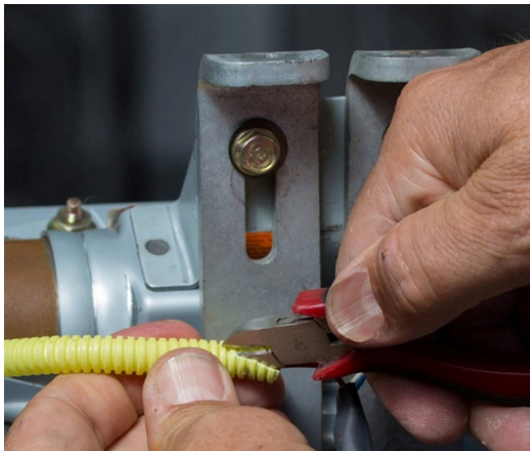
**STEP 3- CAREFULLY** cut the yellow harness cover (approximately 1 1/2 inches) enough to expose the 2 yellow and red wires inside and provide enough room to install the Electro-Tap (shorting) connector using a scissor or wire cutter (no knives or razors).

**TAKE YOUR TIME AND BE CAREFUL TO NOT CUT THE 2 WIRES!**

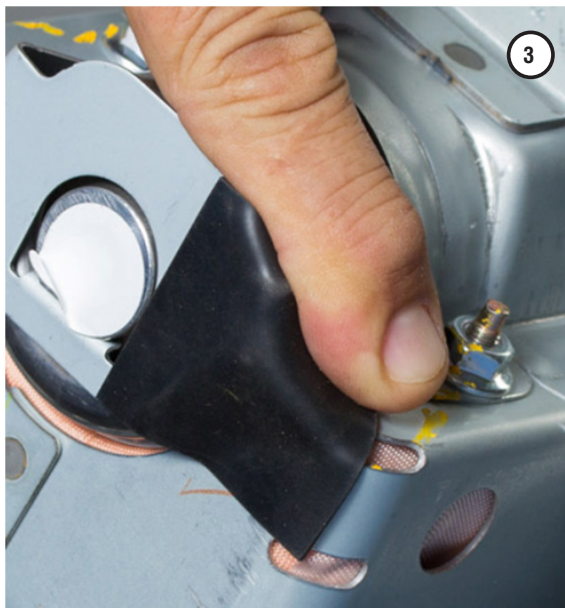
**STEP 10-** Install the black foam self-adhesive protector onto the D-Shaped stopper and mounting bracket positioned as shown in the photo sequence below. Once adhered in place on the new stopper plate, fold over the excess as shown. Always make sure the placement area for the protector is free of any grease or dirt before application.

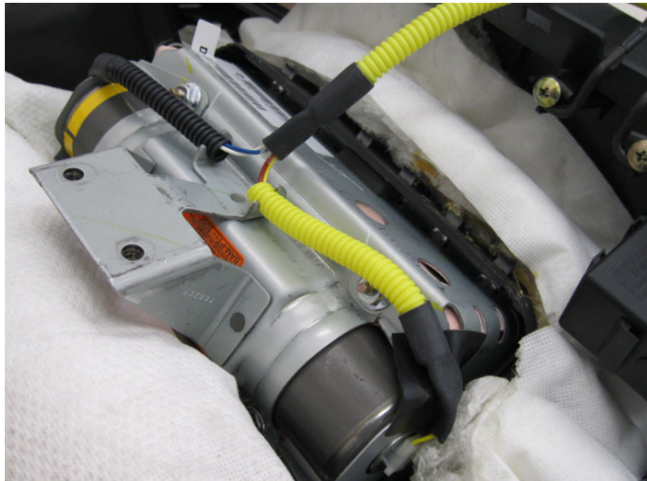
**STEP 13- CAREFULLY** reinstall the airbag module assembly into the instrument panel as shown below.

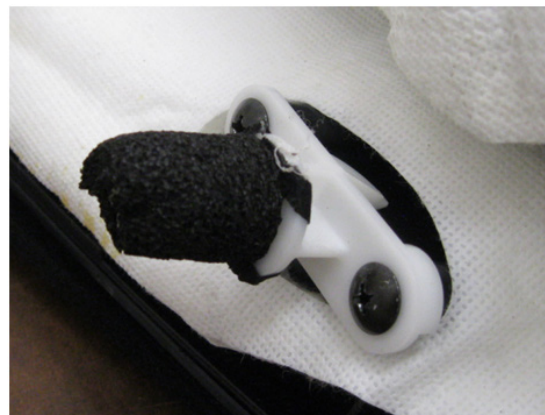
**STEP 14-** To eliminate a possible source of a rattling sound from the dash, wrap the 2 hooks and locator pin with non-woven material, p.n. SOA963W110 (or an equivalent self-adhesive foam) as shown below.

**REMINDER:** 1 sheet of the SOA963W110 non-woven material is enough for approximately 8 vehicles.
