# 2003 - 2005 MODEL YEAR CROWN VICTORIA AND GRAND MARQUIS VEHICLES — HEADLIGHTS INOPERATIVE

#### ATTACHMENT III PAGE 2 OF 8 SAFETY RECALL 15S39

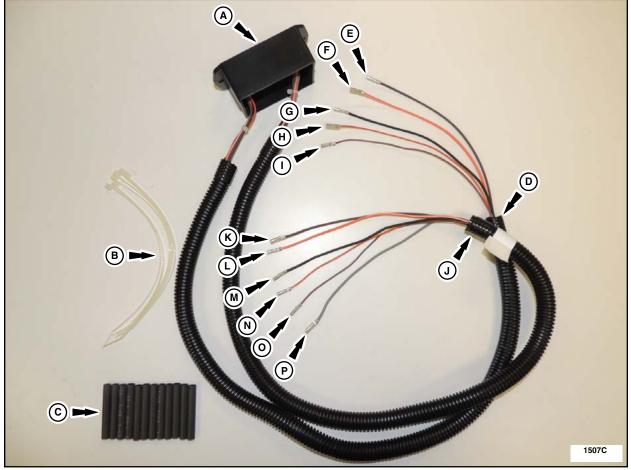
## **FIGURE 1**

### **Kit Contents:**

- A. LCM Bypass Module
- B. Zip Ties
- C. Heat Shrink Tubing
- D. 5-Wire Side of Harness
- E. Brown (BN) wire
- F. Orange/White (OG/WH) wire
- G. Black (BK) wire
- H. Red/Yellow (RD/YE) wire
- I. Violet/Orange (VT/OG) wire

- J. 6-Wire Side of Harness
- K. Brown (BN) wire
- L. Orange/White (OG/WH) wire
- M. Black (BK) wire
- N. Red/Yellow (RD/YE) wire
- O. Violet/Orange (VT/OG) wire
- P. Gray (GY) wire

**NOTE**: The 5-wire side of the LCM bypass module must be connected to the LCM (component) side of the harness.

The 6-wire side of the LCM bypass module must be connected to the vehicle side of the harness. The 6-wire side of the LCM bypass module harness has a part identification label attached near the end of the convolute.

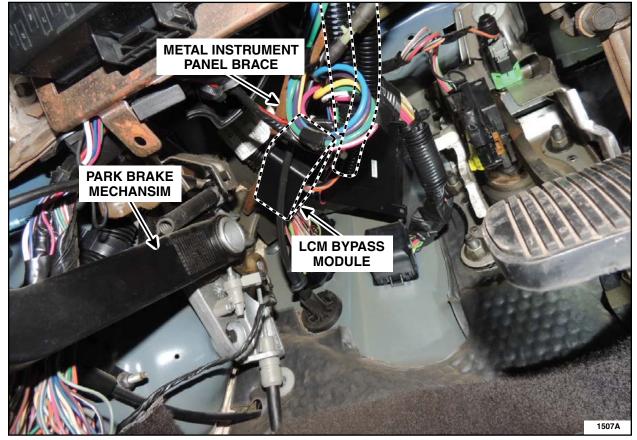
**FIGURE 2**

- **NOTE**: Do not install the instrument panel lower insulator until after the LCM bypass module and harness have been mounted and secured.
- 6. Mount the LCM bypass module to the metal instrument panel brace located under the driver side instrument panel, above the park brake mechanism. Figure 2.

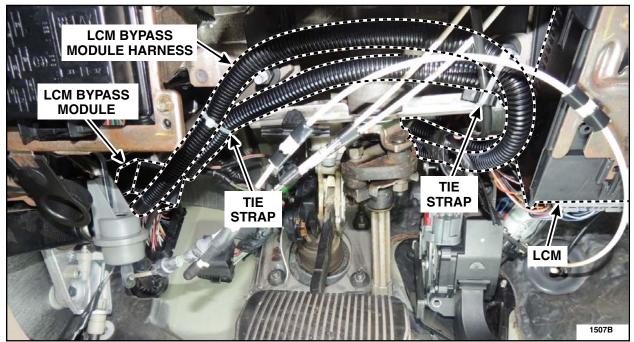
FIGURE 3

- 7. Route and secure the LCM bypass module harness as shown in Figure 3, using tie straps as necessary.
- **NOTICE:** Verify the LCM bypass module harness is secured away from all sharp edges and moving parts.

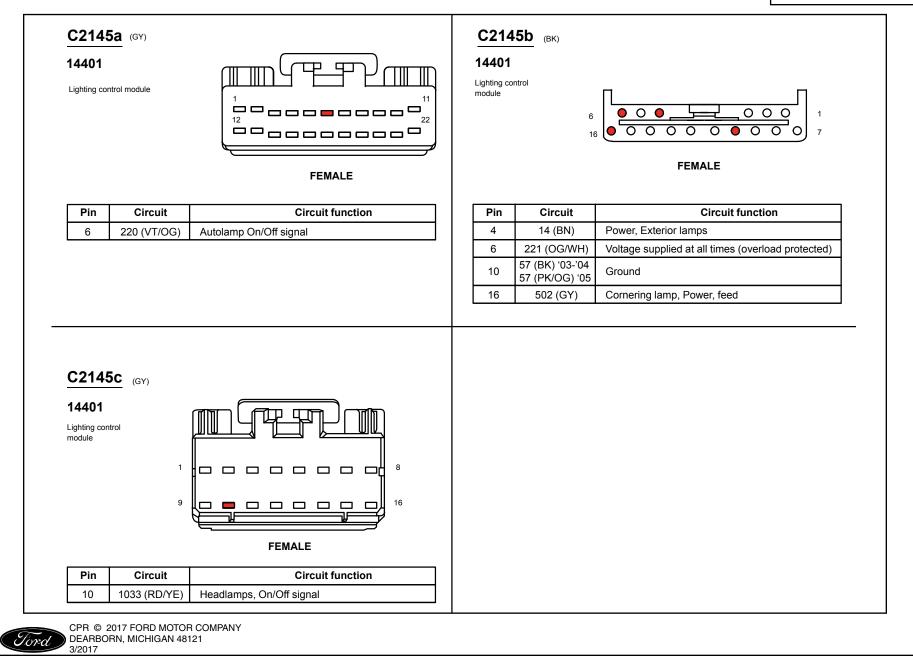
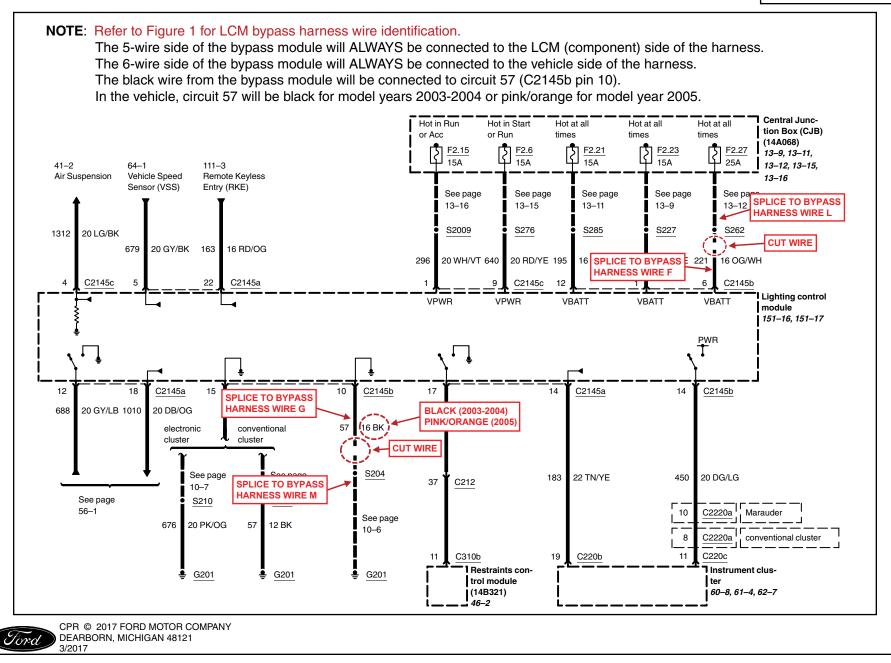
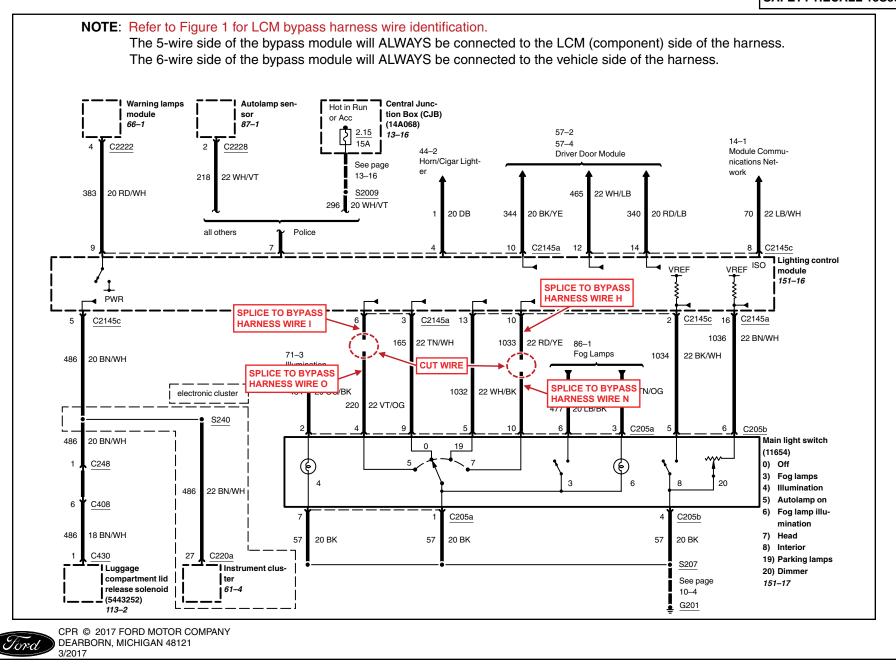
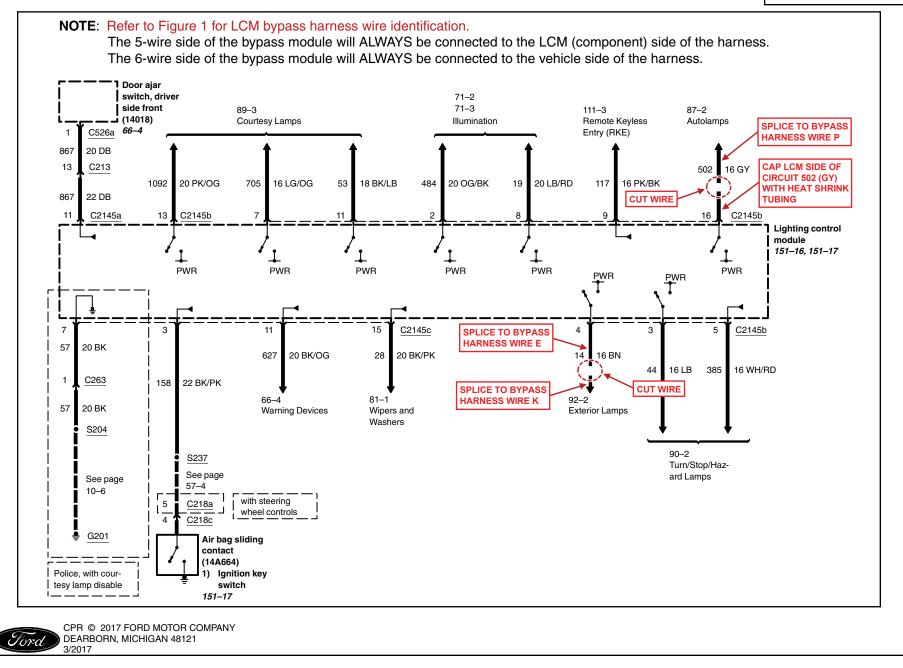
WIRING SCHEMATICS

- 3. Cut the appropriate circuits on the vehicle harness near the LCM connectors leaving at least 1.5 in (3.8 cm) of wire available on both sides of cut. For connector and pin identification, please refer to pages 5-8.

- 4. Complete the wiring connections by following the connector repair procedures for the crimp splicing method. Refer to Wiring Diagram, Section 5.
- 5. Reinstall the LCM. Please follow the WSM procedures in Section 419-10.
