DRV Suites Curb Side Front Reflector

Description

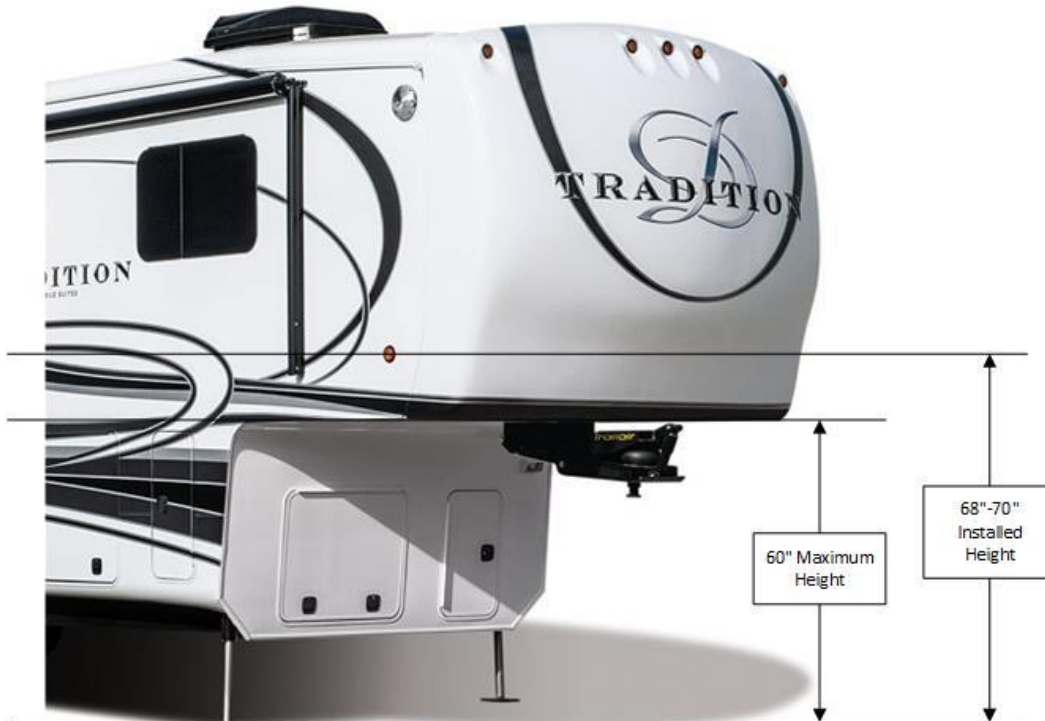
It has been decided the vehicles in this recall population may have been manufactured with the forward reflector on the door side of the camper located above the maximum height allowable by a range of 8 to 10 inches.

1. This is the current location of the reflector that is incorrectly placed.

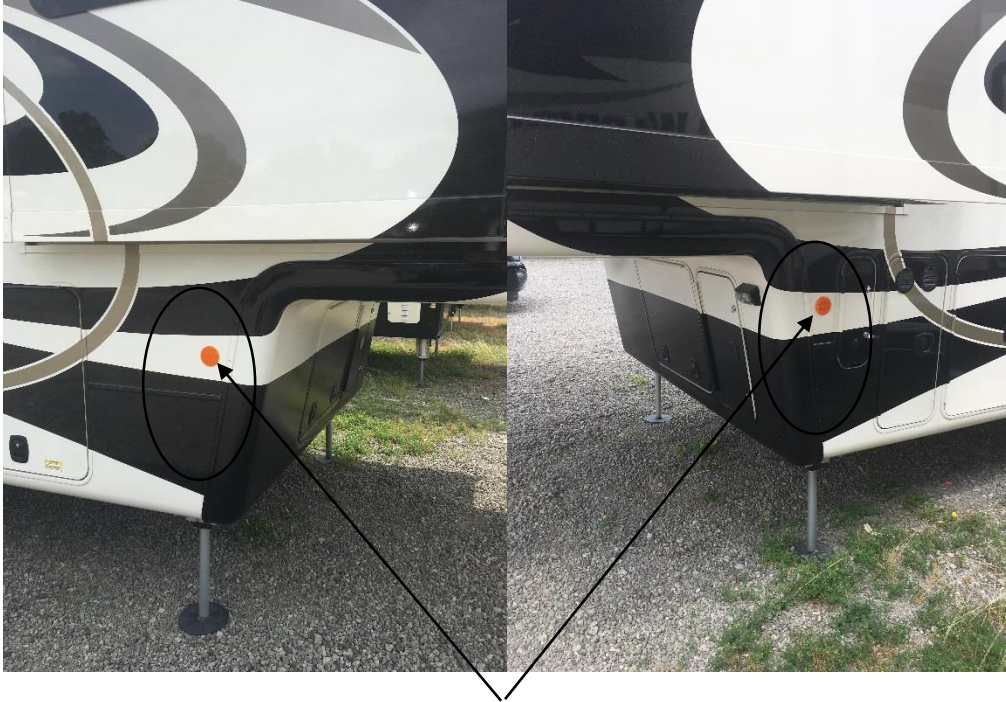
2. Where to install the reflector tape that is being sent to you.

3. Location to install the reflective tape, place one on each side approximately 48” from the ground, any position in this general area is acceptable as long as the reflector is below 60”.
4. Clean any dirt from the sidewall, peel backing from tape and apply. Apply starting on one end of tape and slowly smooth the tape as you apply working from front to back.
