**HYUNDAI**
Technical Service Bulletin

GROUP RECALL	NUMBER 17-01-054
DATE JULY, 2017	MODEL(S) Sonata (LFA) Genesis Sedan (DH)

2015 SONATA (LFA) GENESIS SEDAN (DH)
PARKING BRAKE SWITCH REPLACEMENT,
(RECALL CAMPAIGN 164)

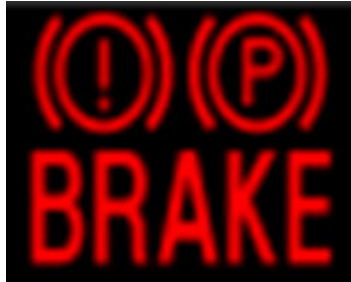
Description: Certain 2015MY Genesis sedan (DH) and Sonata (LFA) vehicles with a manual parking brake are equipped with an electrical switch to illuminate the parking brake warning light in the instrument cluster. Corrosion in the electrical switch can result in the parking brake warning light intermittently not illuminating when the parking brake is applied. If the vehicle is driven with the parking brake applied, symptoms can include parking brake noise, parking brake "drag", smoke and/or smell from the applied parking brake. This bulletin describes the procedure to replace the parking brake switch.

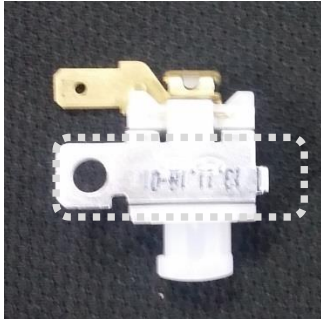
PART NAME	BEFORE	AFTER	QTY.
Parking Brake Switch	<p>93830-B1000</p>

<p>Silver Colored Electrical Contact</p>	<p>93830-B1001QQH</p>

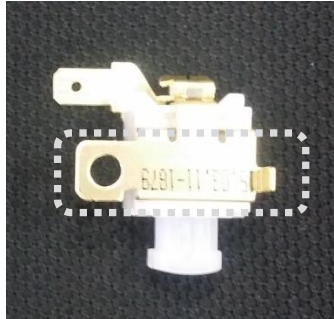
<p>Gold Colored Electrical Contact</p>	1

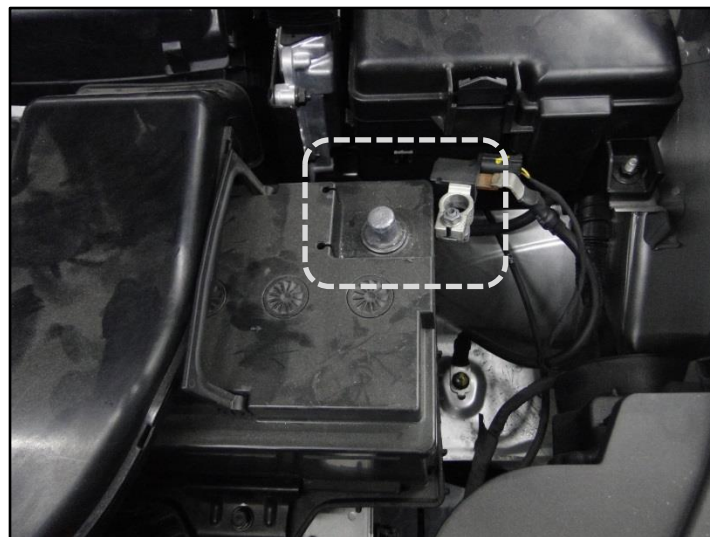
1. If applicable, record the customer's radio preset stations for AM/FM/XM.
2. Turn the ignition switch OFF and disconnect the battery's negative terminal.

Tightening torque :

3.9 ~ 5.8 Nm (0.4 ~ 0.6 kgf.m, 2.8 ~ 4.3 lb-ft)

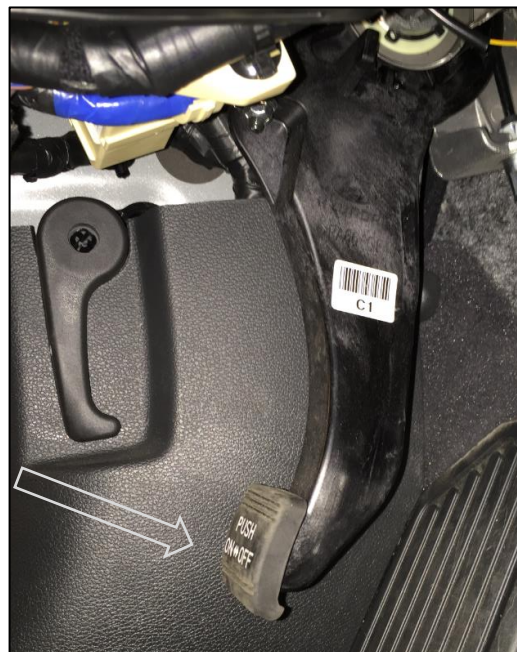
3. Depress the parking brake pedal.

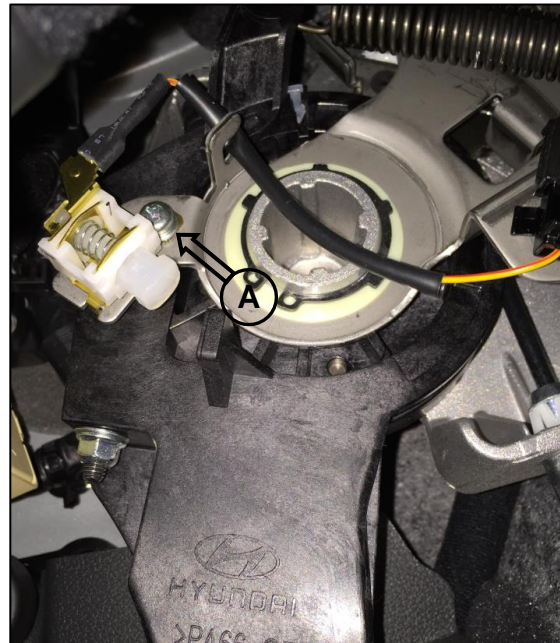
4. Remove the parking brake switch mounting screw (A) and remove the parking brake switch from the parking brake pedal assembly.

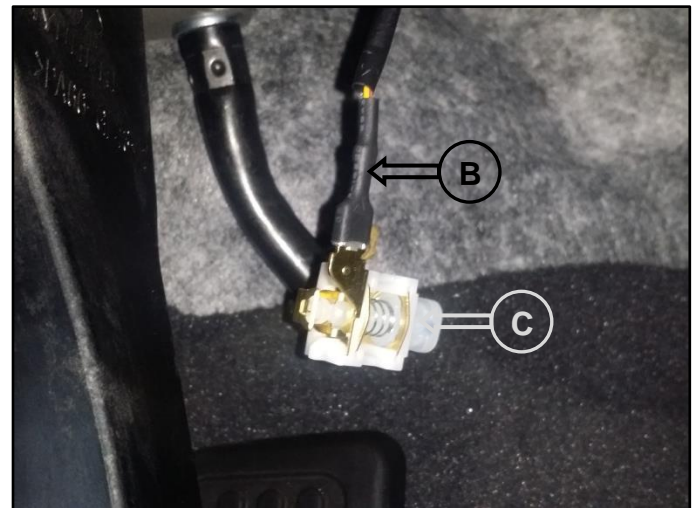
5. Disconnect the connector (B) and then remove the parking brake switch (C).
6. Install the new parking brake switch in the opposite order of removal.
7. Turn 'ON' the ignition switch and confirm the parking brake warning lamp illuminates when the parking brake pedal is applied and turns off with the parking brake released.

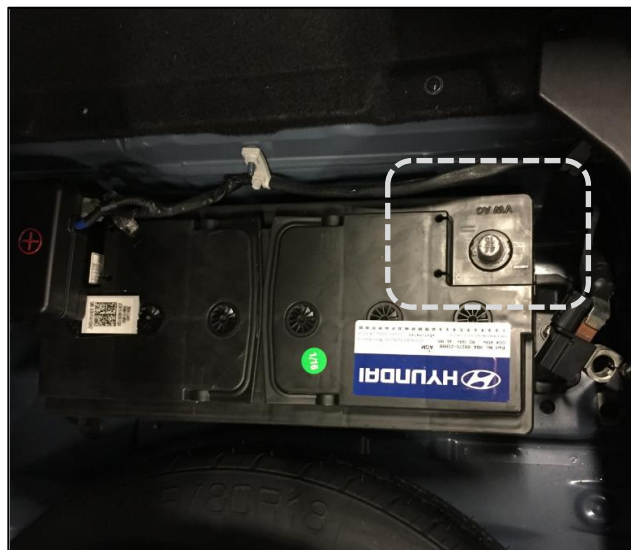
1. If applicable, record the customer's radio preset stations for AM/FM/XM.
2. Turn the ignition switch OFF and disconnect the battery's negative terminal.

Tightening torque :

3.9 ~ 5.8 Nm (0.4 ~ 0.6 kgf.m, 2.8 ~ 4.3 lb-ft)

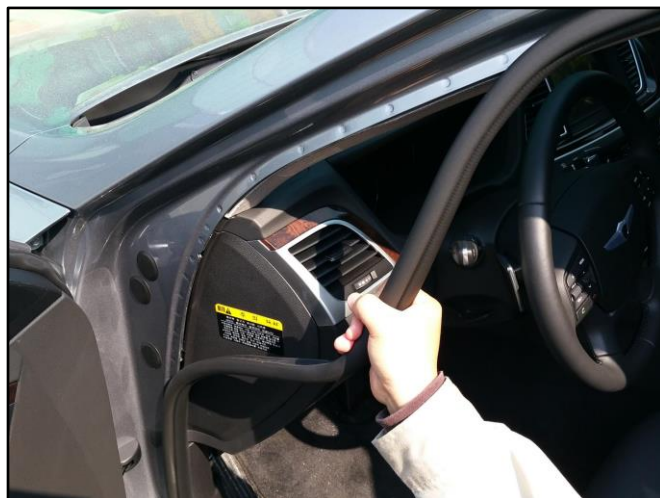
3. Partially remove the body weather strip.

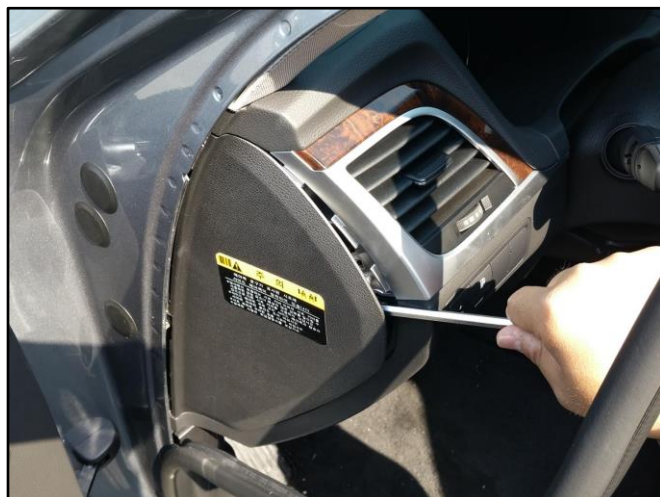
4. Carefully remove the crash pad side cover.

Be careful not to scratch the crash pad side cover during removal.

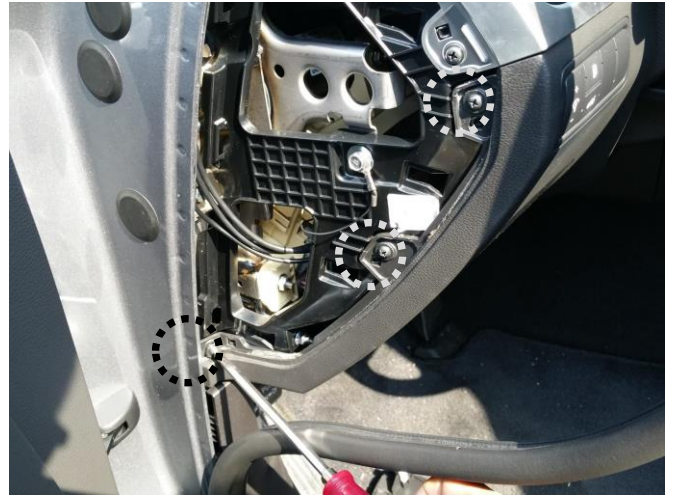
5. Remove three screws.

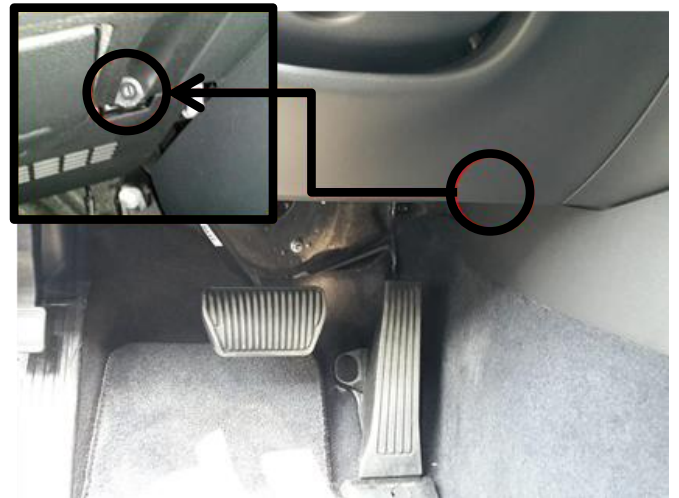
6. Remove crash pad lower panel mounting screw.

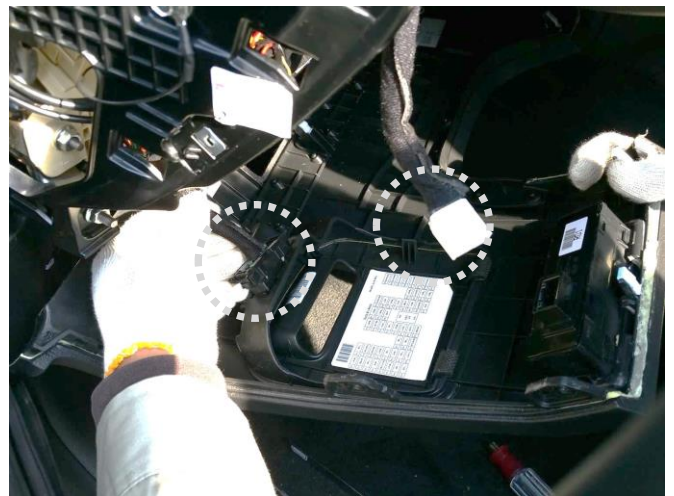
7. Separate the crash pad lower panel from the crash pad and then disconnect the two connectors.

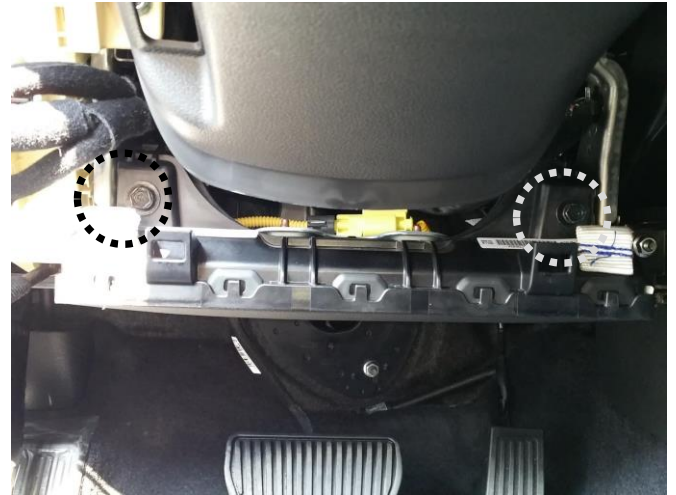
8. Remove the two knee airbag mounting bolts.

Tightening torque:

7.8 ~ 11.8 Nm (0.8 ~ 1.2 kgf.m, 5.8 ~ 8.7 lb-ft)

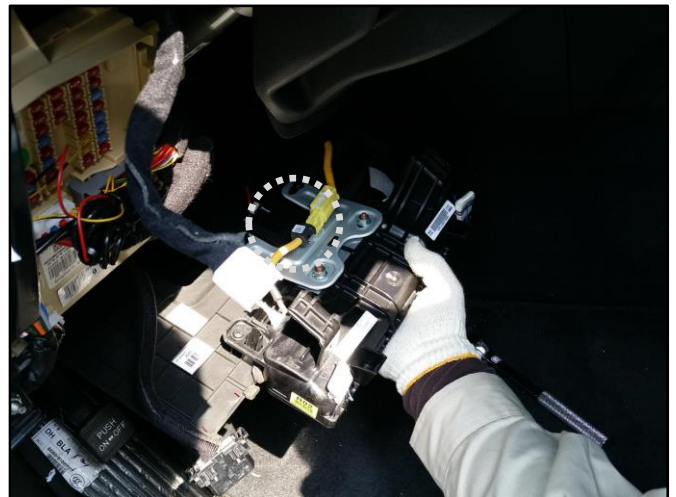
9. Disconnect the knee airbag connector and then remove the knee airbag.

At least three minutes must elapse between disconnecting the battery negative terminal (step 2) and disconnecting the knee airbag (step 9).

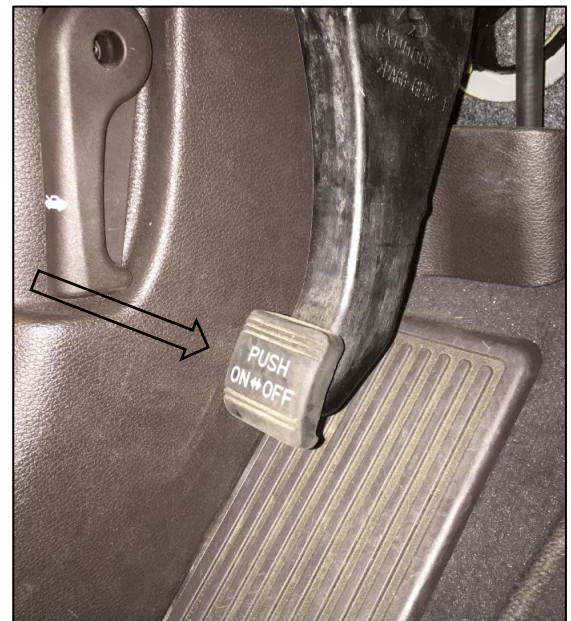
10. Depress the parking brake pedal.

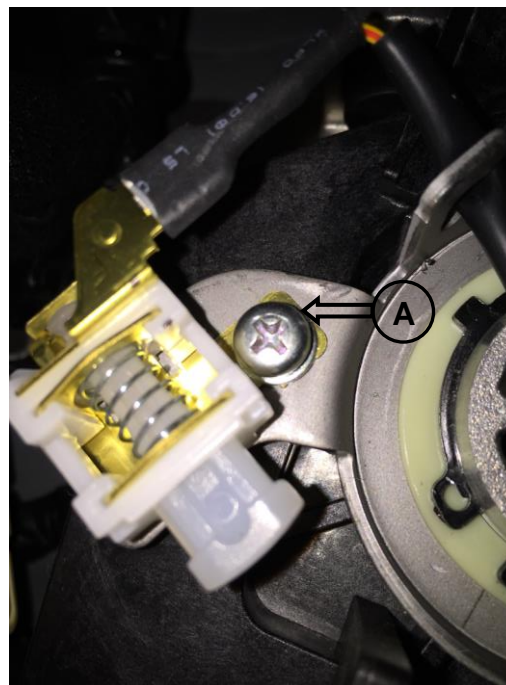
11. Remove the parking brake switch mounting screw (A) and remove the parking brake switch from the parking brake pedal assembly.

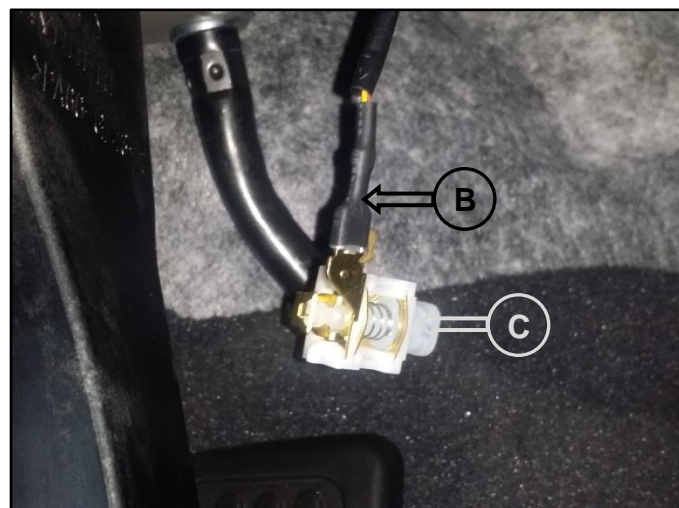
12. Disconnect the connector (B) and then remove the parking brake switch (C).

13. Install the new parking brake switch and reassemble vehicle in the opposite order of removal.

14. Turn 'ON' the ignition switch and confirm the parking brake warning lamp illuminates when the parking brake pedal is applied and turns off with the parking brake released.
