## Technical Service Bulletin

GROUP <b>RECALL</b>	NUMBER <b>17-01-048</b>
DATE <b>June, 2017</b>	MODEL(S) <b>Santa Fe Sport (AN)</b>

**SUBJECT:** 2017-2018 SANTA FE SPORT (AN) DRIVER'S SEAT BELT ANCHOR BOLT INSPECTION (RECALL CAMPAIGN 165)

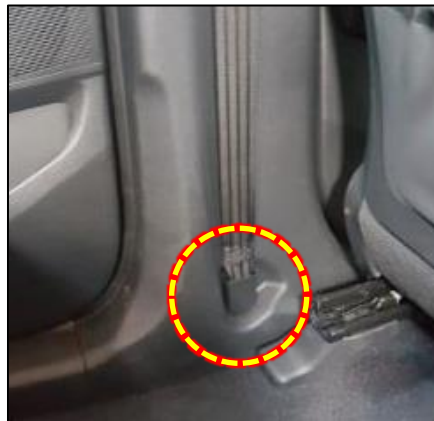
**Description:** The driver's seat belt anchor in the Hyundai Santa Fe Sport (AN) is attached to the vehicle's inner sill structure with a bolt. The bolt may not have been properly torqued during vehicle assembly. If the driver's seat belt detaches from the anchor point in a collision, the risk of injury to the occupant is increased. This bulletin describes the procedure to inspect the driver's seat belt anchor bolt to confirm it is properly torqued.

NOTE: This issue does not affect the front passenger seat belt assembly.

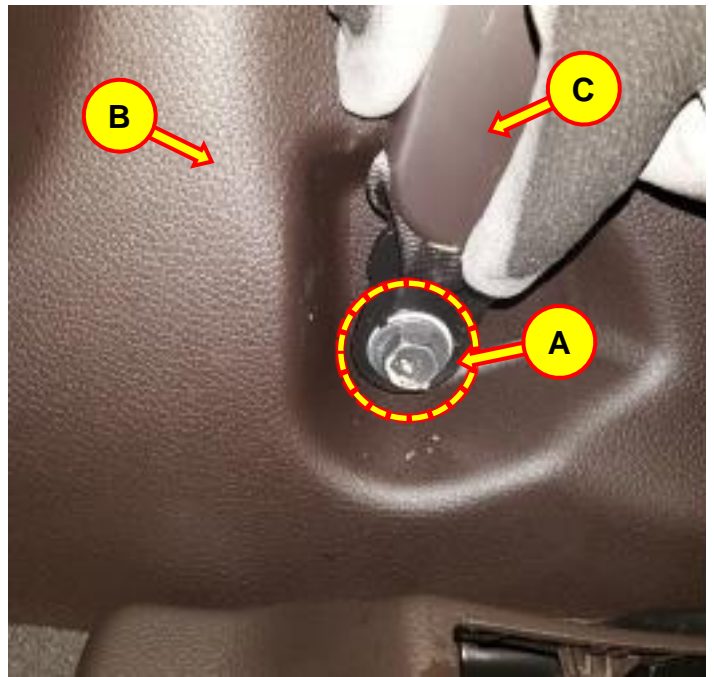
1. Move the driver seat forward to allow access to the driver seat belt anchor bolt (A) located by the lower B pillar trim (B). To access the bolt, pull the anchor bolt cover (C) up to expose the anchor bolt.

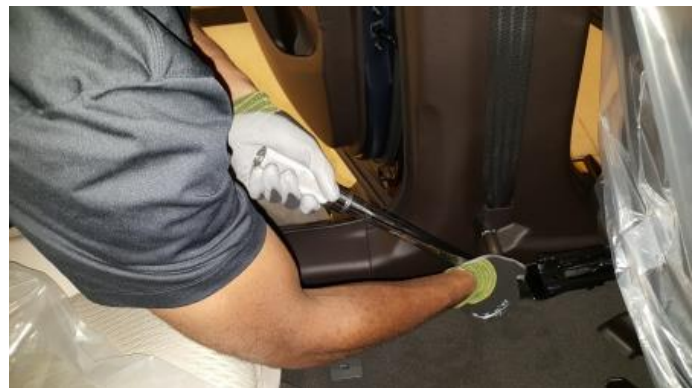
2. Set the torque wrench to nominal (47NM or 34.7 ft-lbs). Apply torque to the anchor bolt until it is tightened to spec.

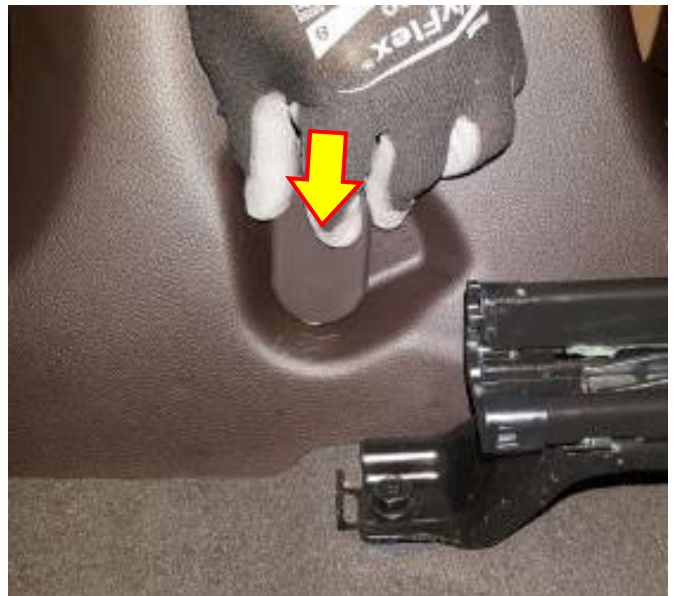
3. Reseat the anchor bolt cover over the anchor bolt and move the driver seat rearward.
