CERTAIN 2016 MODEL YEAR TRANSIT CONNECT VEHICLES — FUEL FILLER PIPE LABEL CORRECTION

OVERVIEW

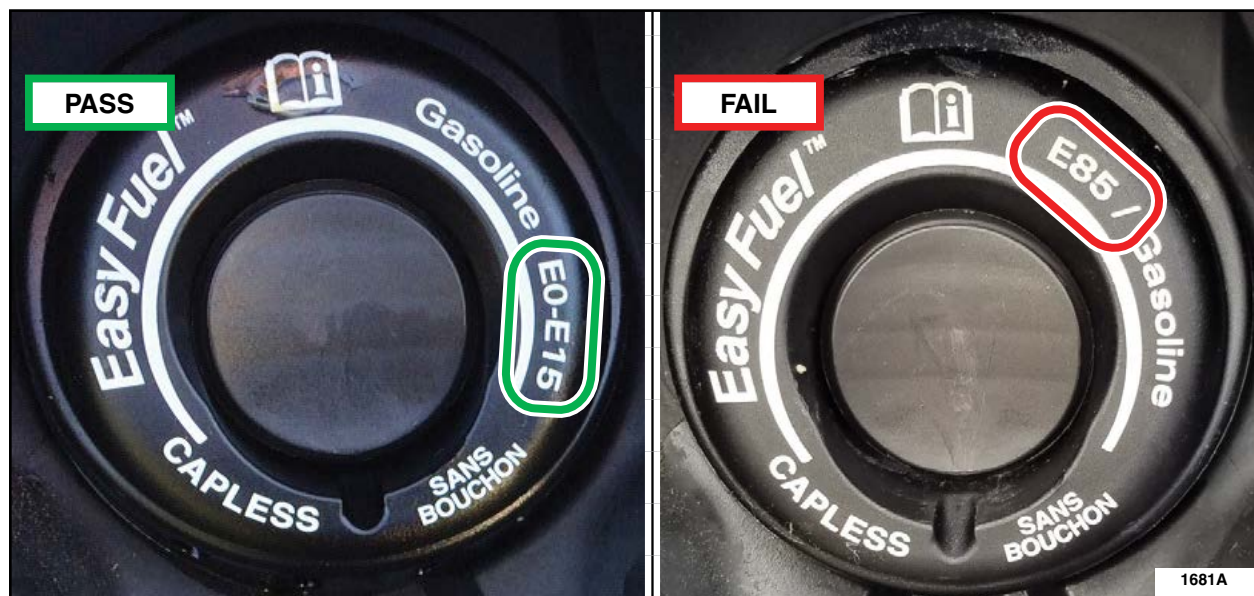
FIGURE 1

1. Inspect the vehicle's fuel filler pipe identification ring for the presence of the "E0-E15" or "E85 /" marking.
 - If the "E0-E15" marking is present, no further action is required.
 - If the "E85 /" marking is present, proceed to Step 2.
