SUBJECT: NEW VEHICLE DEMONSTRATION / DELIVERY HOLD - Safety Recall 16S43

Certain 2017 Model Year Fusion Vehicles Rear 60% Seat Backrest Frame Replacement

#### Safety Recall Notice 16S43 / NHTSA Recall 16V-874 Aviso de Revisión de Seguridad 16S43

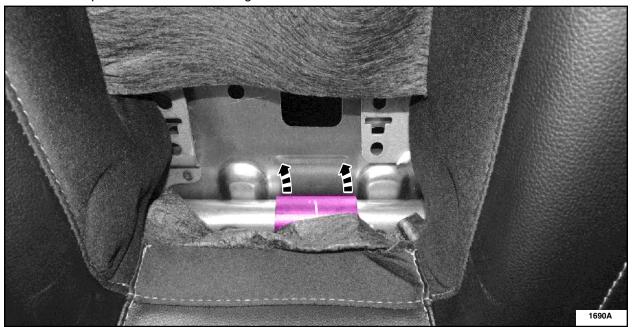
6. Detach J-clips from the frame. See Figures 3 and 4.

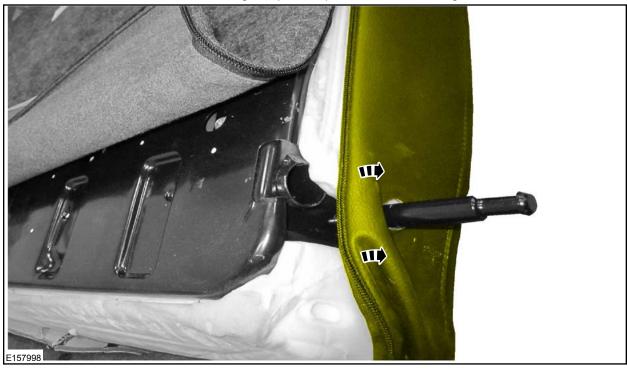
FIGURE 7

9. Pull the seat cover over the rear seat guide pin and position aside. See Figure 7.
