# Safety Recall

## Code: 20Y6

<b>Subject</b>	<b>Suction Pump</b>
<b>Release Date</b>	November 10, 2016
<b>Revision Summary</b>	<b>Additional steps and a note added to the repair procedure.</b>
<b>Affected Vehicles</b>	<b>U.S.A. &amp; CANADA: 2015-2016 MY Volkswagen Golf, GTI &amp; Golf SportWagen</b> <i>Check Campaigns/Actions screen in Elsa on the day of repair to verify that a VIN qualifies for repair under this action. Elsa is the <u>only</u> valid campaign inquiry &amp; verification source.</i> <ul style="list-style-type: none"><li>✓ Campaign status must show "open."</li><li>✓ If Elsa shows other open action(s), inform your customer so that the work can also be completed at the same time the vehicle is in the workshop for this campaign.</li></ul>
<b>Problem Description</b>	The suction pump inside the fuel tank designed to purge fuel from the evaporative emissions (EVAP) system may have been damaged during assembly. This could cause fuel to flow directly into the EVAP system which could, over time, accumulate and cause a leak through the charcoal canister filter element. Leaking fuel, in the presence of an ignition source, may result in a fire.

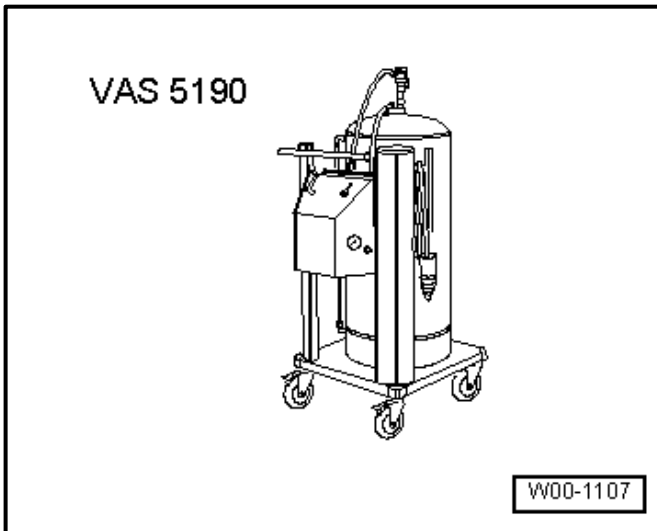
- Fuel Extractor VAS5190A -VAS5190-
