Audi

Safety Recall

Code: 20Y5

| Subject | Suction Pump |

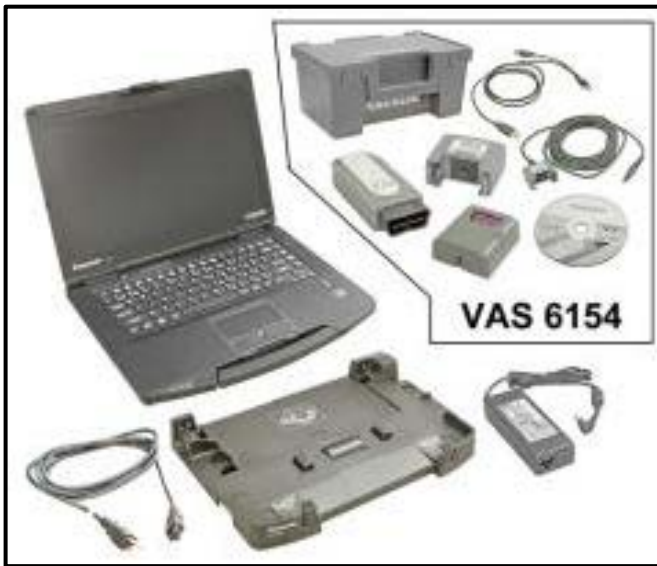
- VAS6150D – Diagnostic Tester (or equivalent)
- VAS 6154 – Vehicle Communication Interface (or equivalent)

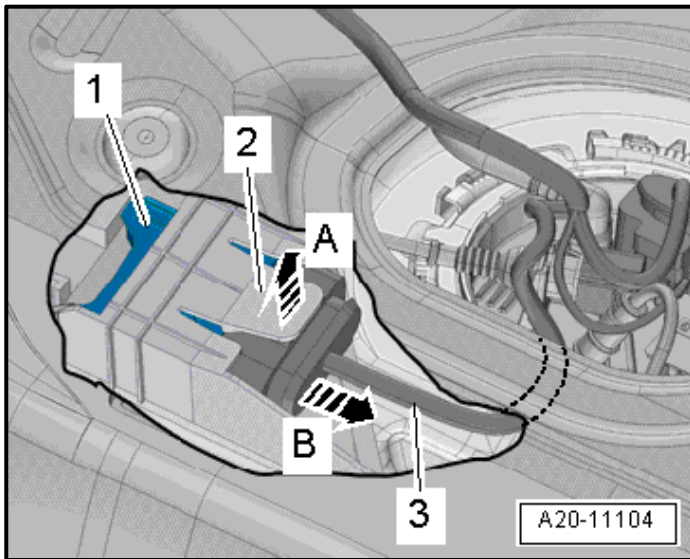
- Lift the tab <2> in the direction of the <arrow A>. To do so, reach a finger between the floor panel and the fuel tank.
- At the same time, carefully pull the Fuel Pump Control Module -J538--1- out of the mount at the wiring harness <3> in the direction of the <arrow B>.
- Remove the Fuel Pump Control Module -J538- toward the inside between the fuel tank and the floor panel.
- Move the Fuel Pump Control Module -J538- together with the wiring harness to the side.

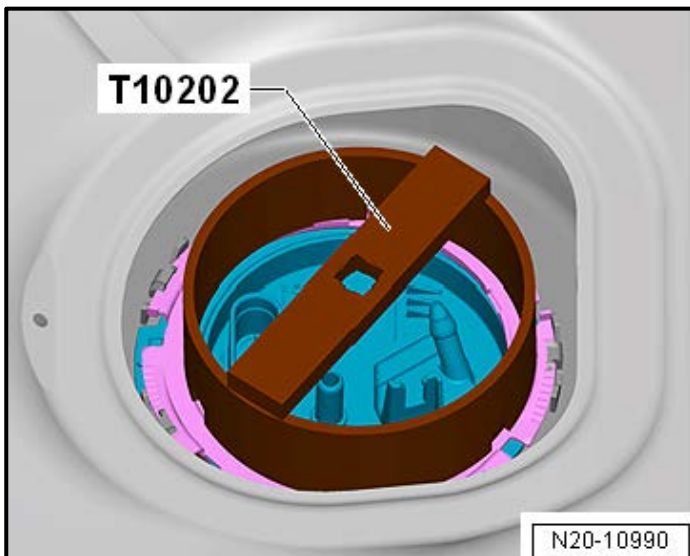
- Open the locking ring using the Wrench - Fuel Sending Unit -T10202-.
- Carefully lift the fuel delivery unit flange.

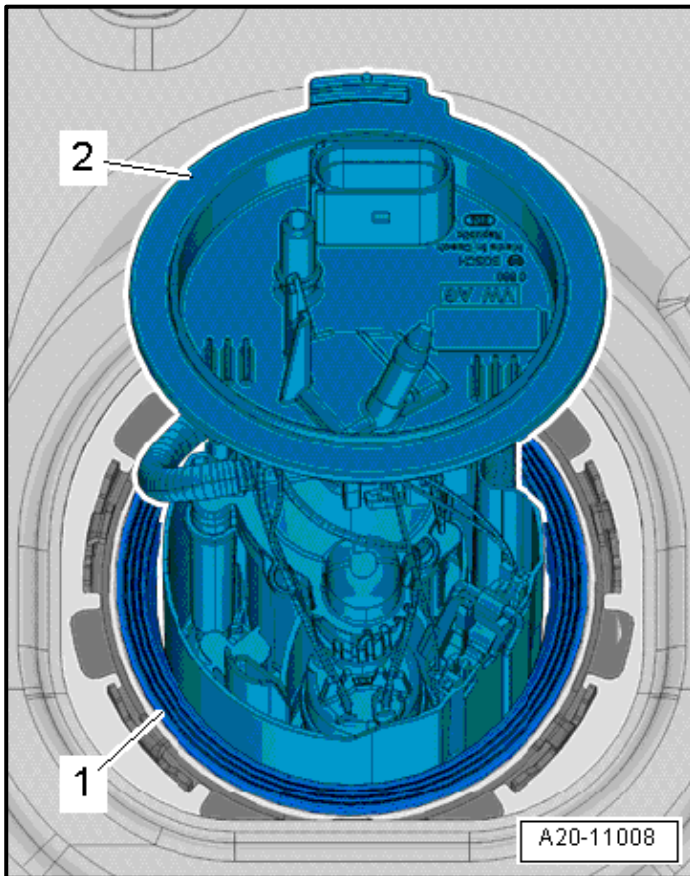
- Pull the sealing flange <2> out of the opening in the fuel tank slightly.
- Remove the seal <1> and slightly lift the fuel delivery unit flange again carefully.
- Attach the ground wire of the -VAS5190- to a bare area on the body.
- Insert the suction hose for the -VAS5190- as deep as possible into the fuel tank.
- Extract the fuel using the -VAS5190.
- Insert the extraction hose into the fuel delivery unit.
- Drain as much fuel as possible from the fuel delivery unit itself.

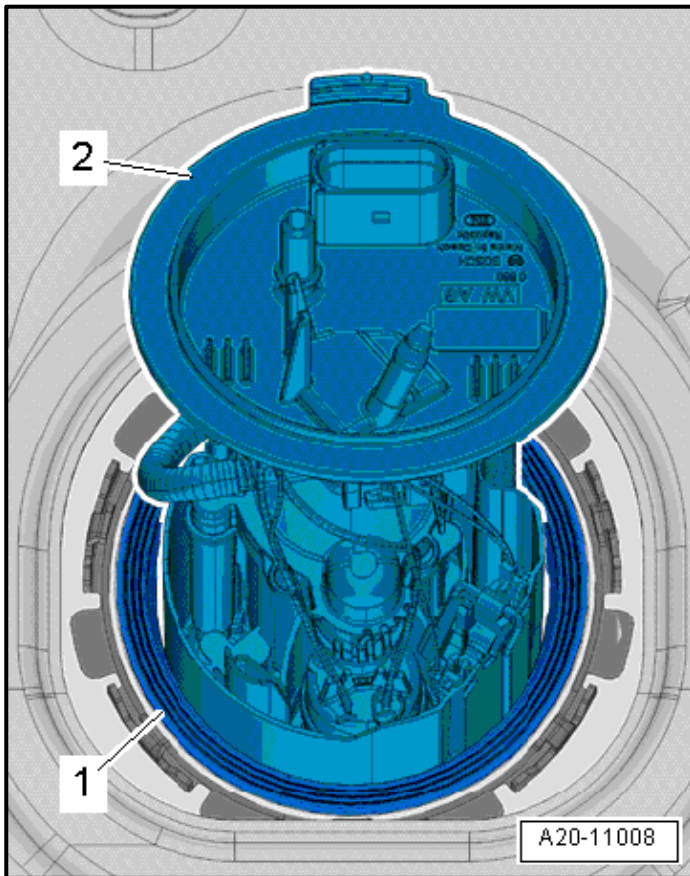
- Reinstall the fuel delivery unit, using caution not to bend the fuel level sensor when installing.

⚠ CAUTION
 Be careful not to bend the fuel level sensor when installing the fuel delivery unit.

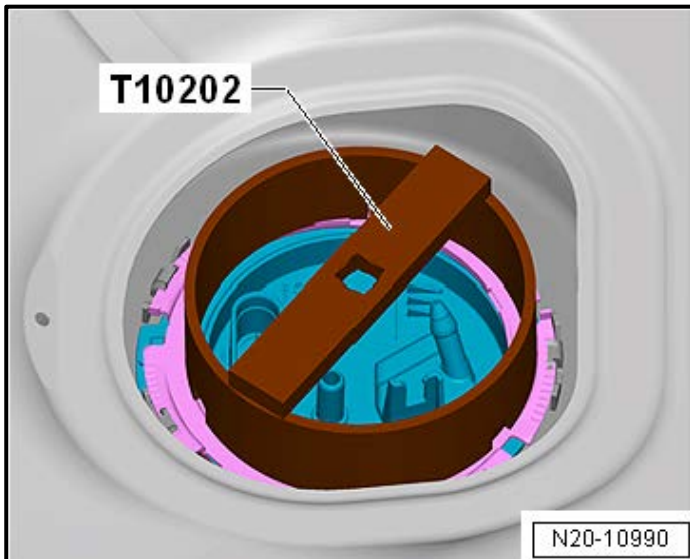
- Using the -T10202-, tighten the locking ring to 110 Nm.
