August 18, 2017

**SUBJECT: NEW VEHICLE DEMONSTRATION / DELIVERY HOLD - Safety Recall 17S15  
 – Supplement #5**  
 Certain 2015-2017 Transit Vehicles Equipped with a Driveshaft Flexible Coupling  
 Driveshaft Flexible Coupling Repair

## CERTAIN 2015-2017 TRANSIT VEHICLES EQUIPPED WITH A DRIVESHAFT FLEXIBLE COUPLING — DRIVESHAFT FLEXIBLE COUPLING REPAIR

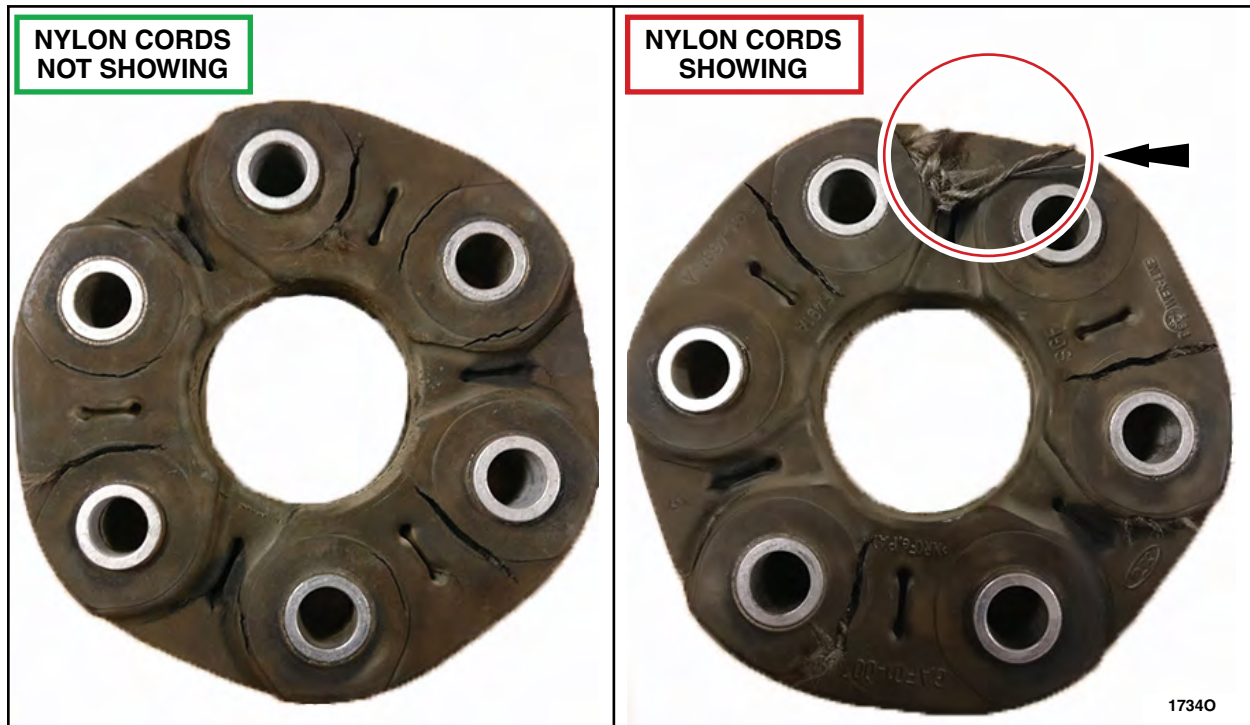
FIGURE 1

1. With the vehicle in NEUTRAL, position it on a hoist. Please follow the Workshop Manual (WSM) procedures in Section 100-02.
2. Inspect the driveshaft flexible coupling. Is the flexible coupling severely cracked with nylon cords showing? See Figure 1.

No - Proceed to Page 3 for Driveshaft Flexible Coupling Replacement.

Yes - Proceed to Page 4 for Driveshaft Pilot Bushing and Driveshaft Flexible Coupling Replacement.

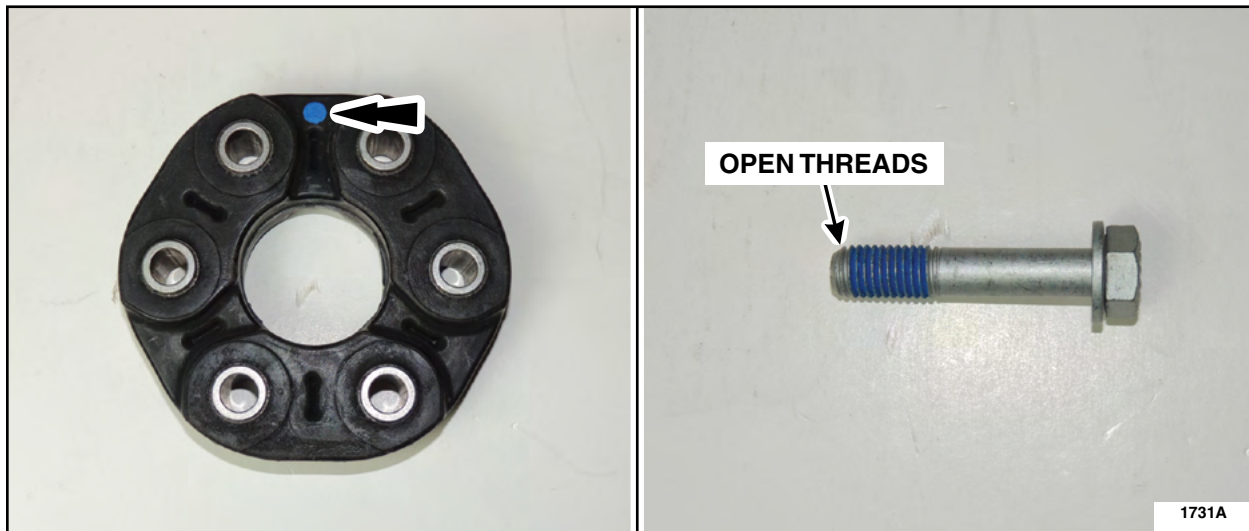
FIGURE 2a

Replace the Driveshaft Flexible Coupling. Please follow the WSM procedures in Section 205-01.

- To assist with the removal of the driveshaft flexible coupling-to-transmission output flange bolts, the use of a Mini-Ductor™ induction heating tool, or equivalent, is recommended.
- The blue paint marking on the *new* driveshaft flexible coupling must be installed facing the transmission output flange or premature failure of the flexible coupling will occur. See Figure 2a.
- Clean and re-use the six driveshaft flexible coupling bolts. Starting at the end of the bolt, leave one or two threads free of adhesive and apply Loctite 243® threadlocking adhesive (or equivalent) to at least seven threads minimum. See Figure 2b.
- The driveshaft center bearing attaching bolts can be reused without the use of Loctite®.

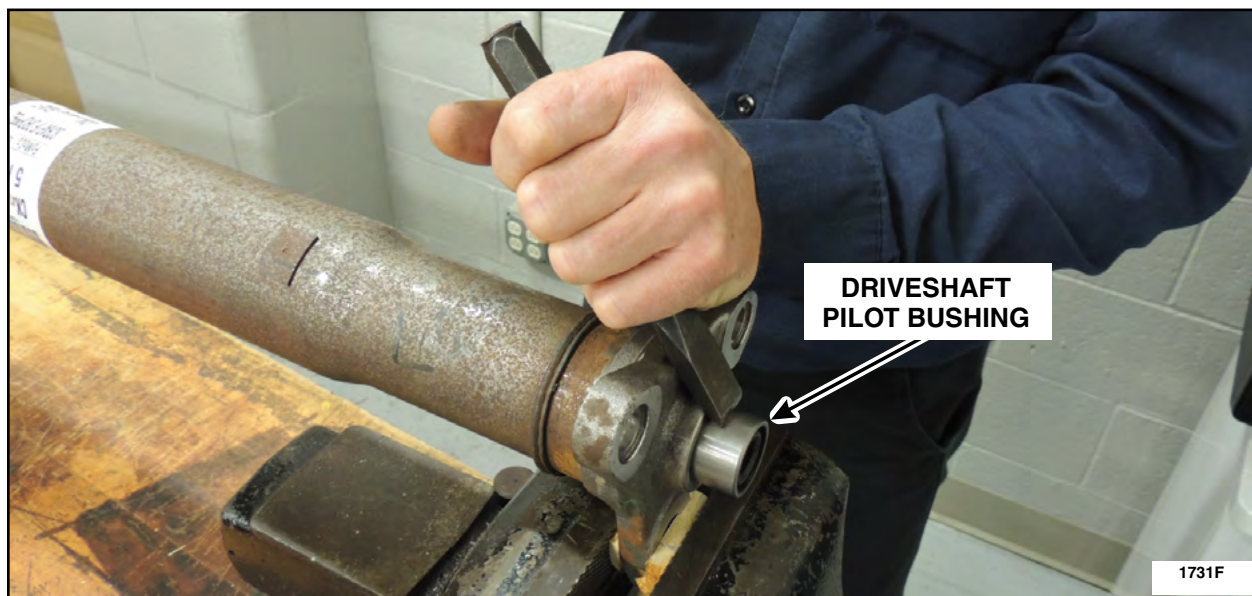
FIGURE 3

2. Using a hammer and chisel with a sharp edge, remove and discard the driveshaft pilot bushing. See Figure 3.

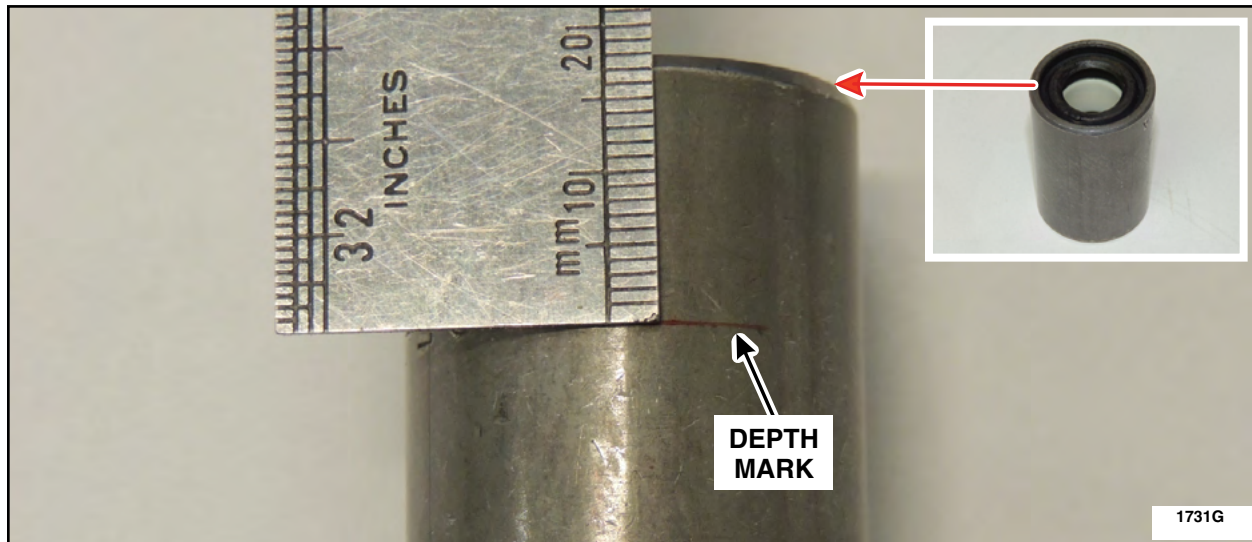
**FIGURE 4**

3. Measure 18 mm (11/16 in) from the seal end of the new pilot bushing and mark the depth.  
See Figure 4.

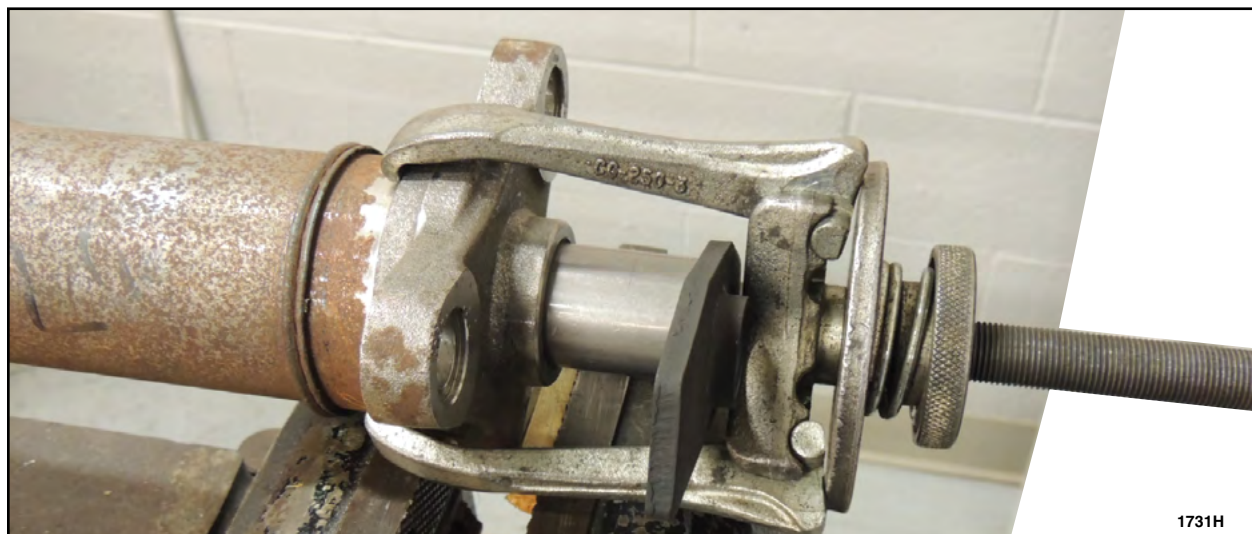
**FIGURE 5**

4. **NOTE:** Prior to installation of the new driveshaft pilot bushing, make sure the rubber seal end of the bushing is facing outward and the capped end is pressed into the driveshaft.

Using a 3-jaw puller and a suitable flat piece of metal, press in the new pilot bushing until the previously measured depth has been reached. See Figure 5.

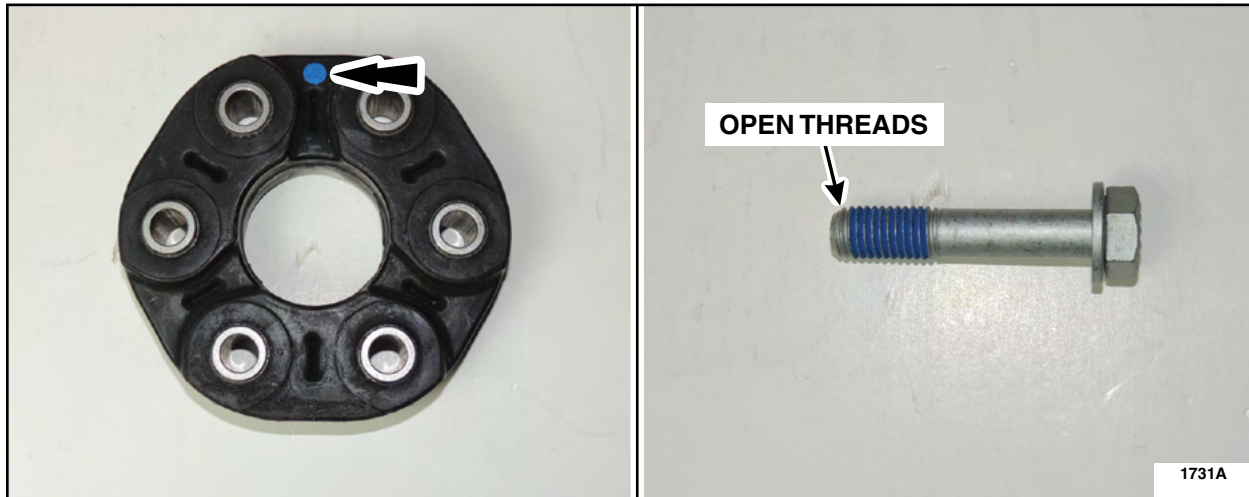
FIGURE 6a

5. Install a new driveshaft flexible coupling and reinstall the driveshaft following the driveshaft removal and installation procedure in WSM Section 205-01.

- The blue paint marking on the new driveshaft flexible coupling must be installed facing the transmission output flange or premature failure of the flexible coupling will occur. See Figure 6a.
- Clean and re-use the six driveshaft flexible coupling bolts. Starting at the end of the bolt, leave one or two threads free of adhesive and apply Loctite 243® threadlocking adhesive (or equivalent) to at least seven threads minimum. See Figure 6b.
- The driveshaft center bearing attaching bolts can be reused without the use of Loctite®.

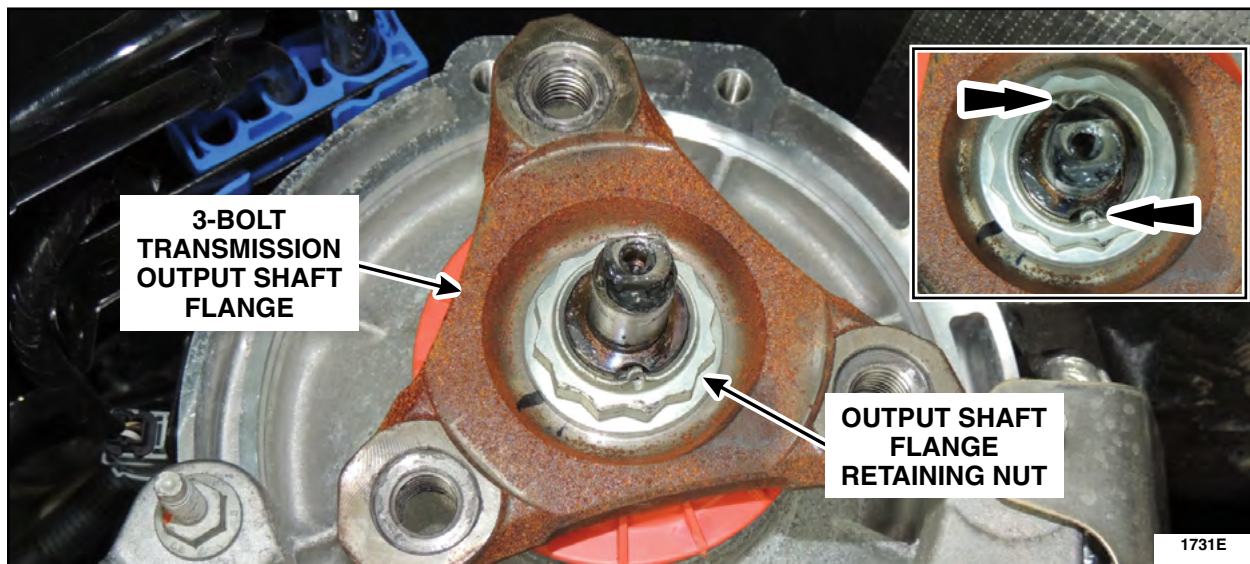
FIGURE 7

**NOTICE: The output shaft flange retaining nut has been staked to prevent it from coming loose. Prior to removing the nut, remove the stake to prevent damage to the output shaft.**

- a. Remove the output shaft flange retaining nut stakes.
- b. Place the vehicle in the PARK position and remove and discard the output shaft flange retaining nut.
- c. Remove and discard the 3-bolt transmission output shaft flange.

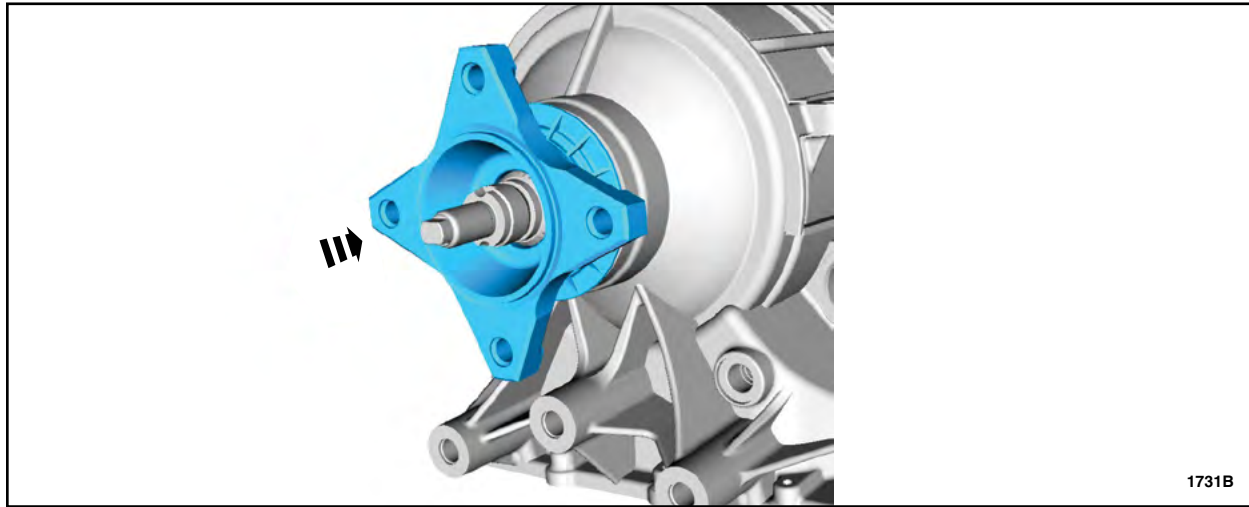
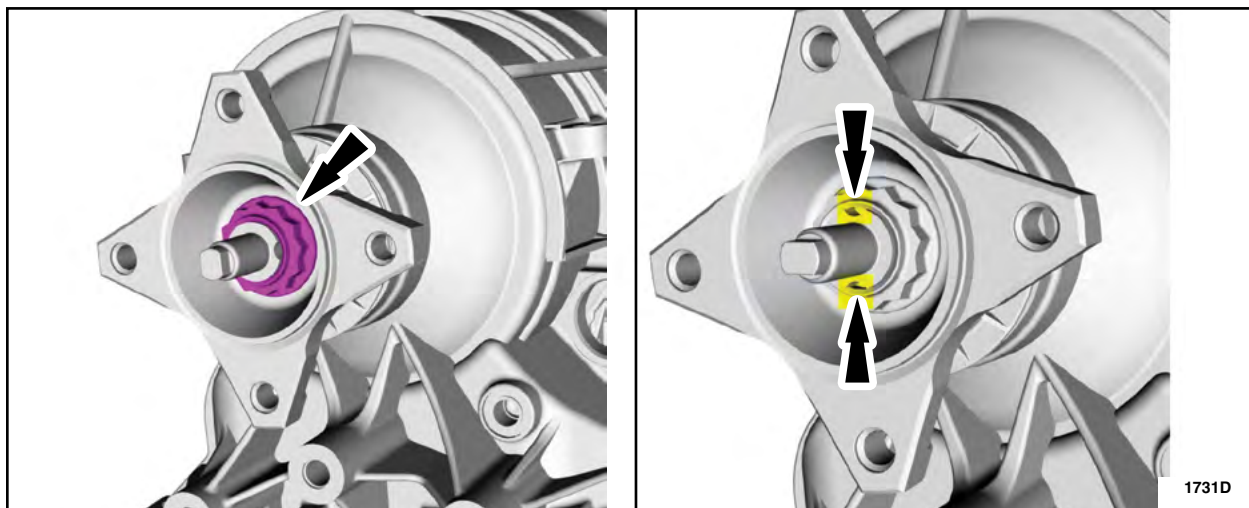
FIGURE 8

**NOTICE:** The output shaft flange retaining must be staked to prevent it from coming loose.

- Install a *new* 4-bolt transmission output shaft flange.
- Install a *new* output shaft flange retaining nut.
  - Tighten nut to 59 lb.ft (80 Nm).
- Stake the output shaft flange retaining nut.

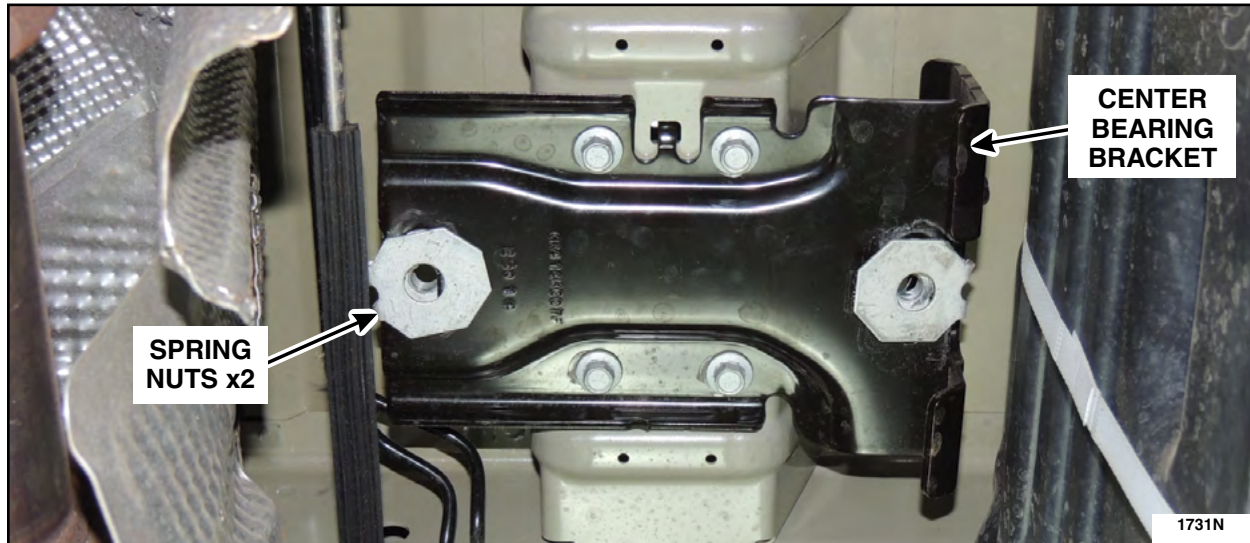
**FIGURE 10**

1. Remove and discard the four center bearing bracket retaining bolts and the center bearing bracket. See Figure 10.

**NOTE:** Original center bearing bracket shown, *new* bracket is similar.

2. Install the center bearing bracket spring nuts onto the *new* center bearing bracket.
3. Install the *new* center bearing bracket using four *new* retaining bolts. See Figure 10.
  - Tighten bolts to 18 lb.ft (25 Nm).
4. Proceed to the next required Permanent Repair Service Procedure.

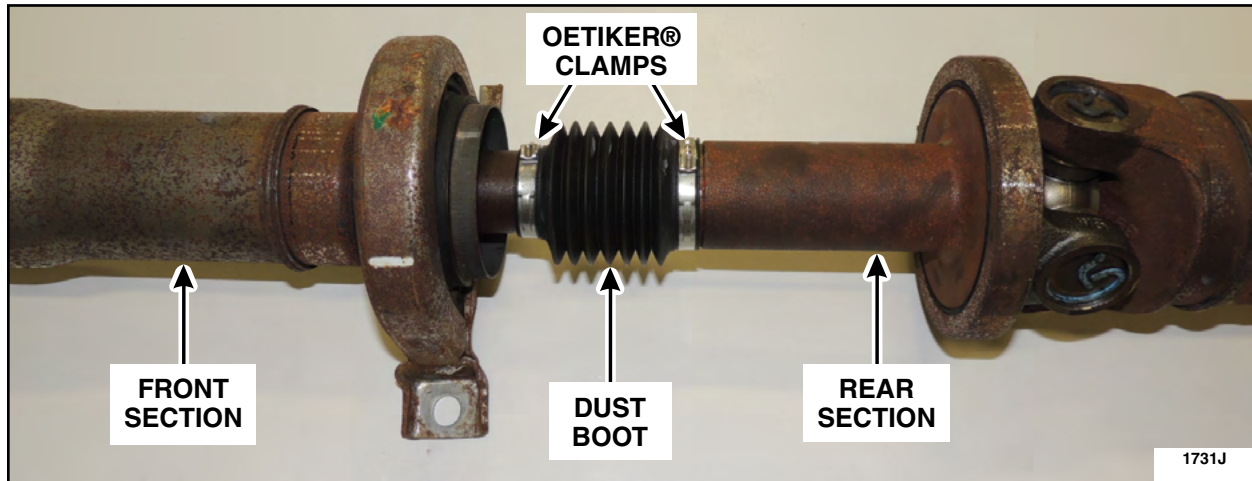
FIGURE 11

1. Separate the driveshaft front and rear sections at the driveshaft slip yoke. See Figure 11.
  - a. Cut and discard both dust boot Oetiker® clamps.
  - b. Separate the driveshaft front and rear sections.
  - c. Remove and discard the dust boot.

2. Install a *new* driveshaft front section onto the rear section. See Figures 11 and 12.
  - a. Slide a *new* slip yoke dust boot over the driveshaft rear section.
  - b. Lubricate the front section splines using 10-20 grams (0.35 - 0.7 oz) of Motorcraft® XG-8 Driveshaft Slip Yoke PTFE Lubricant.
  - c. Attach the driveshaft front and rear sections. Make sure the front and rear driveshaft spline keys are aligned when mating the two sections together.
  - d. Make sure the slip yoke dust boot is properly aligned over each driveshaft section and tighten the dust boot Oetiker® clamps.

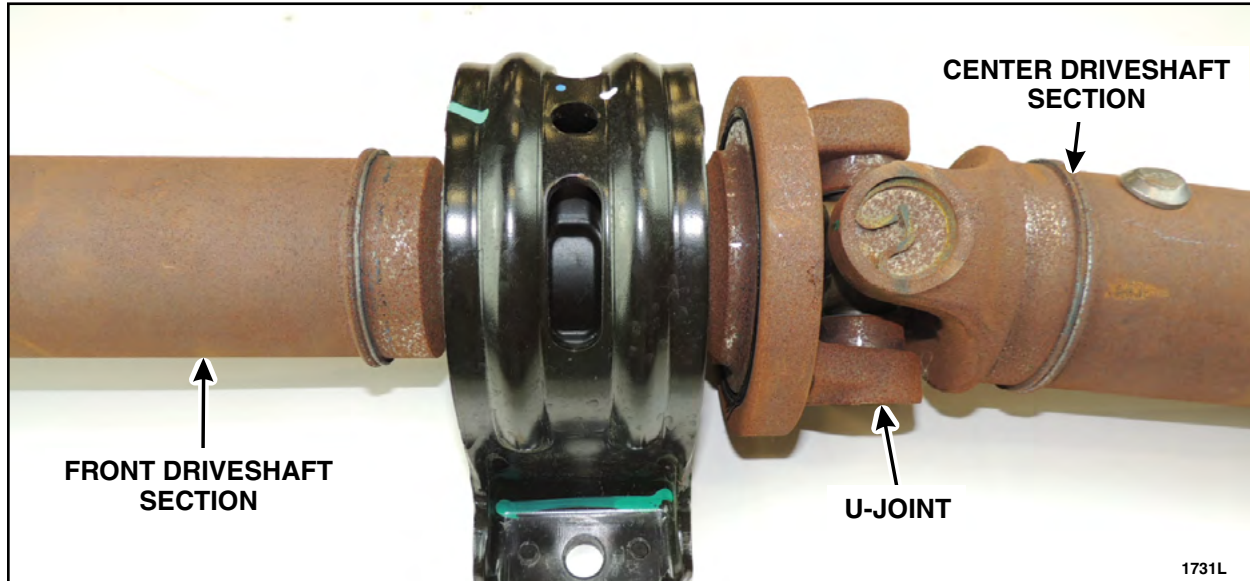
**FIGURE 13**

1. Remove and discard the four snap rings and center u-joint to separate the front driveshaft section from the center section. Please follow the Universal Joint Kit Installation Instructions. See Figure 13.

2. Install a *new* center u-joint and snap rings to attach the front driveshaft section to the center section. Please follow the Universal Joint Kit Installation Instructions.
3. Is the vehicle equipped with a 3.7L gas engine with single rear wheels, and does the Special Service Support Center (SSSC) VIN-specific part order contact response indicate a 4A209 base part number front center bearing shim is required for the vehicle?

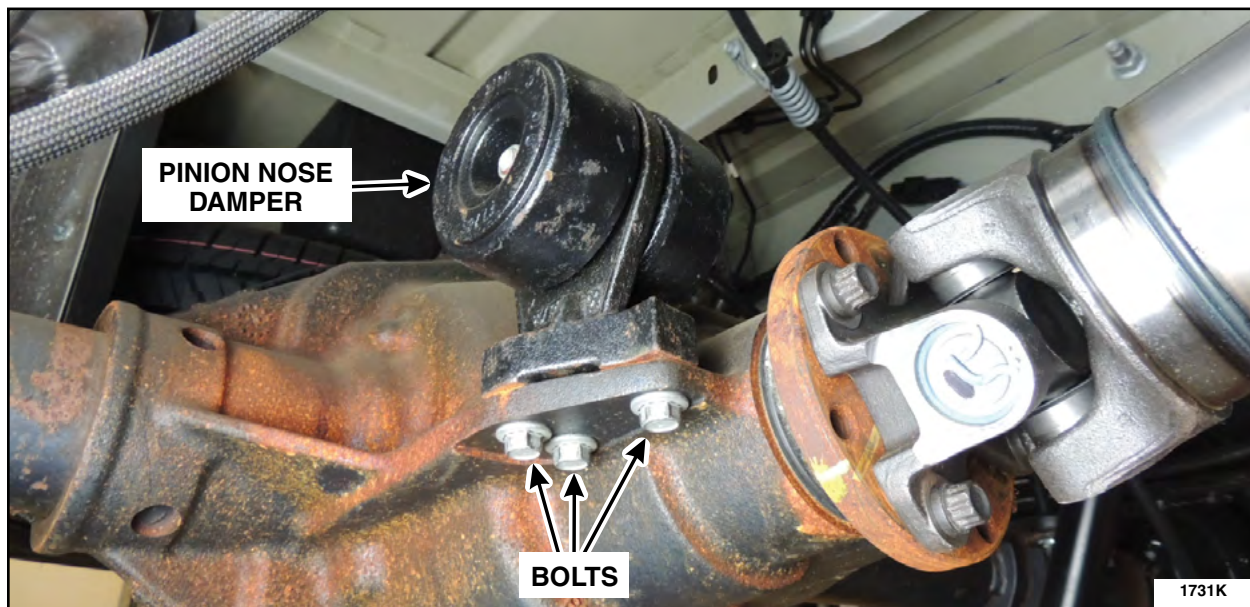
FIGURE 14

1. If a pinion nose damper is present, remove and discard the three bolts and the original pinion nose damper located on the RH side of the rear axle center housing. See Figure 14.
2. Install a *new* pinion nose damper and tighten the three bolts. See Figure 14.
  - Tighten bolts to 46 lb.ft (62 Nm).

**NOTE:** Original pinion nose damper is shown. *New* pinion nose damper may appear similar to the original (if equipped), but the dampening characteristics have been changed.
