**SUBJECT: NEW VEHICLE DEMONSTRATION / DELIVERY HOLD - Safety Recall 17S15  
 – Supplement #4**

Certain 2015-2017 Transit Vehicles Equipped with a Driveshaft Flexible Coupling  
 Driveshaft Flexible Coupling Repair

## CERTAIN 2015-2017 TRANSIT VEHICLES EQUIPPED WITH A DRIVESHAFT FLEXIBLE COUPLING — DRIVESHAFT FLEXIBLE COUPLING REPAIR

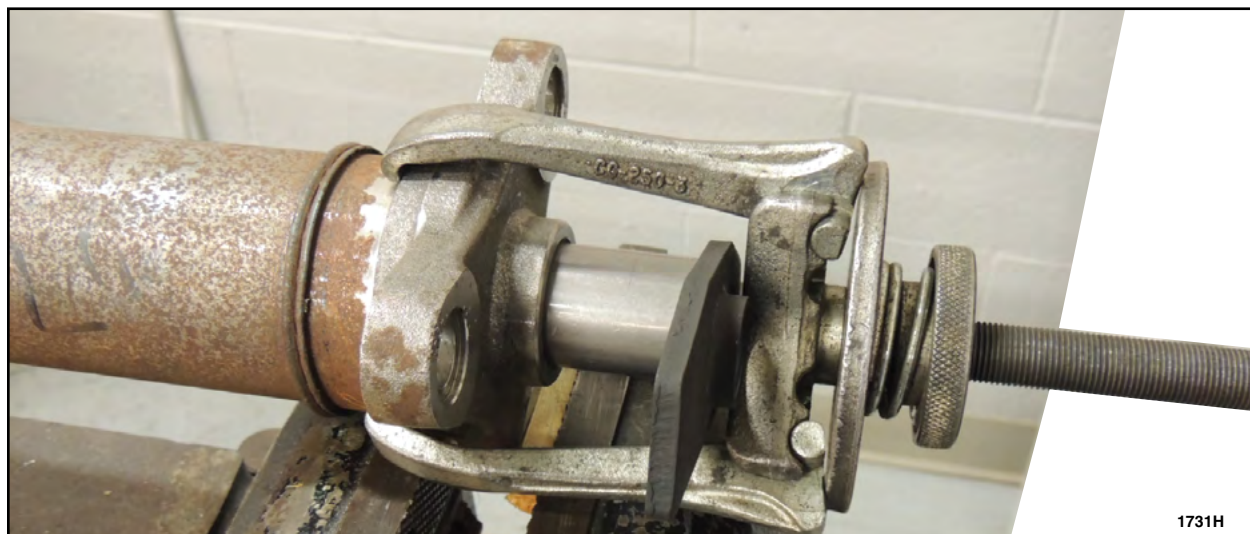
**FIGURE 5**

4. **NOTE:** Prior to installation of the new driveshaft pilot bushing, make sure the rubber seal end of the bushing is facing outward and the capped end is pressed into the driveshaft.

Using a 3-jaw puller and a suitable flat piece of metal, press in the new pilot bushing until the previously measured depth has been reached. See Figure 5.

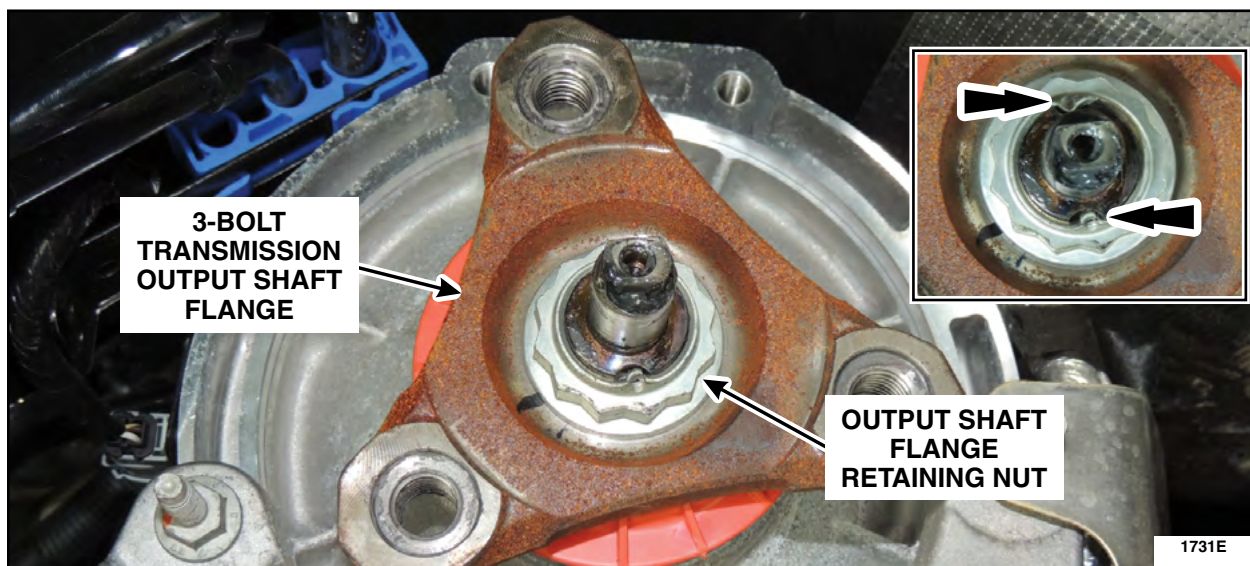
FIGURE 7

**NOTICE: The output shaft flange retaining nut has been staked to prevent it from coming loose. Prior to removing the nut, remove the stake to prevent damage to the output shaft.**

- a. Remove the output shaft flange retaining nut stakes.
- b. Place the vehicle in the PARK position and remove and discard the output shaft flange retaining nut.
- c. Remove and discard the 3-bolt transmission output shaft flange.
