Maserati Technical Bulletin

Date: October 23, 2017
Bulletin Number: MAS001376 - Recall 359
Low Pressure Fuel Pump Resistors
Supersedes: N/A
Section: Compliance

Model Type: Quattroporte GTS V8 - Single Pump Fuel System

Subject: Vehicle Safety Recall Campaign 359, Low pressure fuel pump resistor replacement

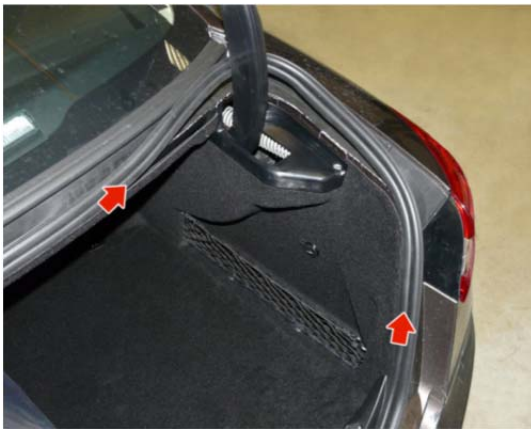
Fig.1

1. Disconnect the battery.
NOTE: Before disconnecting the battery, lower the front and rear door windows a few centimeters then set the “KIN” to the “OFF” position.
2. Remove the R/S trunk liner.
 - a) Lift the trunk seal as shown in Fig.1.
 - b) Remove the trunk light as shown in Fig.2 then disconnect the wires.

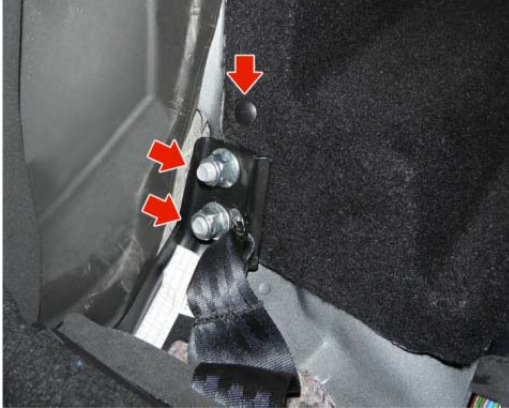
Fig.3

3. Remove the button clip and loosen the two retaining nuts of the seatback. (Fig.3)

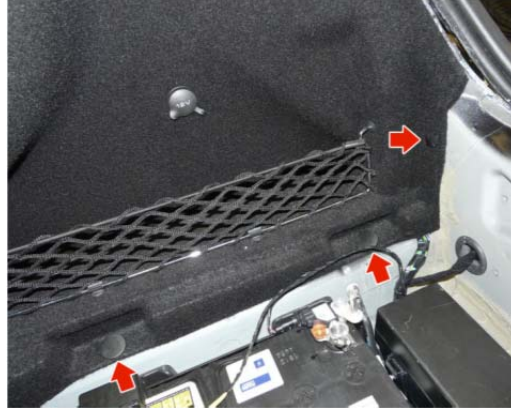
Fig.4

4. Remove the 3 button clips on the right side trunk liner. (Fig.4)
5. Disconnect the wire connector from the 12 V power socket. (Fig.5)

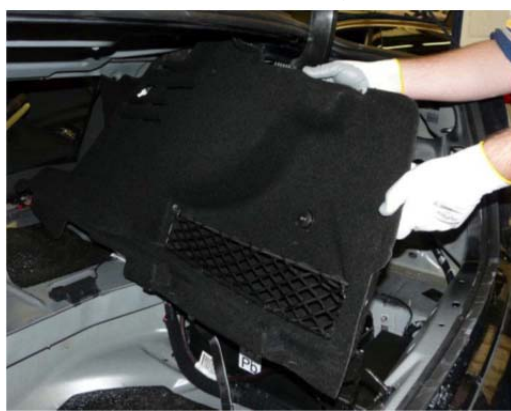
Fig.6

6. Remove the R/S trunk liner. (Fig.6)
7. Using a suitable tool, unfasten the connector retaining clip. (Fig.7)

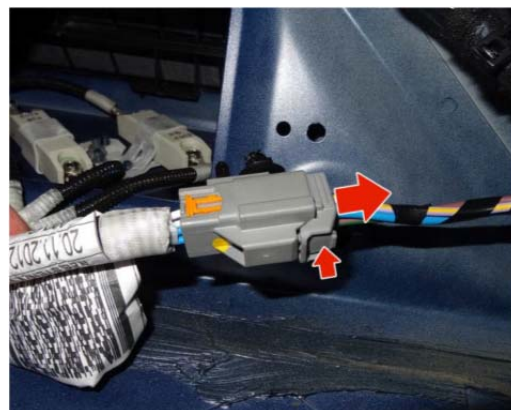
Fig.8

8. Press the locking tab, then disconnect the resistor connector. (Fig.8)

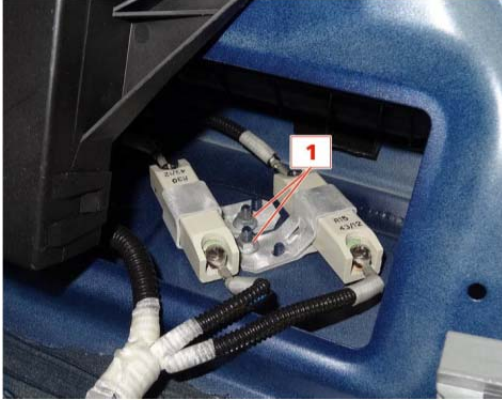
Fig.9

9. Remove the 2 fastening nuts (1) that secure the resistor assembly. (Fig.9)

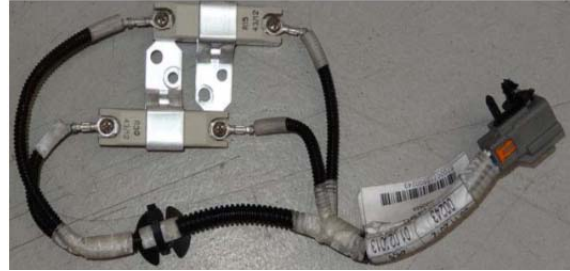
Fig.10

10. Install the new resistor assembly part number: 670104011(Fig.10) by following the removal instructions in reverse order.

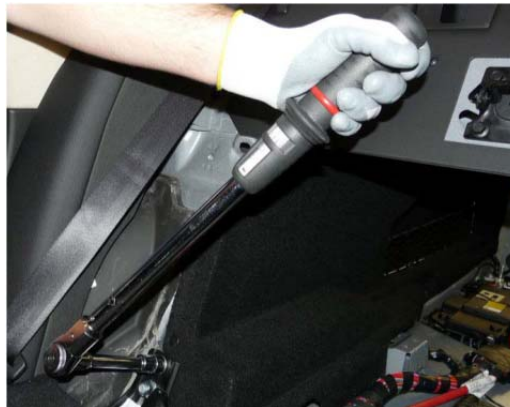
Fig.11

11. When re-installing the seatback retaining nuts, torque them to 55 Nm. (Fig.11)
