# Service Bulletin No. 455

<small>MODEL</small> <b>J4500</b>	<small>TYPE</small> <b>Field Change Program</b>	<small>SECTION/GROUP</small> <b>4-Air System &amp; Brakes</b>	<small>DATE</small>
<small>SUBJECT</small> <b>MISCONNECTION OF INSTRUMENT GAUGE AIR LINES</b>			
<small>CONDITIONS</small>

Ref. MCI NHTSA Recall No.: 17V-687

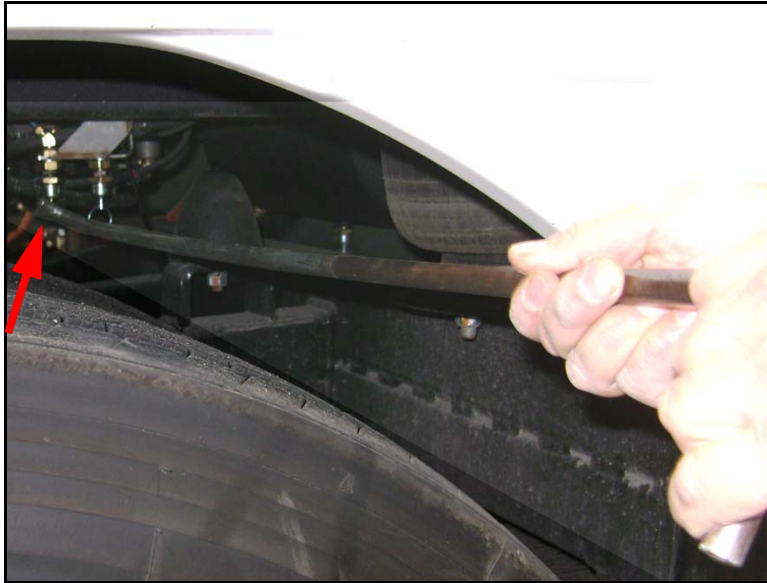
**Figure 1. Reference photo of utilizing a hook rod on the tank automatic drain valve.**

2. Drain the air from the system by releasing all the air in the front and rear tanks equipped with an automatic drain valve ( refer to Figure 1 ).

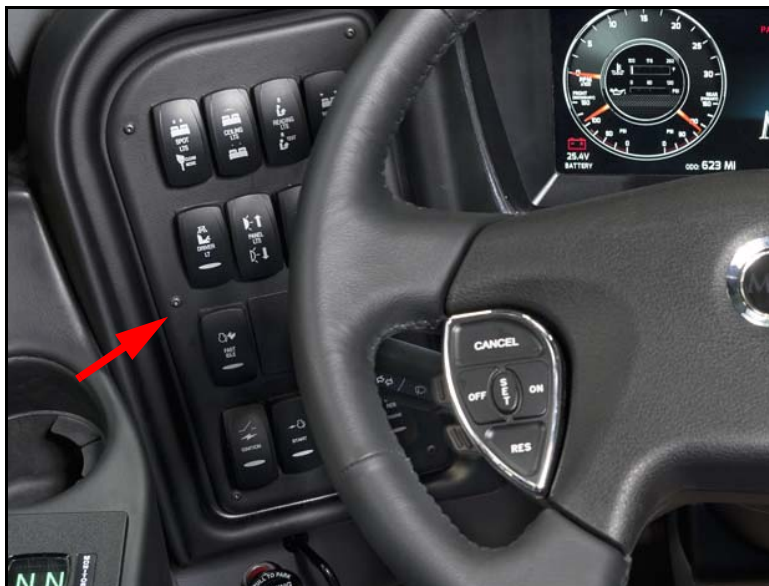
**Figure 2. LH switch panel location on the instrument panel.**

3. Enter the coach cabin. Apply multiple service brake applications to drain any remaining air out of the system.
4. Locate the LH switch panel on the instrument panel ( refer to Figure 2 ).

5. Using an allen wrench, remove and retain the six ( 6 ) mounting screws from the LH switch panel. Carefully lean the LH switch panel towards the driver's seat to allow access to the interior of the instrument panel.
6. Locate the dual air transducer in the cavity behind the LH switch panel mounting plate ( refer to Figure 3 ).
7. Locate the 1/4 inch green and red air lines routed and connected to the dual air transducer.

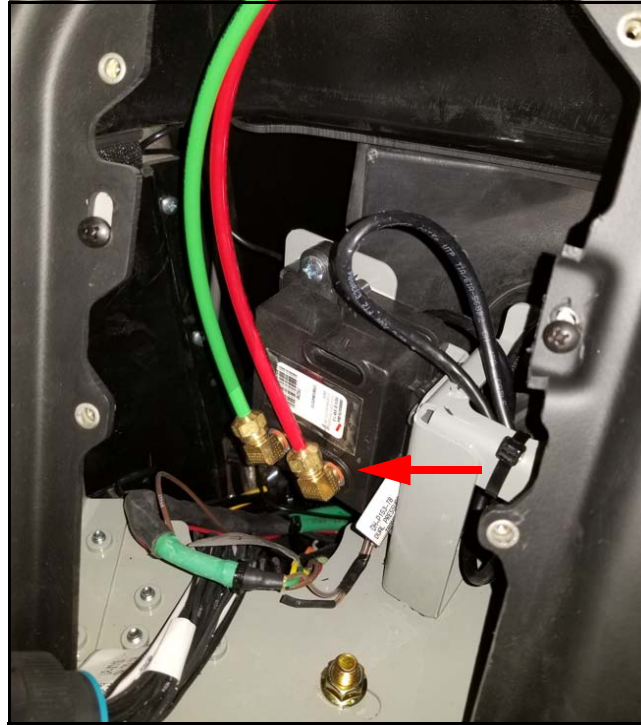
**Figure 3. Dual air transducer location.**

8. Using two ( 2 ) wrenches, one wrench on the nut and one on the fitting body, turn to release the nut on the brass, 90 degree elbow fitting. Carefully pull to release the air line from the fitting body. Repeat step to the remaining brass, 90 degree elbow fitting.

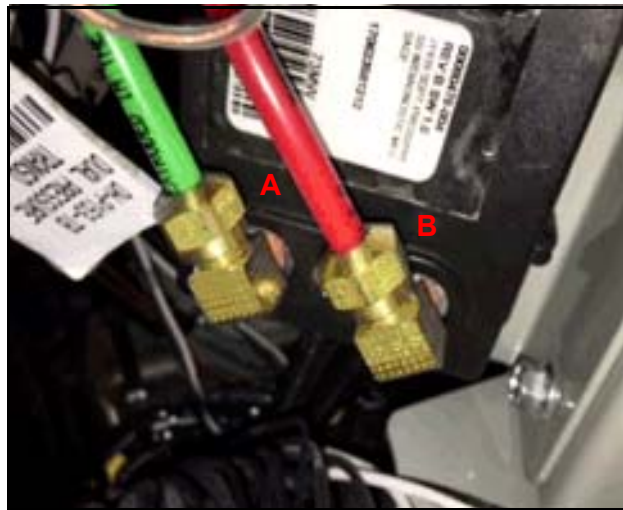
**The dual air transducer body has a stamped A and B directly above the brass 90 degree elbow fitting to aid in correct orientation of air lines ( refer to Figure 4 ).**

**Figure 4. Routed air line connection to brass, 90 degree elbow.**

9. Orient and insert the green, 1/4 inch air line to the outboard 90 degree elbow fitting ( stamped A location on dual air transducer body ) as shown in Figure 4. While simultaneously holding the air line tighten the nut on the 90 degree elbow fitting hand-tight. Using two ( 2 ) wrenches, tighten the nut three ( 3 ) additional turns from hand-tight.
10. Orient and insert the red, 1/4 inch air line to the inboard 90 degree elbow fitting ( stamped B location on dual air transducer body ) as shown in Figure 4. While simultaneously holding the air line tighten the nut on the 90 degree elbow fitting hand-tight. Using two ( 2 ) wrenches, tighten the nut three ( 3 ) additional turns from hand-tight.
11. Apply upwards pressure on both the red and green air line to ensure correct installation and engagement.
