# Service Bulletin

Subject: Rear wheel rim

Product: **Brutale 800 Dragster RR**

MV AGUSTA MOTOR S.p.A.  
Technical Service Department  
Recall 2813

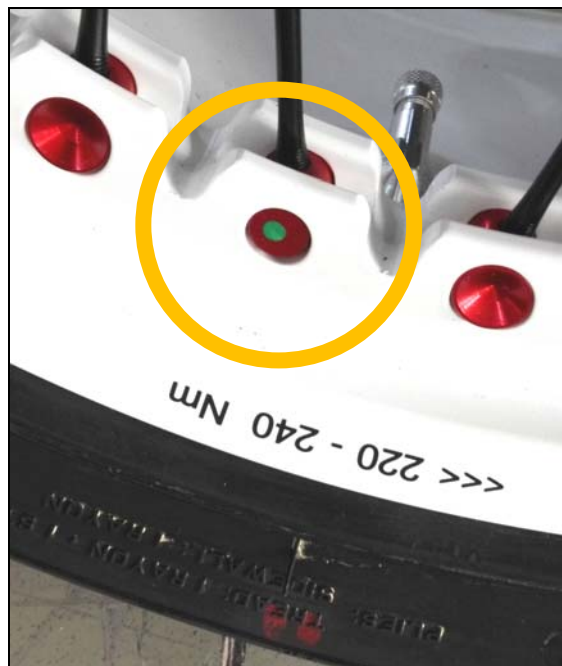
- Send Warranty Claim to activate the spare parts order and subsequent reimbursement of the spare part and labour. In addition to the vehicle's information, provide the following details:
  - Type of warranty = 2 available options:
    - New in stock motorcycles = **GX**
    - Sold motorcycles with activated warranty = **GS**
  - Special warranty number = 2813 ( to be used both for **GX** and **GS** )
  - Qty 1 component code = 3 available options:
    - Code 80C0C0046 black rim / gold hub and nipples;
    - Code 80A0C0046 black rim / red hub and nipples;
    - Code 8000C0046 white rim / red hub and nipples.
  - Operation code: N 099
  - Labour: 0.8 ore
  - Defect code: 099
  - Incident date: enter warranty request date
- Take the new rear wheel rim received and identified by the painted green colour dot as shown in the following photo:

- Install the new rim while respecting the specifications in the workshop manual.
- Run a dynamic test of the motorcycle to verify its conformity.
