<b>Technical Service Bulletin:</b> TSB180058	<b>Released Date:</b> 27-Feb-2019
<b>Belt Noise and Front Engine Accessory Drive Belt Re-routing: Tiffin Recreational Vehicles</b>

## Belt Noise and Front Engine Accessory Drive Belt Re-routing: Tiffin Recreational Vehicles

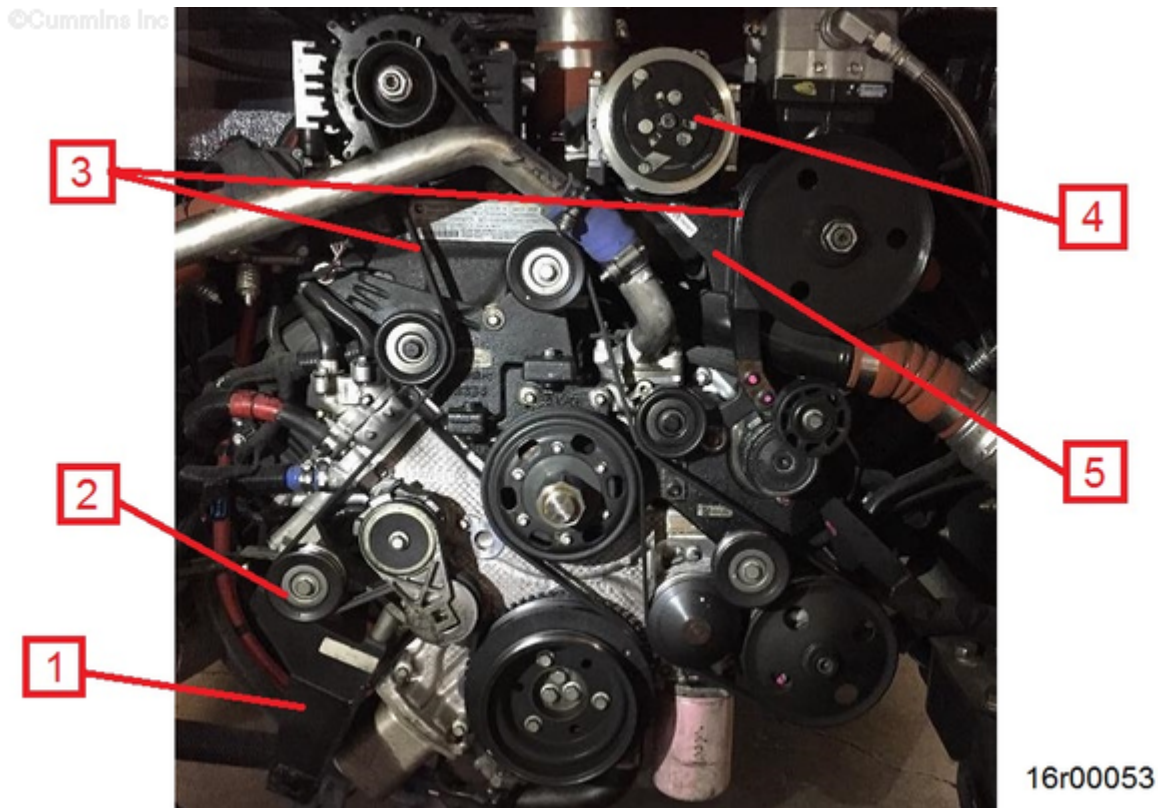
Figure 3, Original Design (Tiffin RV). Compressor Belt Has Already Been Removed From This Figure.

1. OEM Lower Fan Shroud Support Bracket.
  2. Lower Idler Pulley.
  3. Belts to be removed.
  4. Refrigerant compressor.
  5. Upper refrigerant compressor Support.
7. Remove L-Bracket (Figure 4 - 7) and P-clamp (Figure 4 - 8) assembly from lower accessory support, Part Number 4390708 (Figure 4 - 9).
- Disconnecting P-clamp from bracket is **not** necessary.
8. Remove OEM lower fan shroud support bracket (Figure 4 – 4) mounted to lower accessory support bracket, Part Number 4390708, (Figure 4 - 9) and OEM fan shroud.
- a. Reuse p-clip mounting bracket (Figure 4 - 7), capscrews, washers, and nut at fan shroud position. (Figure 4) Tighten all fasteners to proper specifications.

1. Refrigerant compressor wiring connector.
  2. Refrigerant compressor supply and return lines.
4. Remove and discard belts, Part Number: 4335361 and 4335602 (Figure 3).
  5. Remove and discard lower idler pulley assembly, Part Number 4390735 (Figure 3).
  6. Remove refrigerant compressor (Figure 3) from upper refrigerant compressor support.
    - a. Mounted on refrigerant compressor support bracket, Part Number 4360003 (Figure 3).
    - b. Two Sanden refrigerant compressor models have been identified as being used in Tiffin production.
      - i. Model number U4520 - replace with model number U4883
      - ii. Model number U4897 - replace with model number U4883
