CERTAIN 2015 THROUGH 2018 MODEL YEAR F-150 REGULAR CAB AND SUPERCREW CAB VEHICLES — CARPET SHIELDING AND INSULATION REWORK

SERVICE PROCEDURE - SUPERCREW CAB VEHICLES ONLY

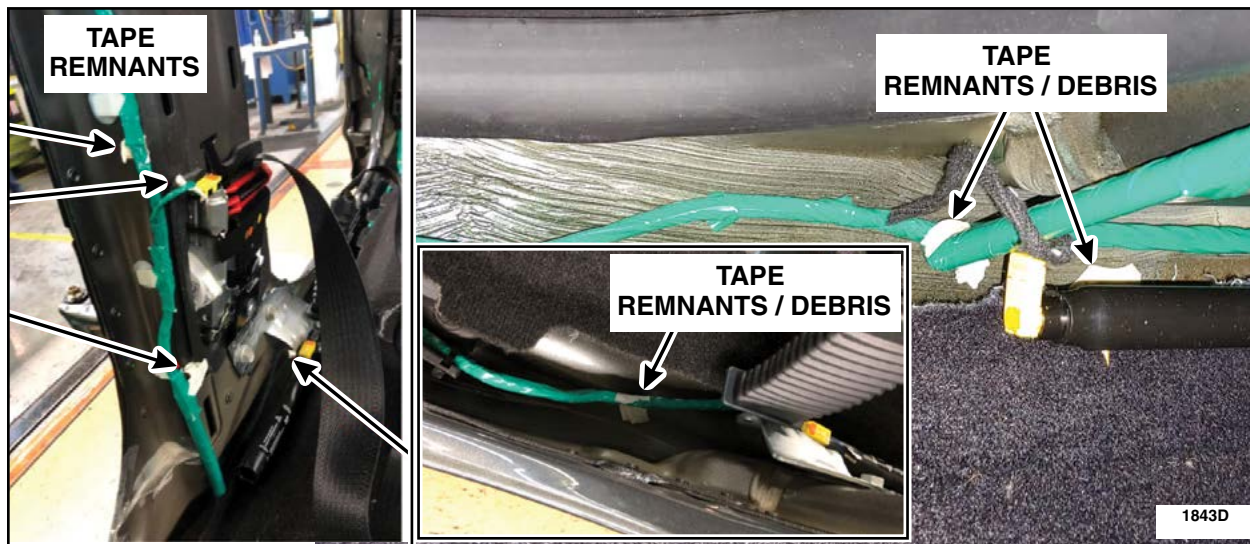
FIGURE 1

1. Remove the lower B-pillar trim panel. Please follow the Workshop Manual (WSM) procedures in Section 501-05.
 - It is not necessary to position aside the door weatherstripping for this procedure.
2. From the A-pillar backward to the C-pillar check vehicle metal floor, carpet and wire harness for tape remnants or other debris. Remove if present. See Figure 1.
 - Use a compressed air blow gun to remove smaller, hard to access debris.

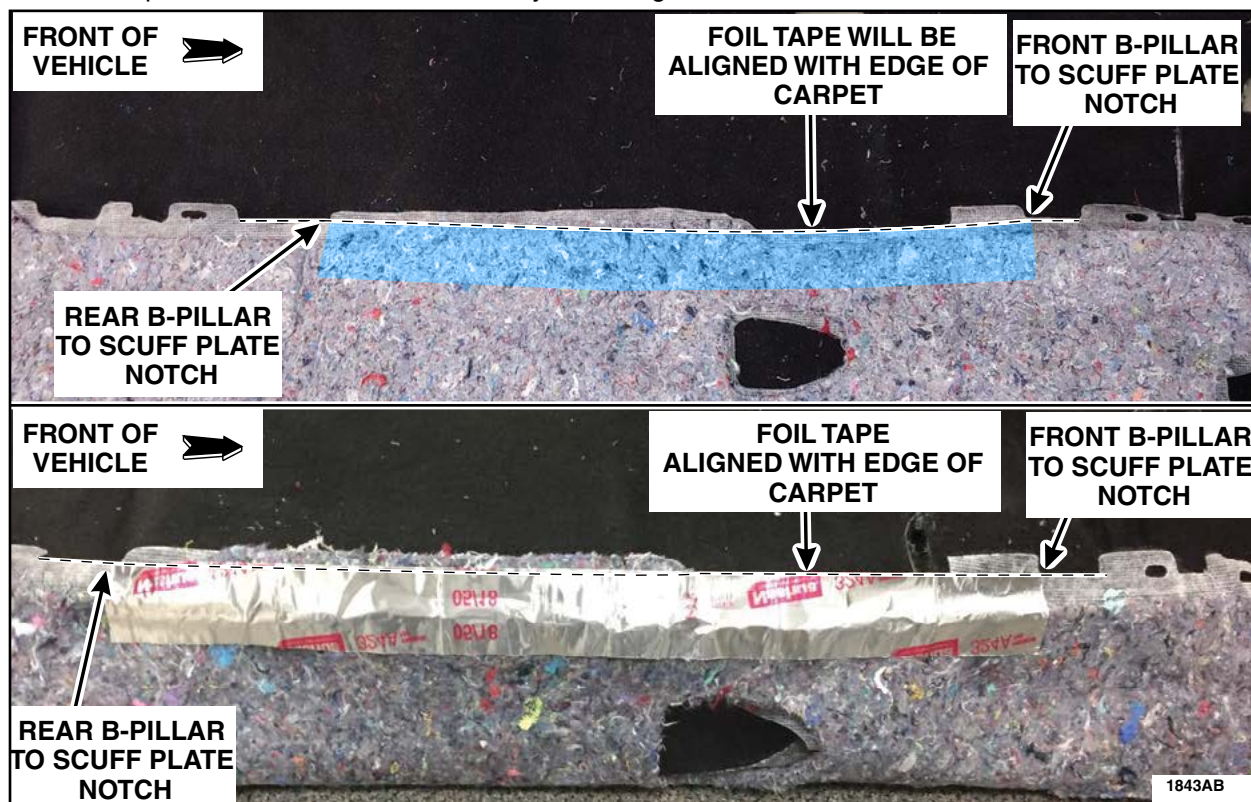
FIGURE 2

5. Apply the first length of foil tape. See Figures 2 and 3.
 - a. Position the first length of tape under the carpet and align with the edge of the carpet and the rear edge of the front B-pillar to scuff plate notch. See Figure 2.
 - b. Start from the front, peeling the paper backing off of the tape while pressing the tape into the insulation and carpet. See Figure 3.
 - c. Continue applying the tape, ending at the front edge of the rear B-pillar to scuff plate notch.**IMPORTANT! Ensure the edge of the tape stays aligned with the edge of the carpet while applying the foil tape. See Figure 2.**

NOTE: Carpet shown out of vehicle for clarity. Passenger side shown, driver side similar.

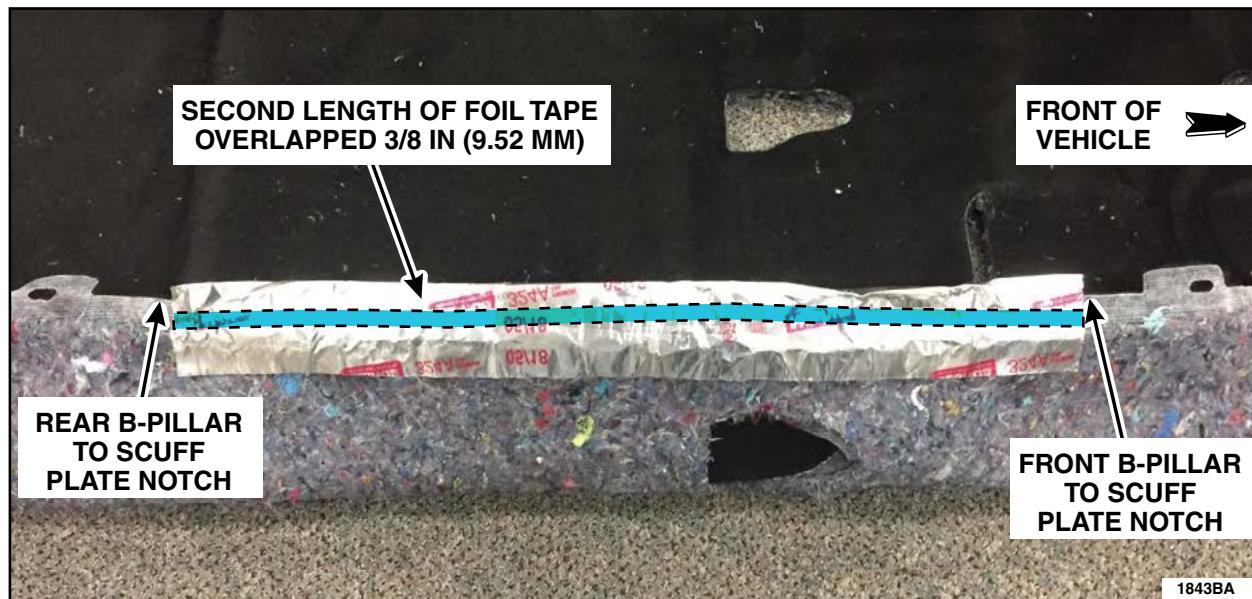
FIGURE 4

6. Apply the second length of foil tape overlapping the first. Start from the front, peeling the paper backing off the tape while applying, overlapping the first length of tape by $\frac{3}{8}$ in (9.52 mm). See Figure 4.

NOTE: Carpet shown out of vehicle for clarity. Passenger side shown, driver side similar.

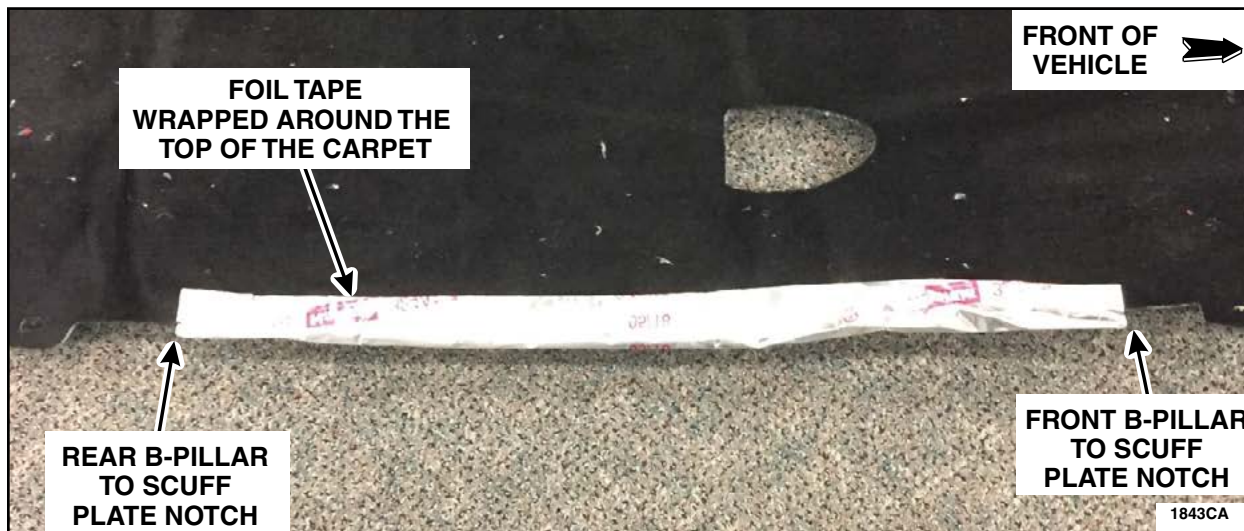
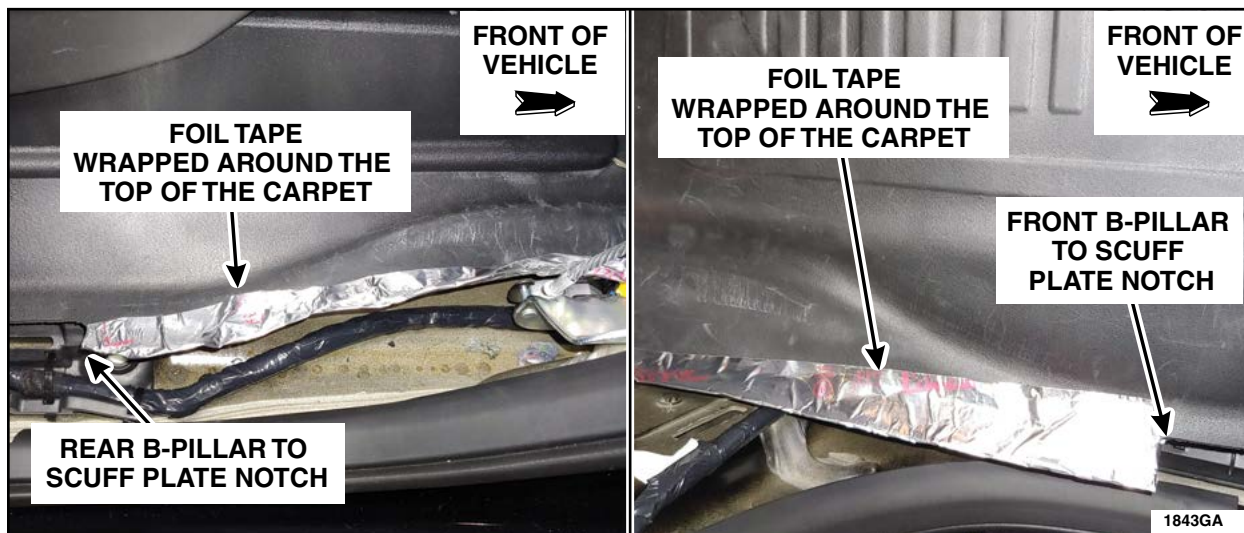
7. Wrap the foil tape around the top of the carpet. See Figures 5 and 6.

NOTE: Carpet shown out of vehicle for clarity. Passenger side shown, driver side similar.

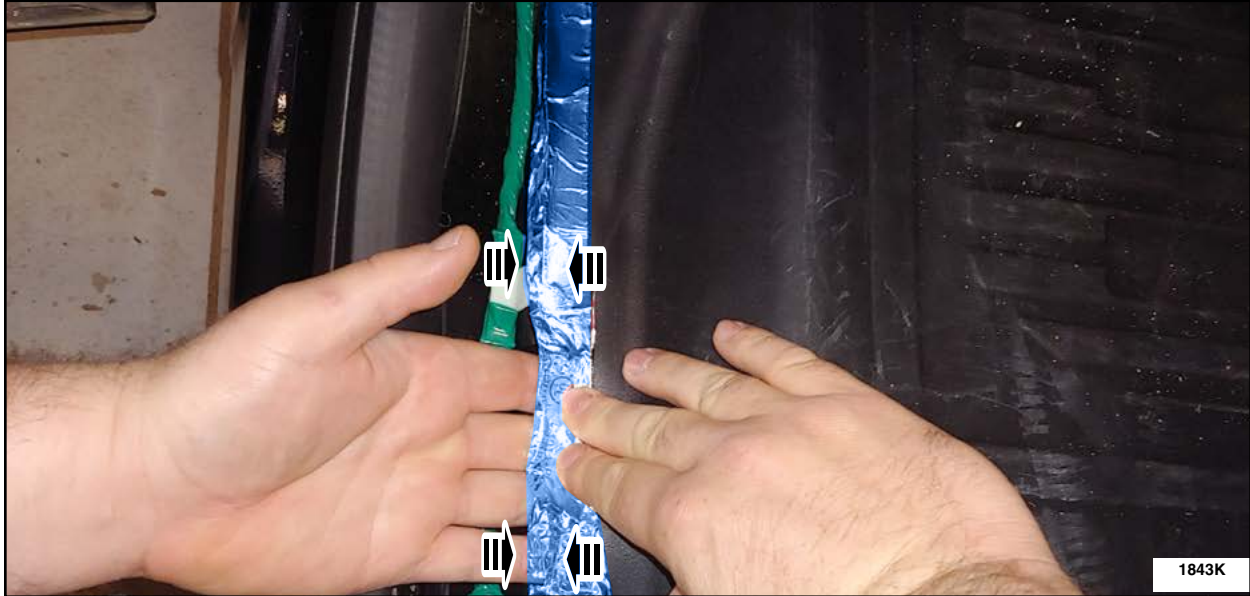
FIGURE 7

8. Using hand pressure, pinch / crimp both sides of the applied foil tape to ensure positive adhesion with no exposed insulation. See Figure 7.

- Apply additional foil tape as needed to correct any gaps or improper overlap.

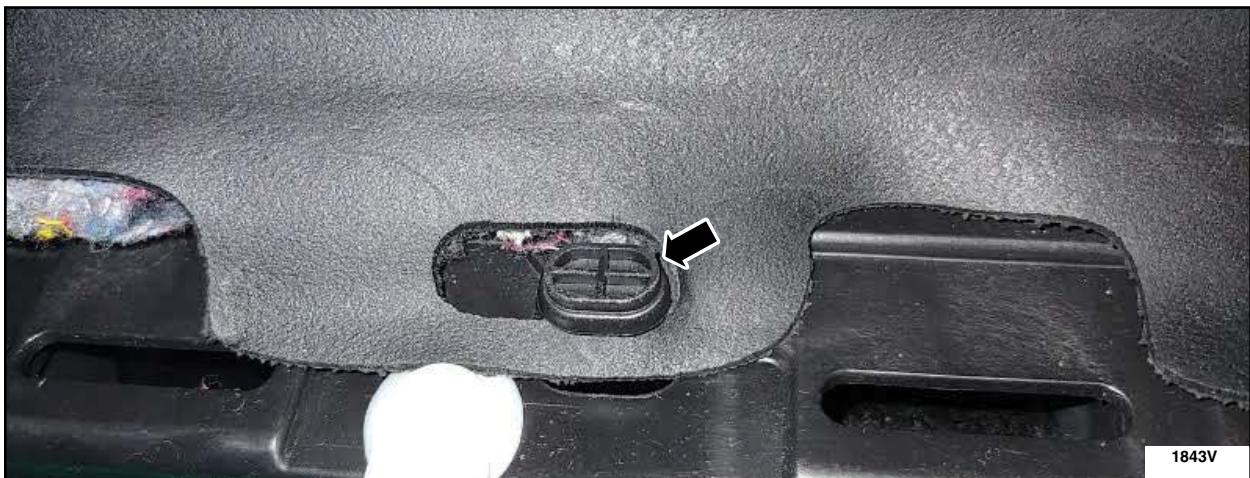
FIGURE 8

9. Position the carpet back into its original position and hook the loops into the carpet retention clips. See Figure 8.

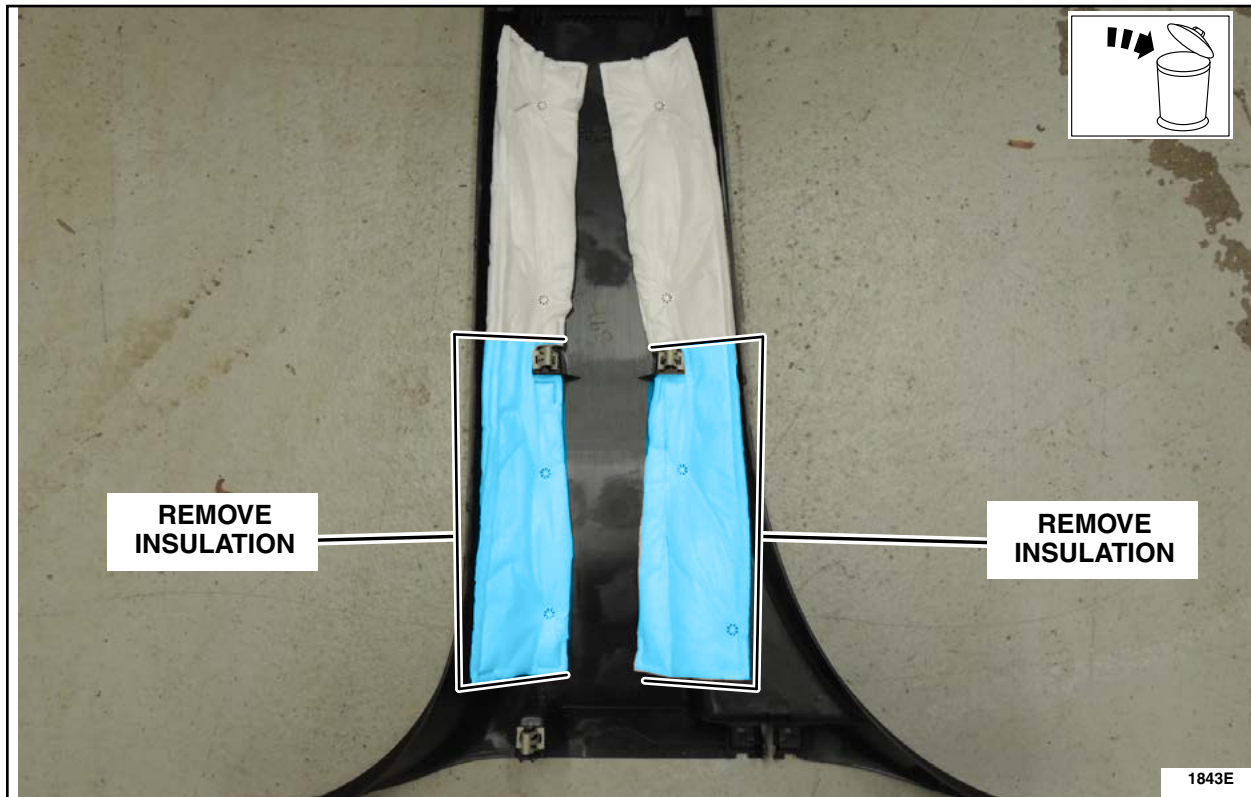
FIGURE 9

10. Using scissors, remove the insulation from the B-pillar trim panels, from the area shown.
See Figure 9.

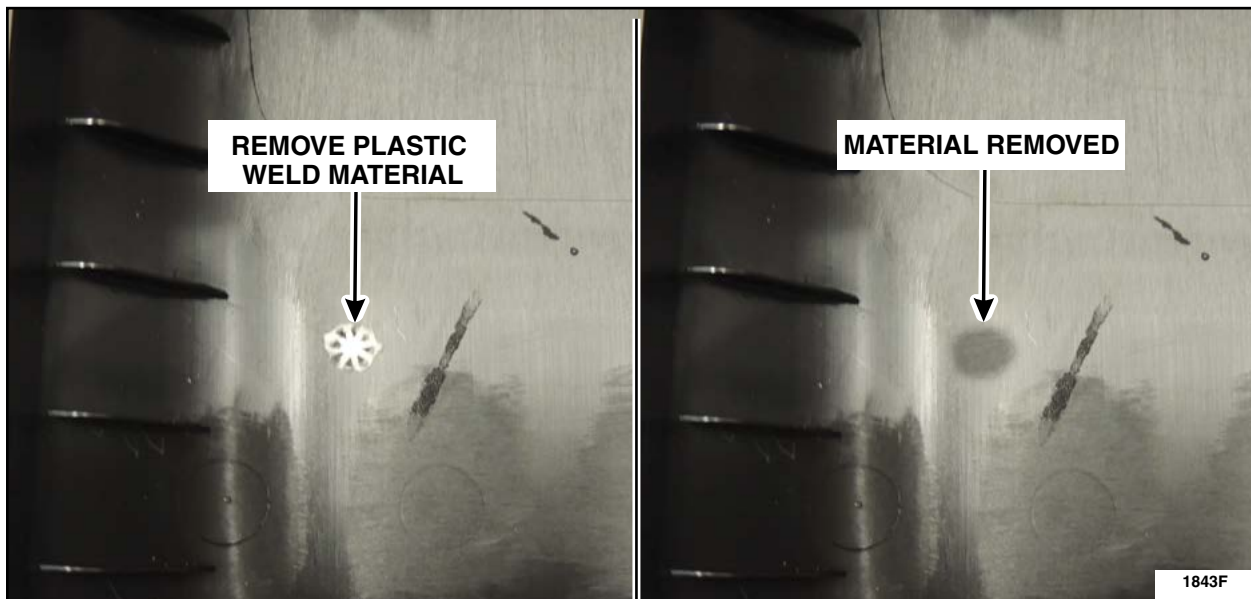
FIGURE 10

11. Lightly use a die grinder with abrasive pad to remove any remaining cloth material from the all of the plastic welds. See Figure 10.

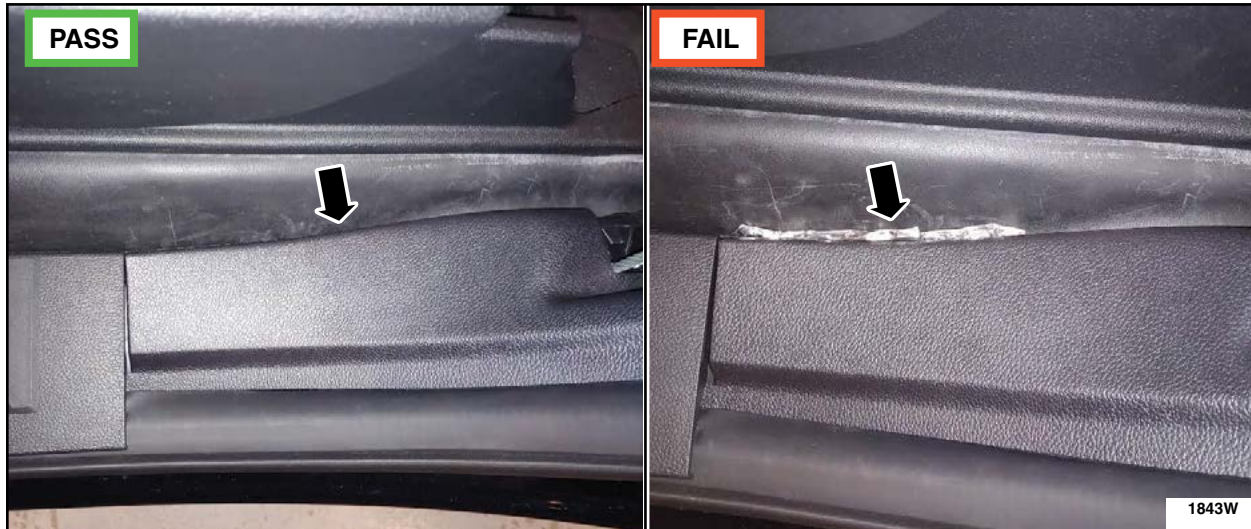
FIGURE 11

- For appearance purposes, when reinstalling the vehicle trim panels inspect to ensure foil tape is not exposed with trim panels installed. See Figure 11.

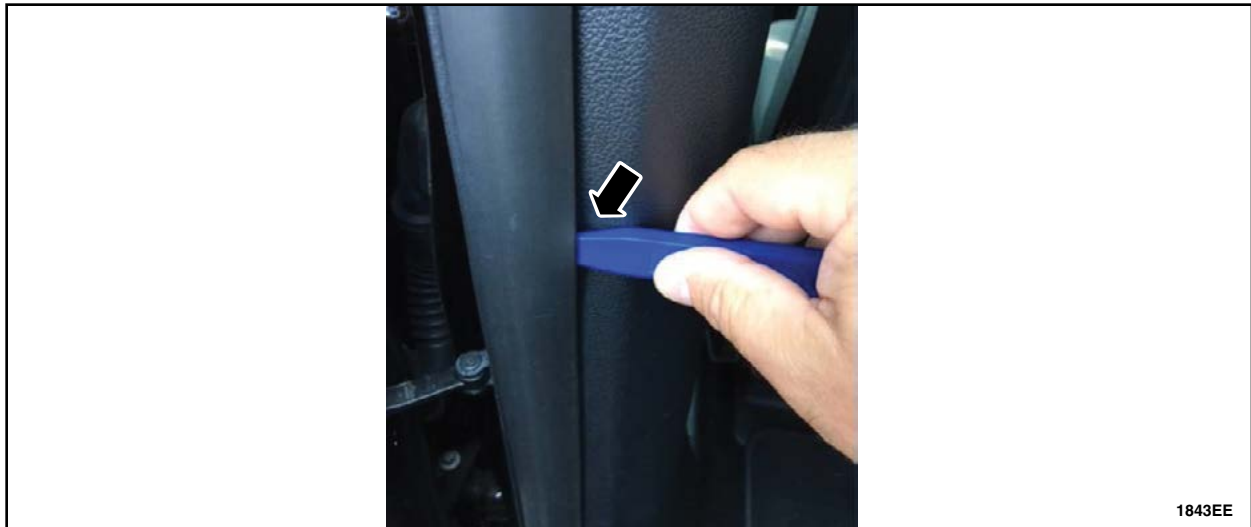
FIGURE 12

13. Use a plastic trim tool to correct any areas where the door weather stripping may be pinched behind the installed B-pillars. See Figure 12.
