**TECHNICAL BULLETIN**

09 FEB 2018

501-20B: Supplemental Restraint System

SAFETY RECALL: Takata Passenger Airbag

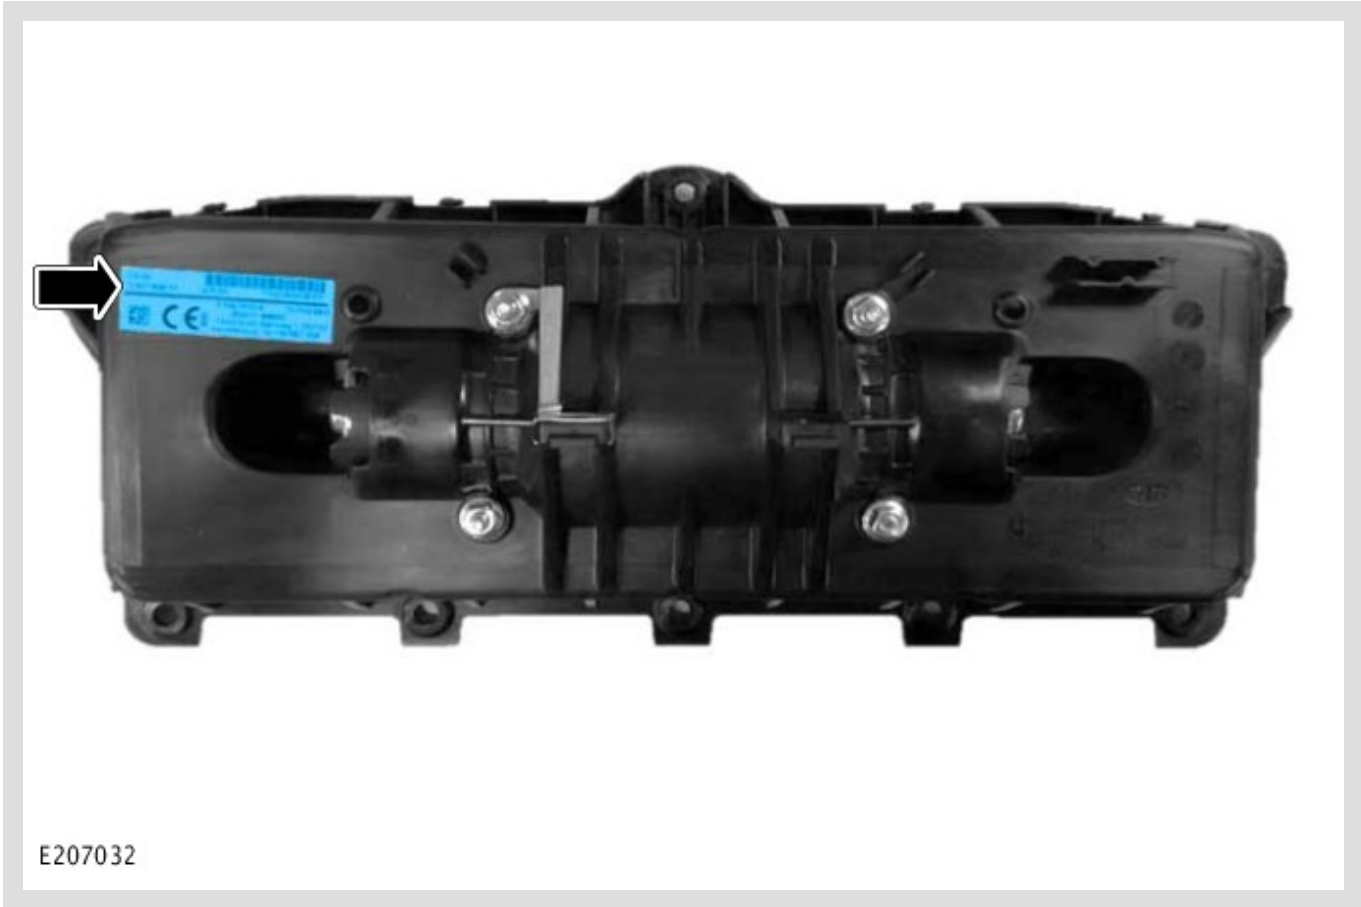
1

Locate the label on the rear side of the replacement passenger airbag module.

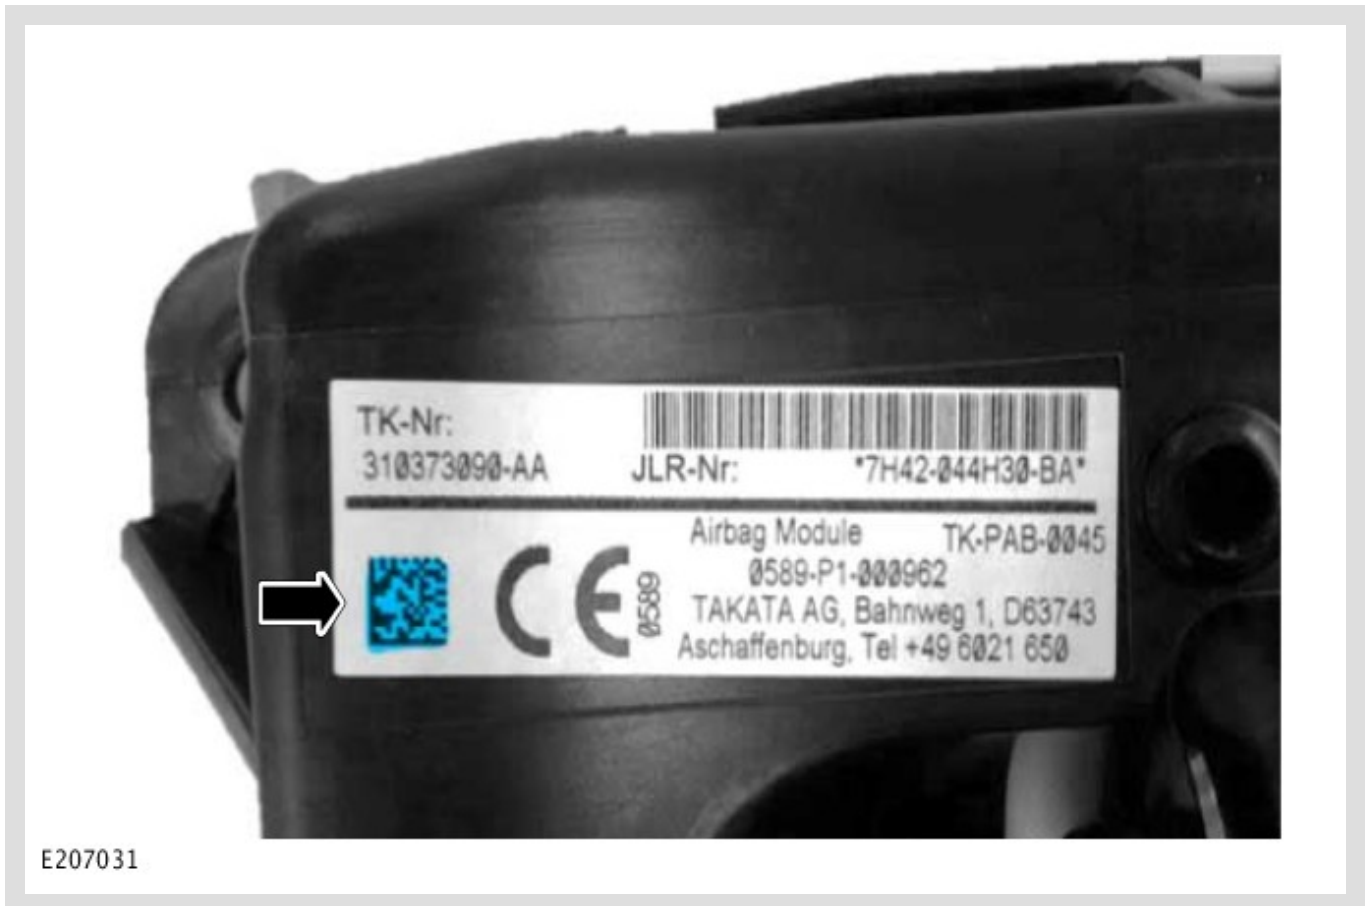
2

Locate the QR code on the label as illustrated.
