# TECHNICAL INSTRUCTIONS FOR SAFETY RECALL G0P FRONT PASSENGER AIRBAG INFLATOR MODULE CERTAIN 2008 – 2013 MY SCION xB

**Updated 4-18-2018**

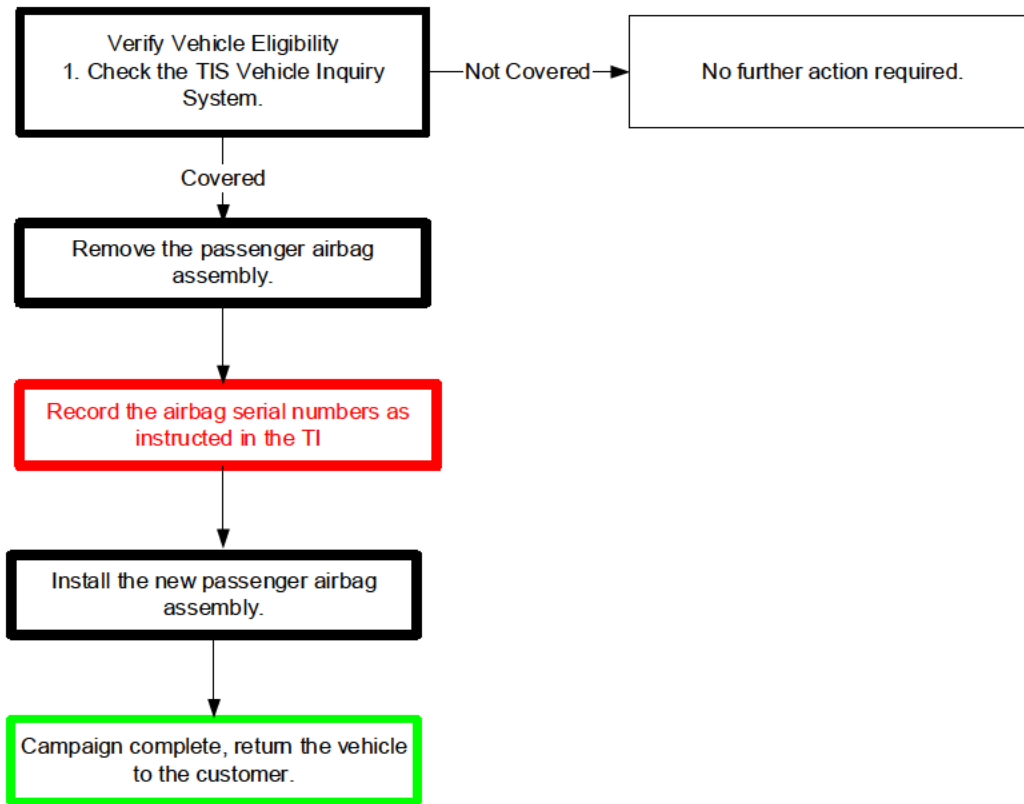
## I. OPERATION FLOW CHART

The flow chart is for reference only. **DO NOT** use it in place of the full technical instructions. Follow **ALL** steps as outlined in the full technical instructions to confirm the campaign is completed correctly.

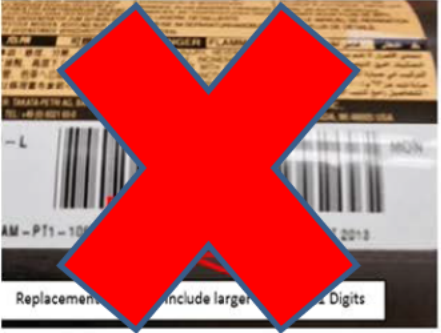
**Replacement Inflator**

The Inflator serial code is an 11 digit code on the Inflator can. It can be found with a bar code on removing the Inflator can from the Airbag Assembly unit.

The first two characters of the Replacement Inflator Serial code will be either 'LT' or 'LR'.

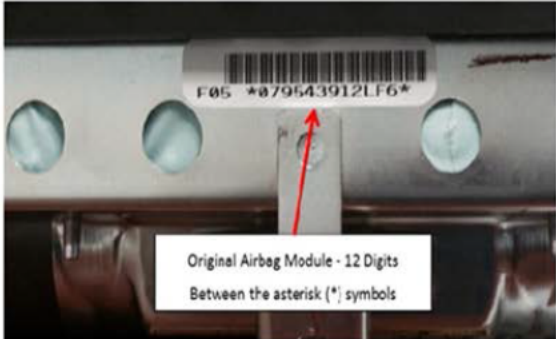
Original Airbag Module - 12 Digits  
Between the asterisk (\*) symbols

Check this box if the label is damaged or missing

a) If the airbag serial number cannot be scanned or is not present check the box as shown below.
