# TECHNICAL INSTRUCTIONS FOR SAFETY RECALL G0P/G0R/H0A FRONT PASSENGER AIRBAG INFLATOR MODULE CERTAIN 2010-2016 MY 4Runner

### UPDATE 1-11-2019

The subject vehicles are equipped with front passenger airbag inflators produced by Takata. According to Takata, the propellant in these inflators may degrade after prolonged exposure to high absolute humidity and fluctuating high temperatures. Degraded propellant can cause inflator rupture during airbag deployment. In the event of an inflator rupture, metal fragments could pass through the airbag cushion material, striking the vehicle occupants, and result in serious injury or death.

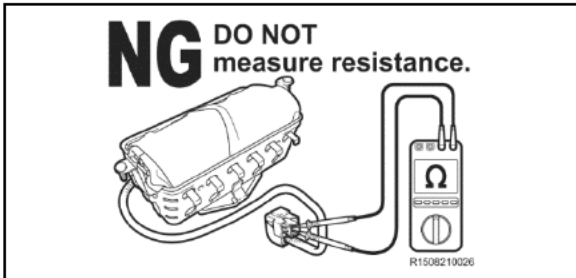
#### 2. DO NOT MEASURE RESISTANCE

- a) **DO NOT** measure resistance of airbag components, this may cause accidental activation.

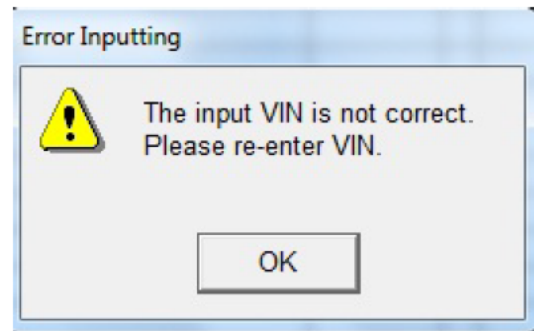
- After the health check has completed, run a diagnostic report by clicking on the link on the health check screen.

**NOTE: If the VIN was not entered in ALL CAPS when Techstream was launched, an error will be displayed and there will be a prompt to reenter the VIN**

- Enter the vehicle mileage and repair order information, then click the 'report' button.

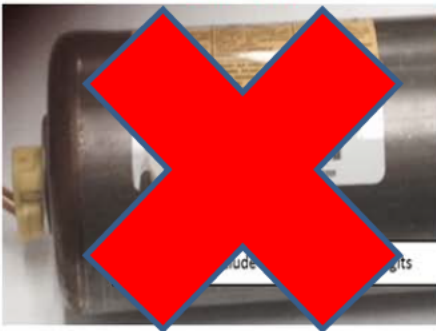
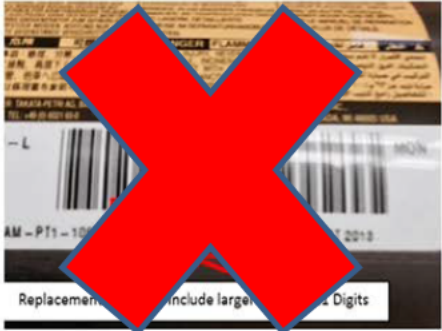
How to Identify the Inflator serial code on the Original and Replacement Inflator can?

The Inflator serial code is an 11 digit code on the Inflator can. It can be found with a bar code on removing the Inflator can from the Airbag Assembly unit.

The first two characters of the Original Inflator Serial code will be from [AA, AB, AJ, FD or JD].

The first two characters of the Replacement Inflator Serial code will be either 'LT' or 'LR'.
