## TECHNICAL INSTRUCTIONS FOR SAFETY RECALL H0A FRONT PASSENGER AIRBAG INFLATOR MODULE CERTAIN 2009 MODEL YEAR COROLLA

### UPDATE 7-17-18

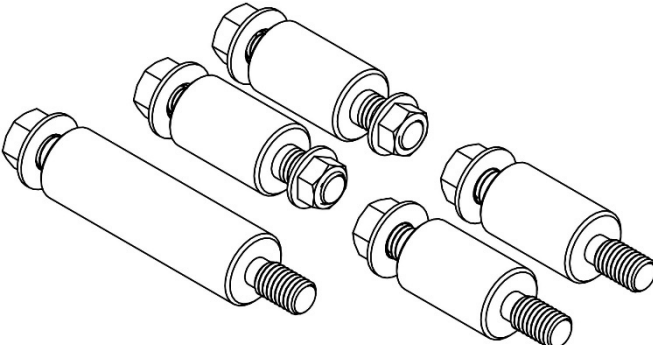
| Image | Name | Quantity |
|---|---|---|
| | Adaptor set* | 1 |

\*The adaptor set was sent to dealers at the start of this campaign.

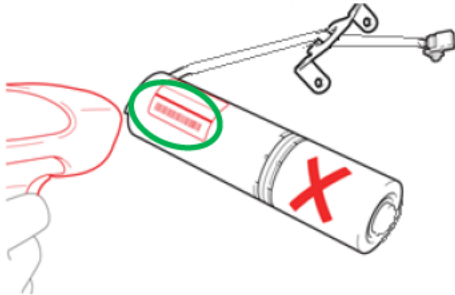
**Step a) Old Inflator (bar code)**

- Scan the **OLD** inflator bar code.
- Scan the **NEW** inflator QR code.

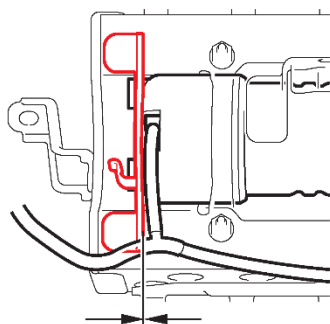
(b) No gap.
