TECHNICAL INSTRUCTIONS FOR SAFETY RECALL G0R FRONT PASSENGER AIRBAG INFLATOR MODULE CERTAIN 2008 - 2010 MY SCION xB

UPDATED 4-18-2018

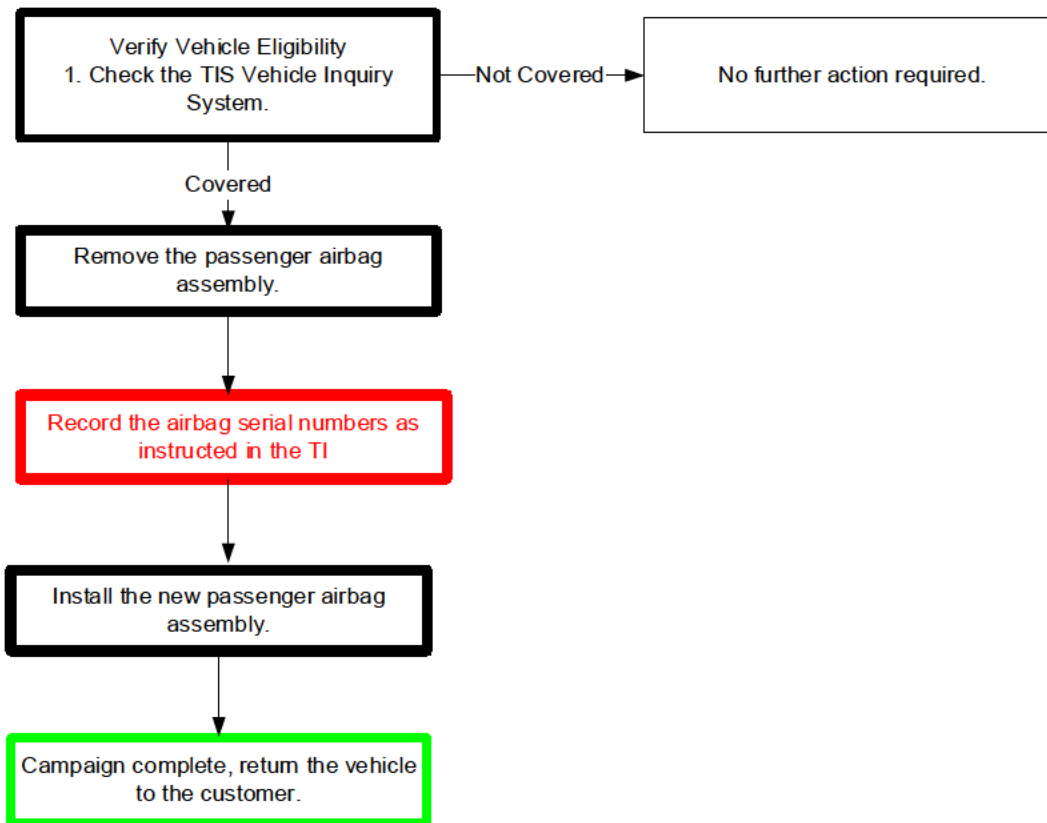
I. OPERATION FLOW CHART

The flow chart is for reference only. **DO NOT** use it in place of the full technical instructions. Follow **ALL** steps as outlined in the full technical instructions to confirm the campaign is completed correctly.

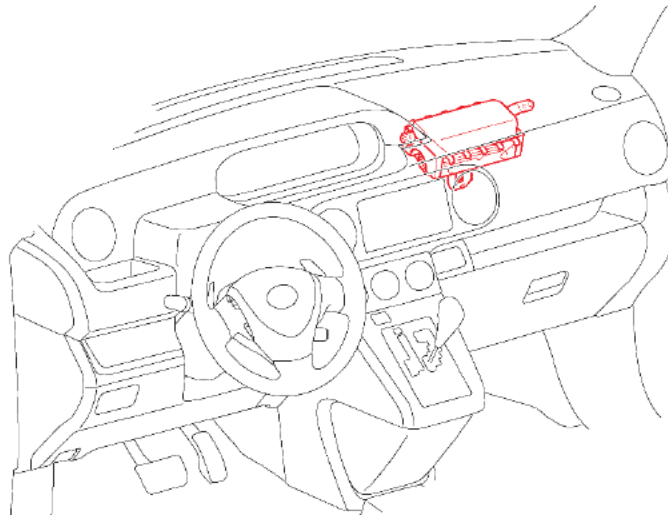
C162294

The subject vehicles are equipped with front passenger airbag inflators produced by Takata. According to Takata, the propellant in these inflators may degrade after prolonged exposure to high absolute humidity and fluctuating high temperatures. Degraded propellant can cause inflator rupture during airbag deployment. In the event of an inflator rupture, metal fragments could pass through the airbag cushion material, striking the vehicle occupants, and result in serious injury or death.

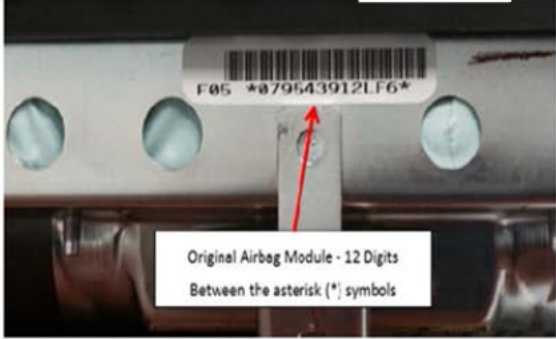
Original Airbag Module - 12 Digits
Between the asterisk (*) symbols

Check this box if the label is damaged or missing

If the airbag serial number and barcode are not legible or are not present, check the box in the application indicating the serial number is not legible.

a) If the airbag serial number cannot be scanned or is not present check the box as shown below.
