## TECHNICAL INSTRUCTIONS FOR SAFETY RECALL GLG FRONT PASSENGER AIRBAG INFLATOR REPLACEMENT CERTAIN 2010-2013 MY IS 250/350 CONVERTIBLE

**UPDATED 4-18-2018**

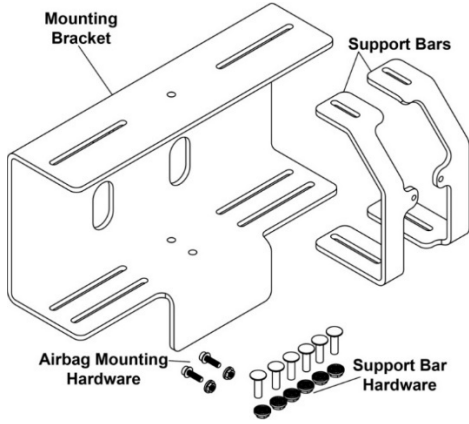
Airbag Mounting Bracket & hardware (Provided to the dealership at the launch of SSC DLC)	1

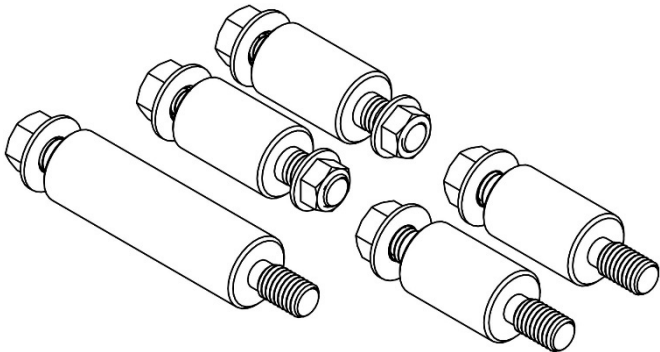
579943 Adaptor set*	1

\*The adapter set was sent to dealers prior to the start of this campaign.

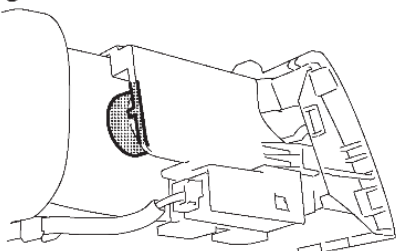
Back side of part manufactured  
before August 2008:

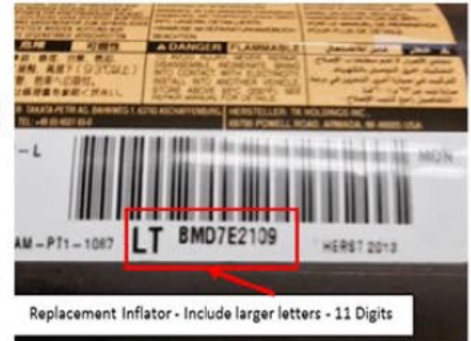
### Replacement Inflator

The first two characters of the Replacement Inflator Serial code will be either 'LT' or 'LR'.
