TECHNICAL INSTRUCTIONS FOR SAFETY RECALL G0P FRONT PASSENGER AIRBAG INFLATOR CERTAIN 2008 – 2013 MY SCION xB

Updated 4-18-2018

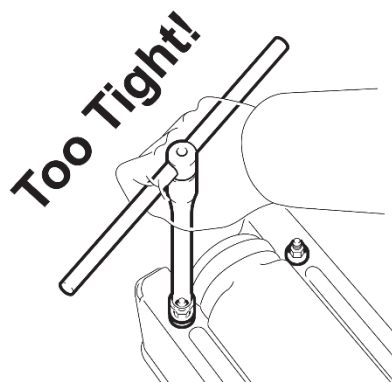
R1707250013

The tightening torque is low (3.9 N·m). Use of an air ratchet wrench or tightening strongly with a T-handle wrench or a ratchet handle may cause deformation of the stud bolt.

Too Tight!

These tools cause overtightening !
