# IMPORTANT UPDATE

## TECHNICAL INSTRUCTIONS FOR SAFETY RECALL H0A FRONT PASSENGER AIRBAG INFLATOR MODULE CERTAIN 2009 MODEL YEAR MATRIX UPDATE 7-17-18

The subject vehicles are equipped with front passenger airbag inflators produced by Takata. The propellant in these inflators may degrade after prolonged exposure to high absolute humidity and fluctuating high temperatures. Degraded propellant can cause inflator rupture during airbag deployment. In the event of an inflator rupture, metal fragments could pass through the airbag cushion material, striking the vehicle occupants, and result in serious injury or death.

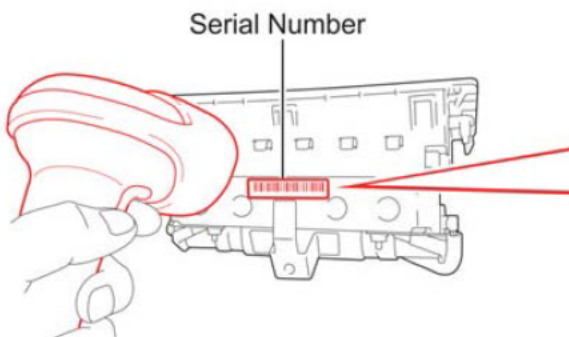
**Airbag Serial Number Label Example**

**AIRBAG SERIAL NUMBER IDENTIFICATION**

- The airbag serial number is **ALWAYS** the 12 **DIGITS** located between the asterisks.
- The 3 digits before the asterisk **ARE NOT** part of the serial number, and **SHOULD NOT** be entered or an inaccurate response may be returned.

The **AIRBAG ASSEMBLY** serial number and the **INFLATOR** serial number are **DIFFERENT**. The **AIRBAG ASSEMBLY** serial number **MUST** be recorded prior to replacement.

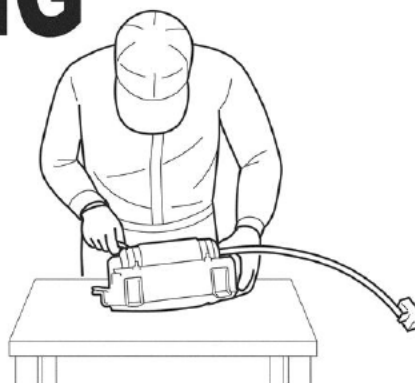
- Carefully place the airbag on the bench inflator side up.

**NOTE:** Place clean sheet(s) of paper on the bench to protect the airbag.

- Avoid standing directly over the inflator.

# OK

# NG

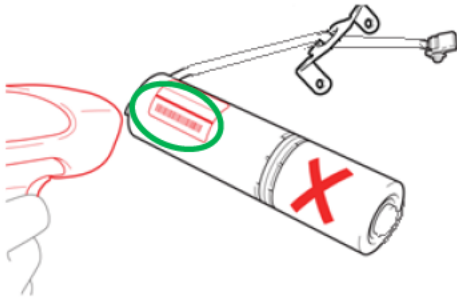
**Step a) Old Inflator (bar code)**

- Scan the **OLD** inflator bar code.
- Scan the **NEW** inflator QR code.

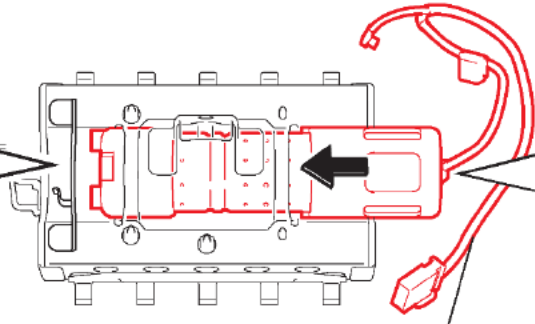
R1702270040

- a) Carefully slide the new inflator into the airbag assembly and align as shown.

- DO NOT** connect the inflator harness at this time. It is **CRITICAL** to first confirm that the inflator is installed in the correct position before connecting the harness.

**DO NOT** insert fully.

Check orientation

Upper side

Bottom

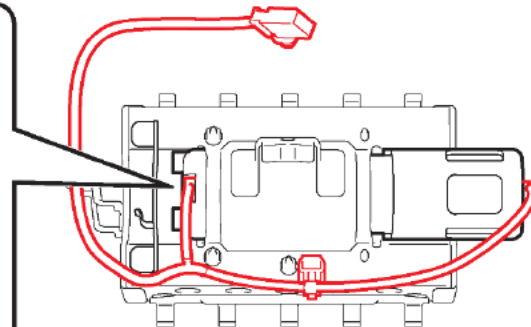
R1702270041

- b) Connect the connector to the inflator and ensure that the connector lock is fully engaged as shown.  
c) Route and secure the wire harness as shown.

**ALIGN CONNECTORS**

Wire Harness Side:

Inflator Side:

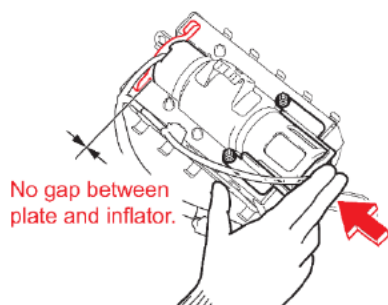
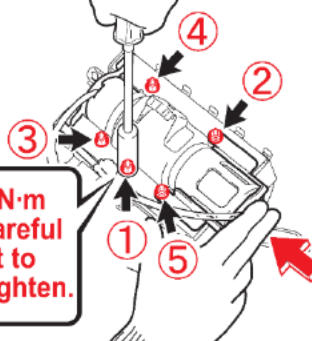
R1702270046

- a) Tighten the 5 nuts evenly in several increments in the sequence shown. Use a socket driver or torque wrench to tighten the nuts.

Torque: 35in. lbf (3.9N·m)

- There will be some resistance when tightening the nuts because they are self-locking, confirm the nuts are tightened correctly.
- **DO NOT** use a power tool, T-handle, or ratchet when tightening the nuts to avoid over torqueing and deforming the studs.
- You may need to turn the airbag to the left or right with in the mounting bracket to access the center nut.

**OK**

Socket Driver

**Too Tight!**

**These tools cause overtightening !**

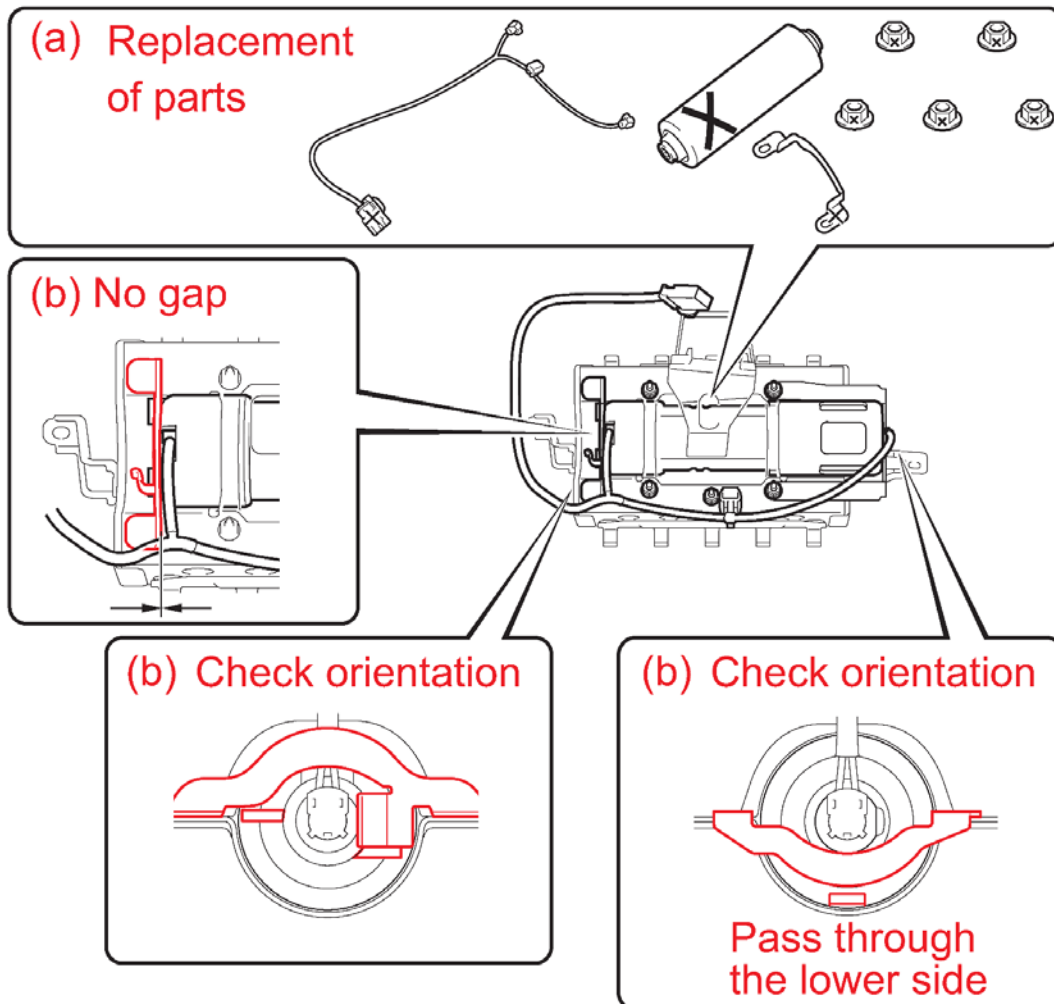
R1703080022

- a) Confirm the **NEW** inflator and 5 **NEW** nuts have been installed.
- b) Confirm the position of the inflator and position determining plates are correct.
- c) Confirm the routing of the inflator wire harness.
