# IMPORTANT UPDATE

## TECHNICAL INSTRUCTIONS FOR SAFETY RECALL H0A FRONT PASSENGER AIRBAG INFLATOR CERTAIN 2008 - 2009 MY SCION xB

**UPDATED 7-17-18**

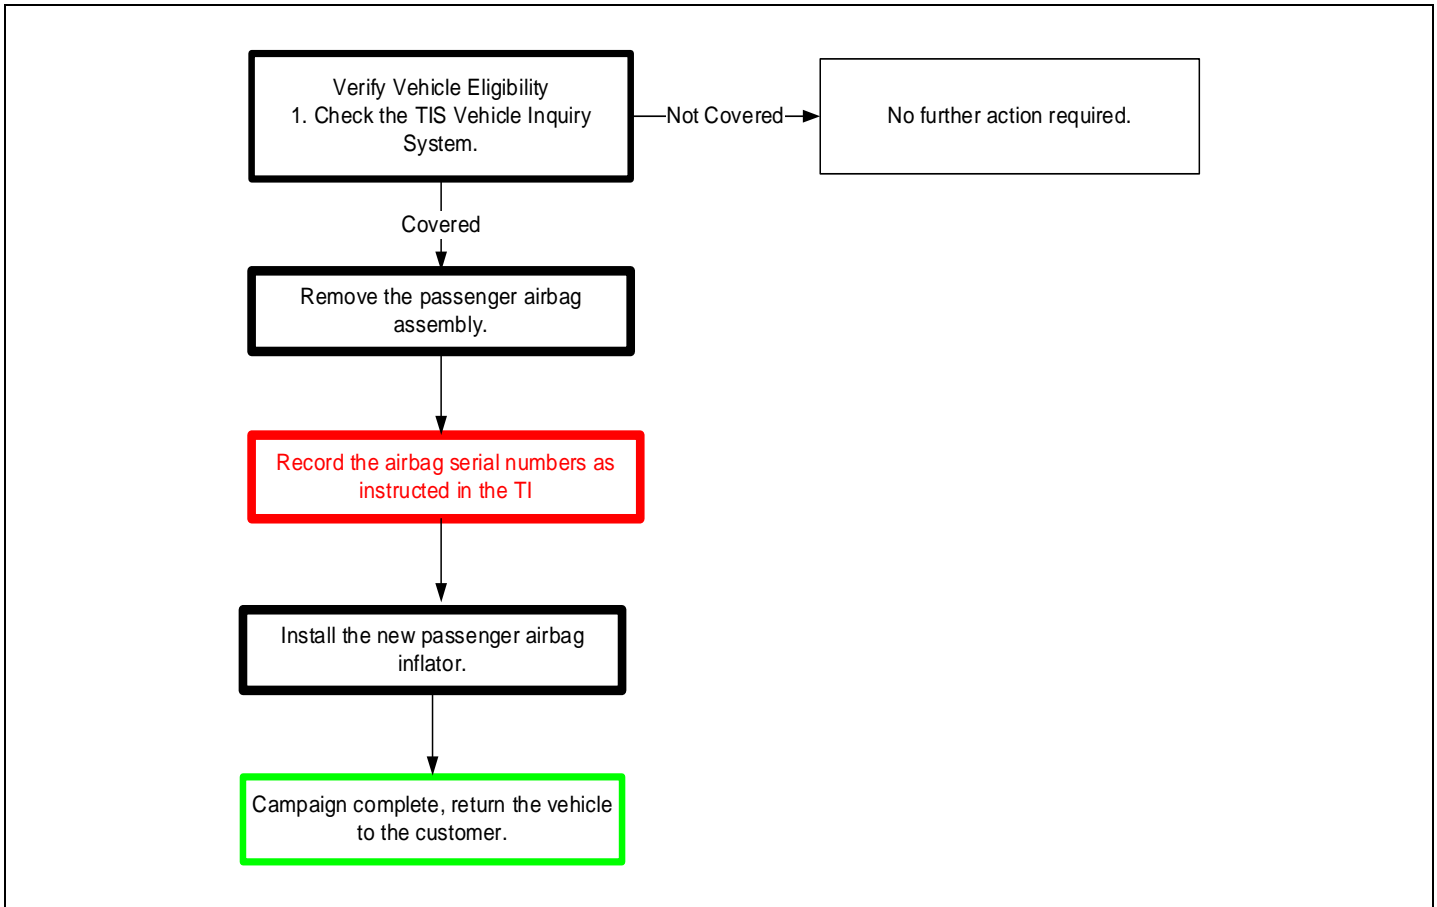
## I. OPERATION FLOW CHART

The flow chart is for reference only. **DO NOT** use it in place of the full technical instructions. Follow **ALL** steps as outlined in the full technical instructions to confirm the campaign is completed correctly.

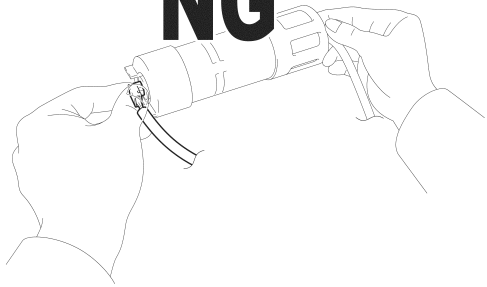
R1701200003

DO NOT CONNECT PREMATURELY  
CANNOT DISCONNECTED

1. **IMPORTANT NOTICE WHEN CONNECTING INSTRUMENT PANEL WIRE CONNECTOR TO AIRBAG INFLATOR**
  - a) Once connected, the instrument panel wire connector cannot be disconnected from the airbag inflator. If the instrument panel wire connector is incorrectly connected to the inflator, replace the instrument panel wire and inflator with new ones.

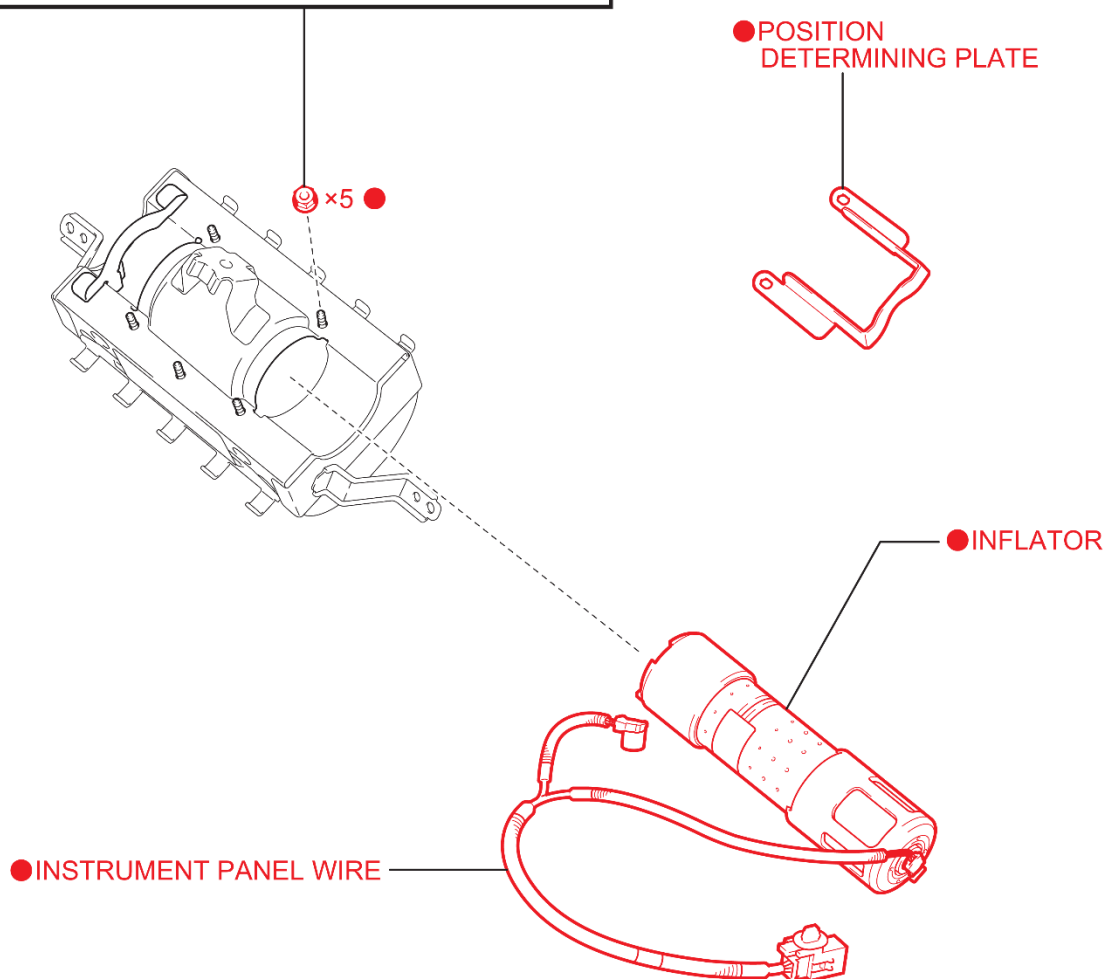
R1707250002

**3.9 N·m (40, 35 in.\*lbf)**  
**Be careful not to**  
**overtighten.**

● : Replacement part

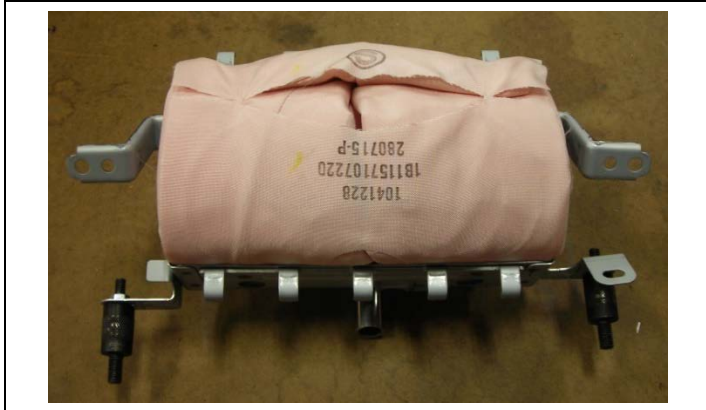
- a) Mount the adaptors (579943-3R3) to the airbag as shown.

**NOTE: The 6mm stud mounts to the airbag.**

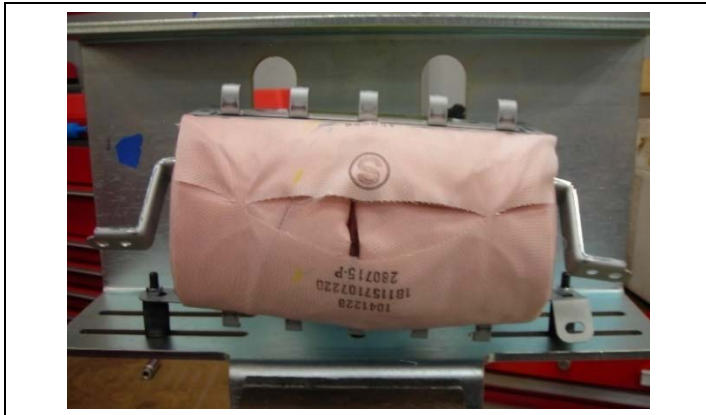
- b) Mount the airbag to the mounting bracket as shown.

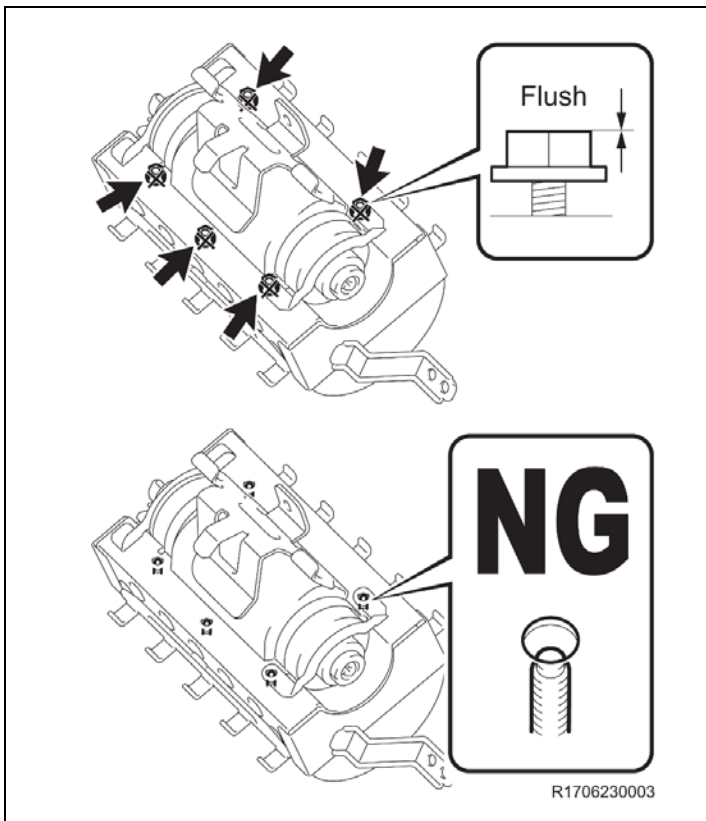
- c) Loosen the 5 nuts until each nut is flush with the top of the stud as shown.

**NOTE:** You may need to slide the airbag to the left or right to access the middle nut.  
**DO NOT** use power tools to remove the nuts.

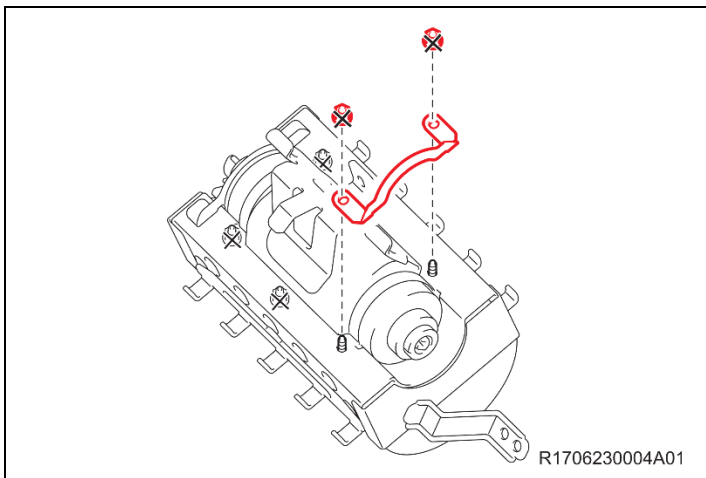
- d) Loosen and discard the 2 nuts on the end where the positioning plate is removeable.  
e) Remove and discard the plate.

**NOTE:**  
**DO NOT** use power tools.

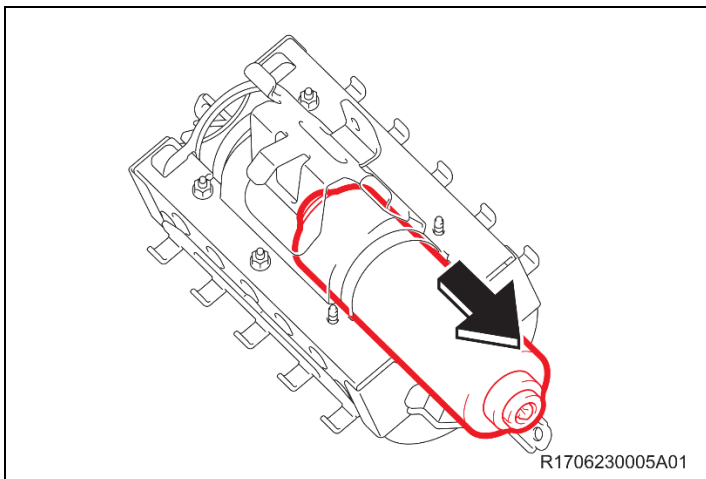
- f) Remove the inflator.

- g) Mark the old inflator so it is not reused.  
**NOTE: Return the old inflator to the parts department for recovery.**

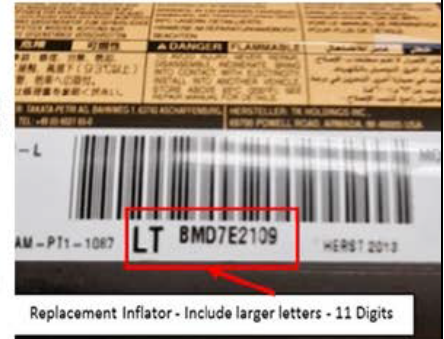
### Replacement Inflator

The first two characters of the **Replacement Inflator Serial code** will be either 'LT' or 'LR'.

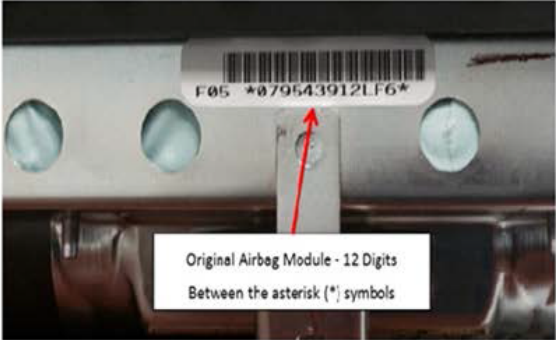
Original Airbag Module - 12 Digits  
Between the asterisk (\*) symbols

How to Identify an Airbag module Assembly number?  
The Airbag module Assembly serial number is a 12 digit code. It can be found along with a bar code on opening the Airbag assembly unit. To manually enter these details into the application, the technician has to identify the 12 digit code between two Asterisks (\*) inside the Airbag assembly unit. The first seven characters of this 12 digit code are numbers and the 10<sup>th</sup> digit is either 'K' or 'L' always.

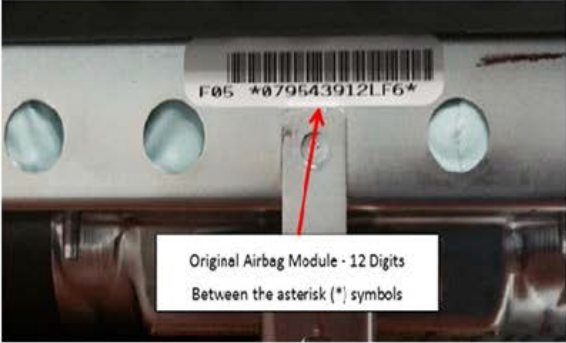
Original Airbag Module - 12 Digits  
Between the asterisk (\*) symbols

#### How to Identify an Airbag module Assembly number?

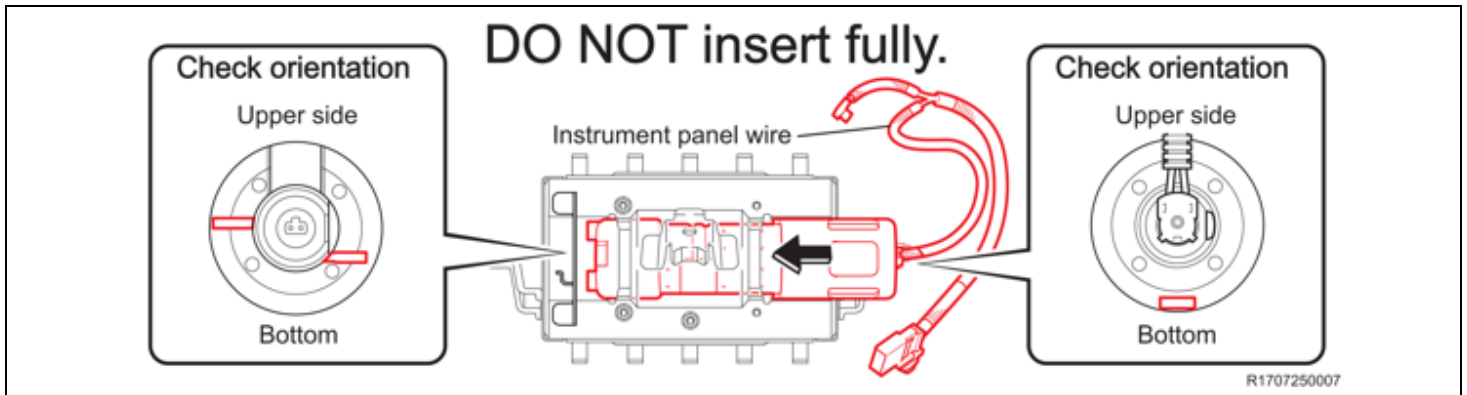
- **Make sure that the passenger airbag inflator is oriented correctly as shown in the illustration, not upside down.**
- **If the passenger airbag inflator is upside down, it will not be able to be fully inserted.**

- b) Connect the airbag connector to the instrument panel passenger airbag assembly and then push in the airbag connector lock as shown in the illustration.

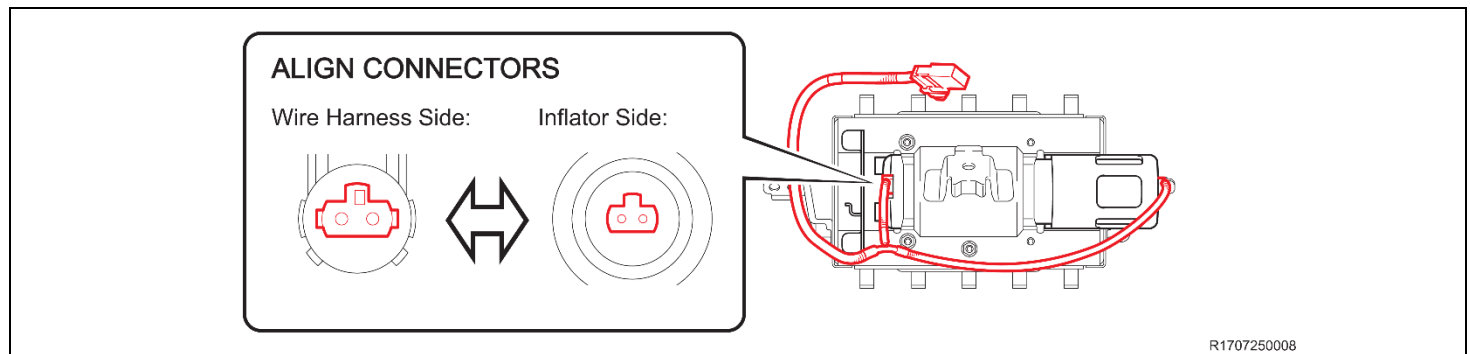
- **Make sure to correctly align the connectors before connecting them.**
- **Make sure that the airbag connector is securely connected.**

c) Insert the inflator fully as shown in the illustration.

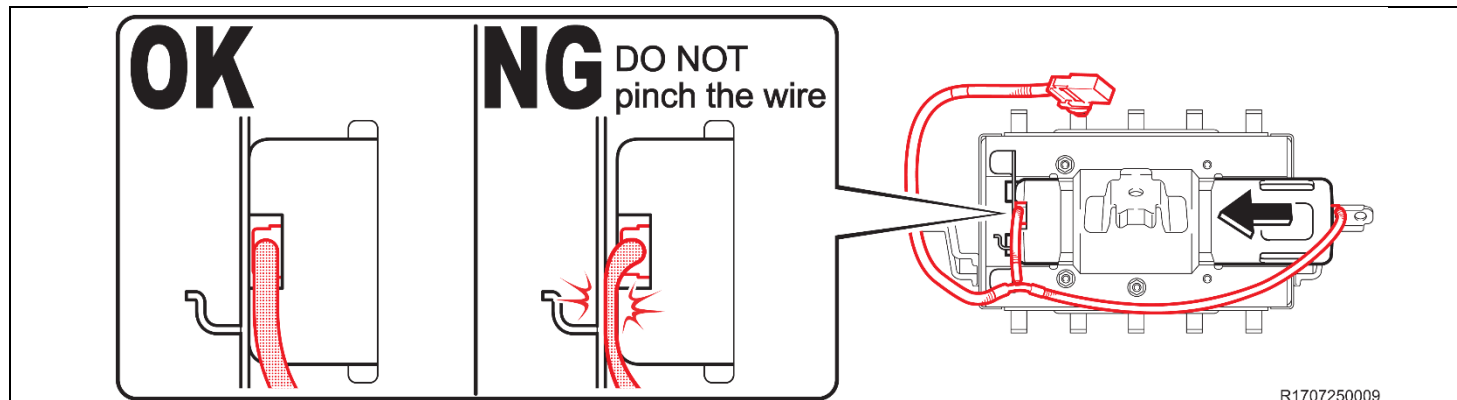
R1707250009

**DO NOT pinch instrument panel wire.**

d) Insert the inflator with the correct orientation as shown in the illustration.

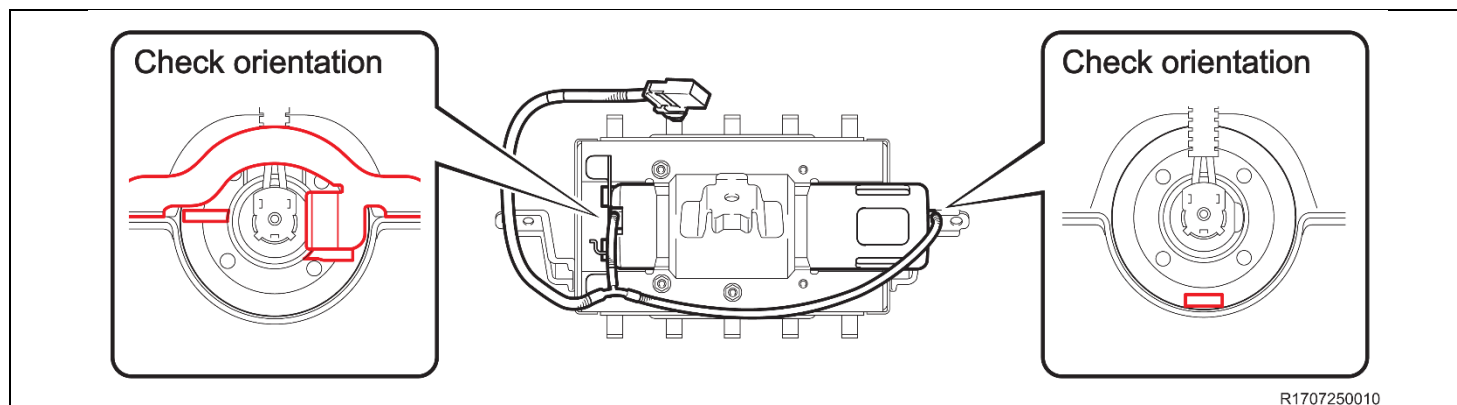
R1707250010

- Make sure that the inflator is oriented correctly as shown in the illustration, not upside down.
- If the passenger airbag inflator is upside down, it will not be able to be fully inserted.

**Install temporarily by hand.**

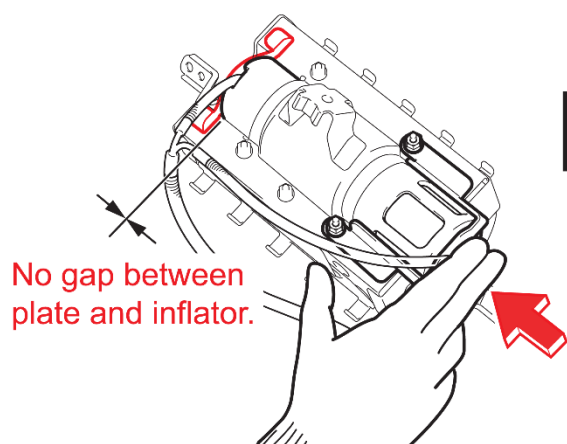
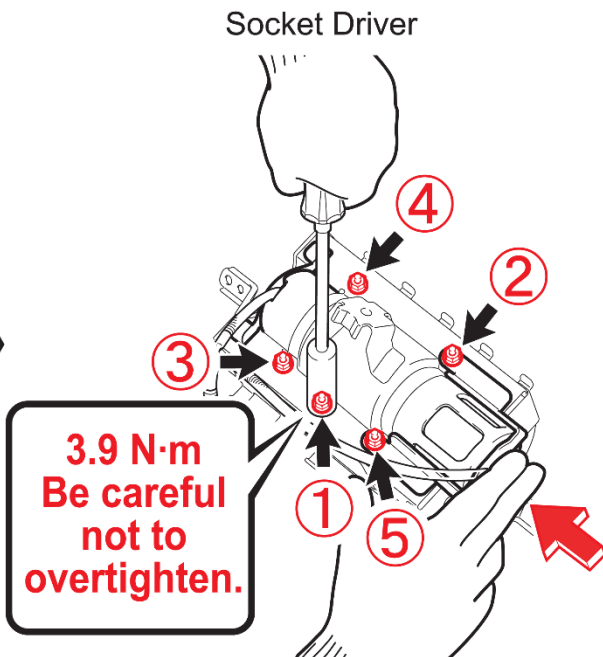
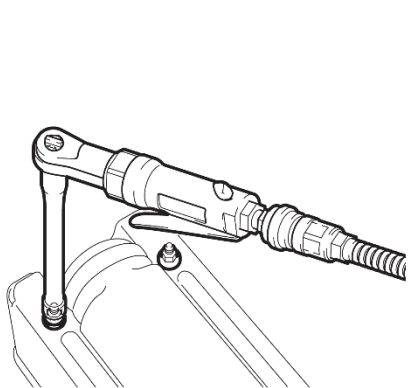
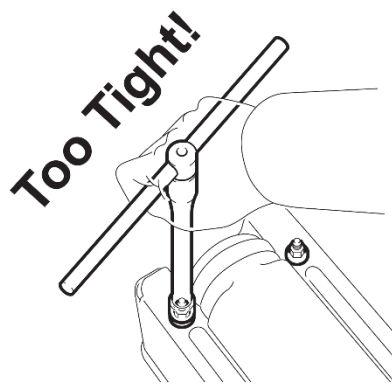
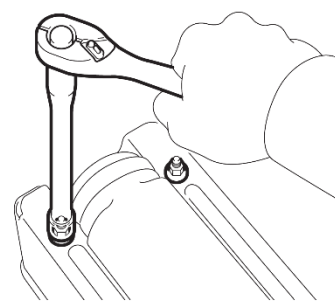
R1707250013

**The tightening torque is low (3.9 N·m). Use of an air ratchet wrench or tightening strongly with a T-handle wrench or a ratchet handle may cause deformation of the stud bolt.**

**OK**

**Too Tight!**

**These tools cause overtightening !**

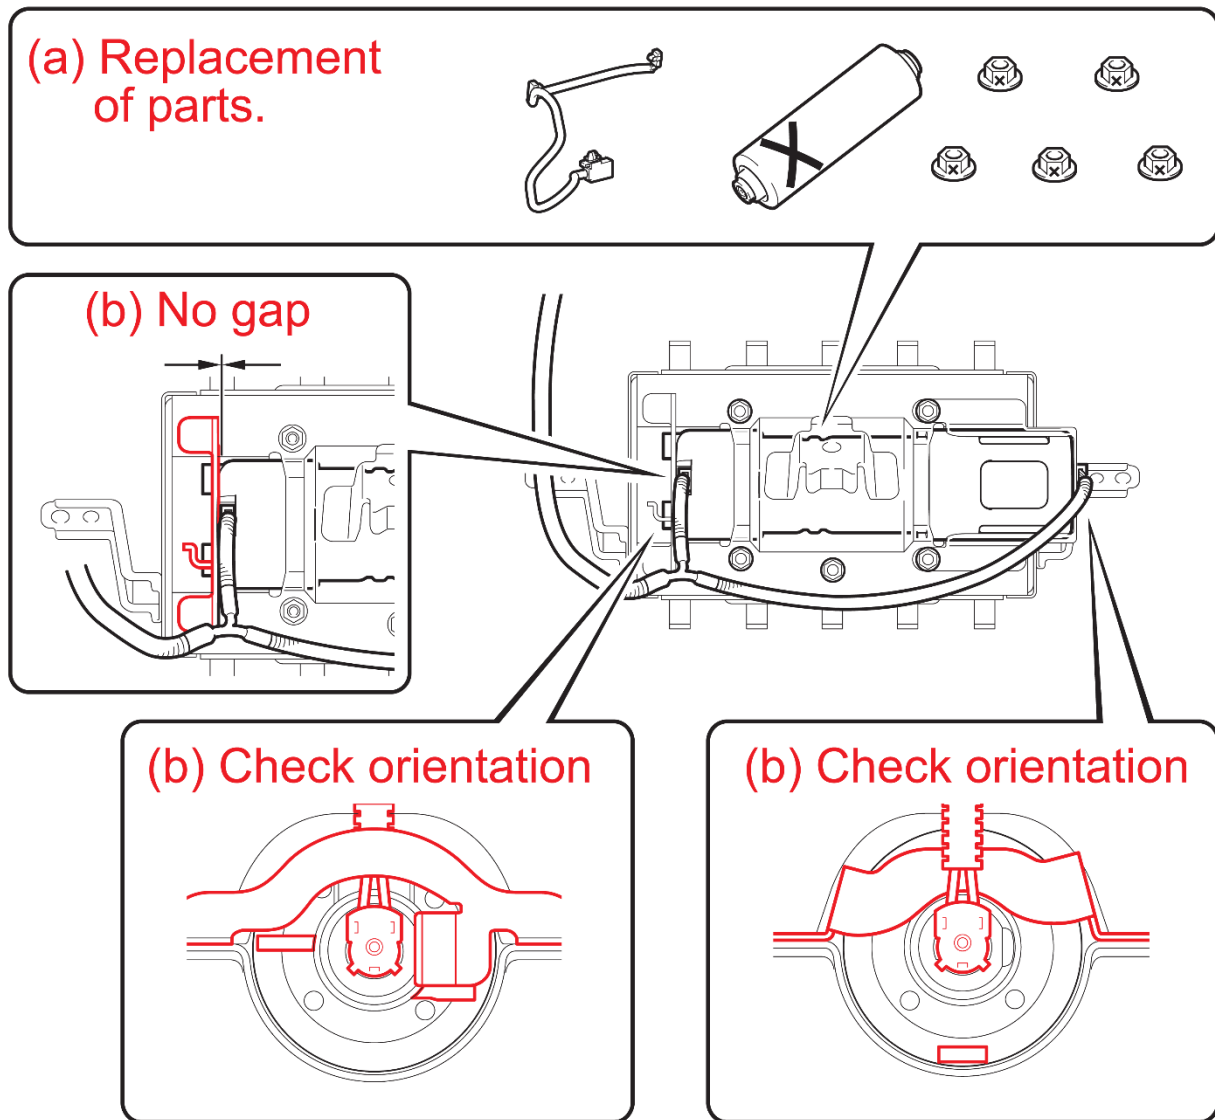
R1707250014

- Check that the inflator and the 5 self-locking nuts, instrument panel wire are replaced.
- Check that positions of the inflator and the position determining plate are correct.  
(There should be no gap.)
