## TECHNICAL INSTRUCTIONS FOR SAFETY RECALL G0P/G0R/H0A FRONT PASSENGER AIRBAG INFLATOR MODULE CERTAIN 2009 – 2013 MODEL YEAR COROLLA

**Updated 1-9-2019**

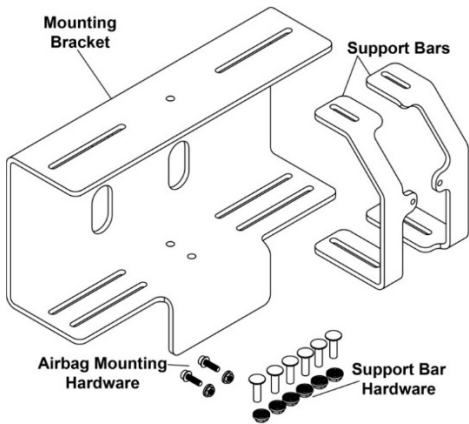
| Image | Name | Quantity |
|---|---|---|
| | Airbag Mounting Bracket & hardware | 1 |

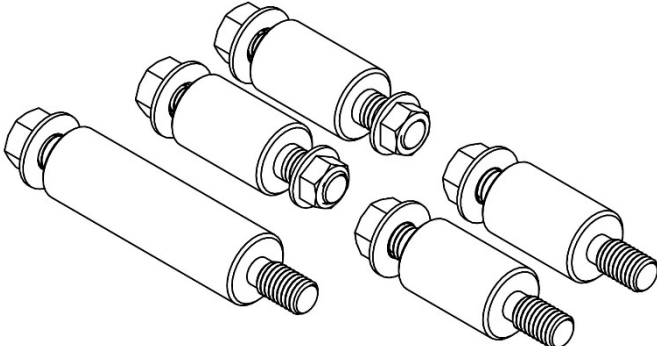
| Image | Name | Quantity |
|---|---|---|
| | Adaptor set* | 1 |

\*The adapter set was sent to dealers at the start of this campaign.

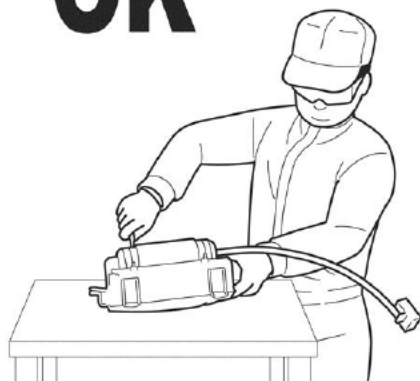
# OK

- Carefully place the airbag on the bench inflator side up.

**NOTE:** Place clean sheet(s) of paper on the bench to protect the airbag.

- Avoid standing directly over the inflator.

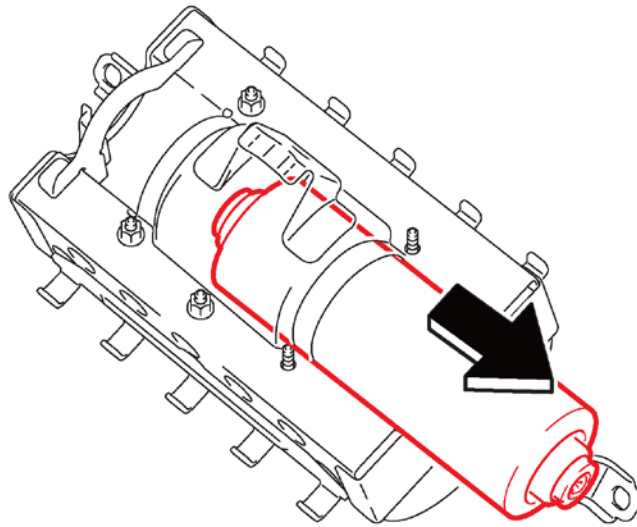
- a) Gently push in the studs until the nuts make contact with the housing to loosen the inflator for removal.

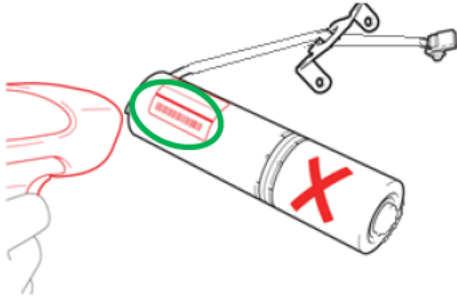
**Step a) Old Inflator (bar code)**

- Scan the **OLD** inflator bar code.
- Scan the **NEW** inflator QR code.

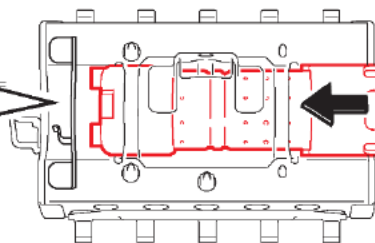
a) Carefully slide the new inflator into the airbag assembly and align as shown.

- DO NOT** connect the inflator harness at this time. It is **CRITICAL** to first confirm that the inflator is installed in the correct position before connecting the harness.

**DO NOT** insert fully.

Check orientation

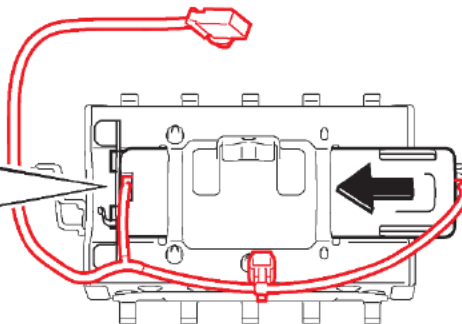
**NG**

**DO NOT**  
pinch the wire

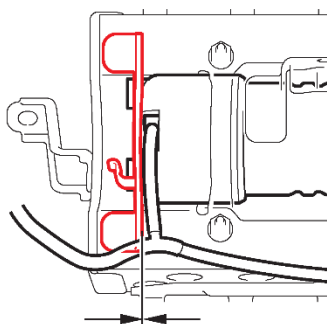
(b) No gap.
