## SAFETY RECALL JOA, JOB, JOC

### FRONT PASSENGER AIRBAG "MODULE" REPLACEMENT ONLY

## **CERTAIN 2003 – 2008 MODEL YEAR MATRIX**

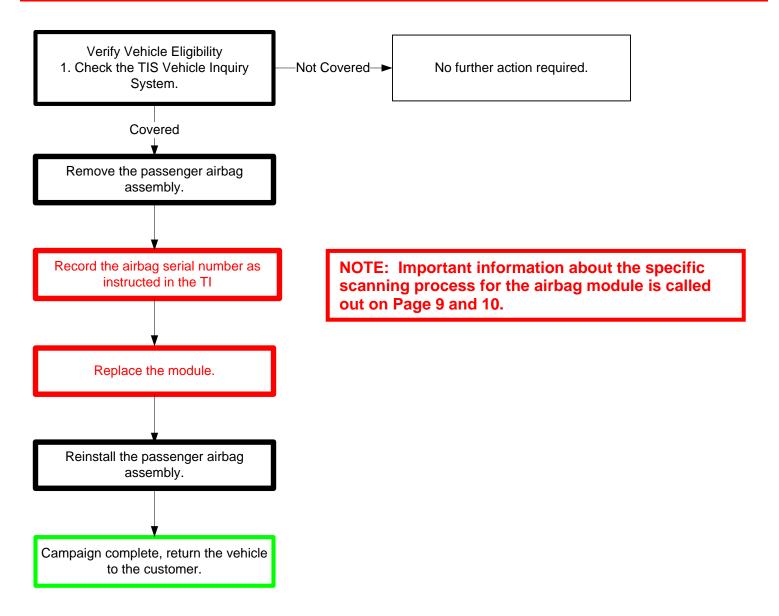
### I. OPERATION FLOW CHART

The flow chart is for reference only. *DO NOT* use it in place of the full technical instructions. Follow *ALL* steps as outlined in the full technical instructions to confirm the campaign is completed correctly.

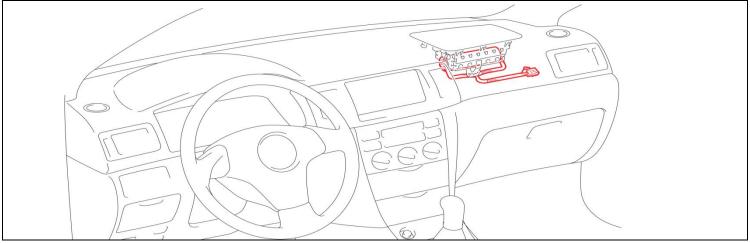
The subject vehicles are equipped with front passenger airbag inflators which may have been manufactured in such a way as to have a potential for the intrusion of moisture over time. Depending on the circumstances, this could create excessive internal pressure when the airbag is deployed and cause the inflator to rupture. In the event of an inflator rupture, metal fragments could pass through the airbag cushion material, striking the vehicle occupants and potentially resulting in serious injury or death.

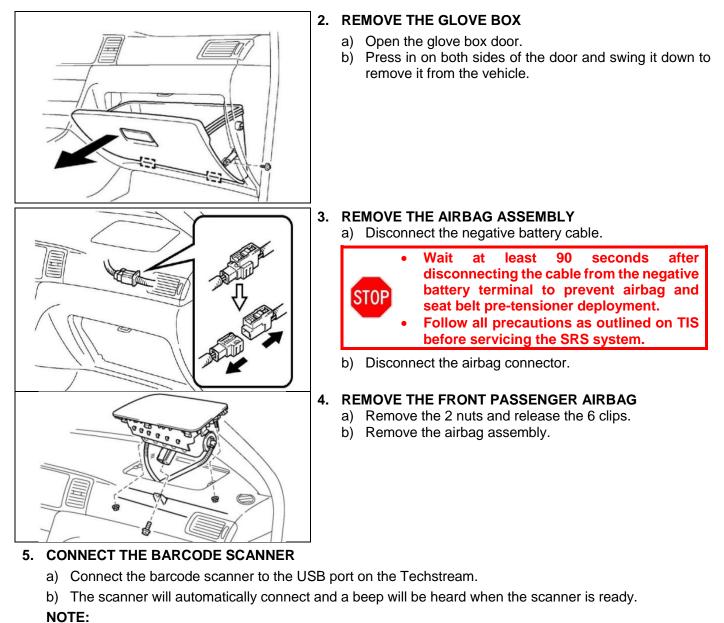
- The scanner was provided for SSC D0F.
- The scanner works best in low light conditions.

#### • Always hold the scanner directly in front of and parallel to the barcode label.

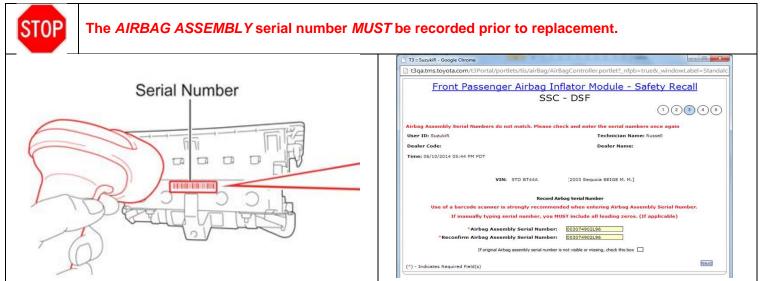
#### SCAN THE AIRBAG SERIAL NUMBER 6. a) Scan the **AIRBAG ASSEMBLY** serial number 2 AIRBAG SERIAL NUMBER IDENTIFICATION times. • The airbag serial number is ALWAYS the 12 DIGITS 1) Confirm the cursor is in the first serial number located between the asterisks. box then scan the serial. The 3 digits before the asterisk ARE NOT part of the 2) Position the cursor in the second serial serial number, and SHOULD NOT be entered or an number box then scan the serial. inaccurate response may be returned. NOTE: Airbag Serial Number Label Example If both serial numbers that are entered do not match, confirm and reenter. If the serial number barcode will not scan, it can be entered manually. F22 \*00000000XX0

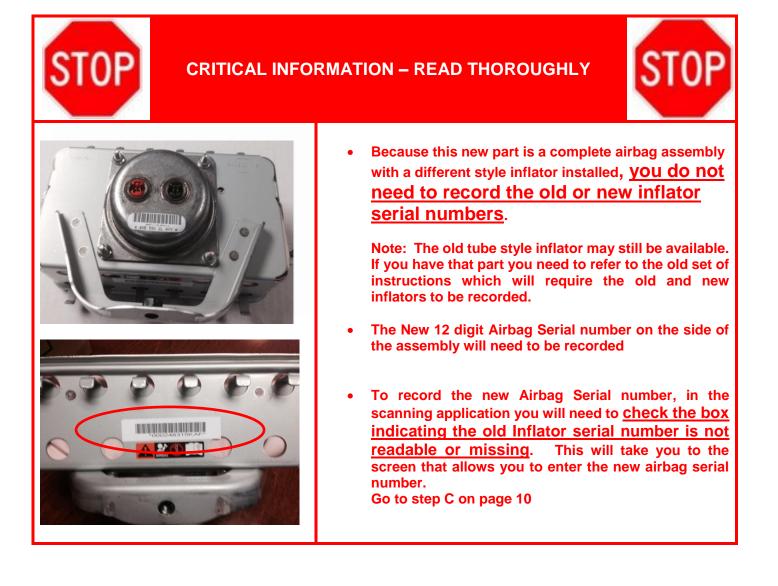
### Remember: You will need to <u>check the box indicating the old inflator serial number</u> is not readable or missing to move to the next screen.

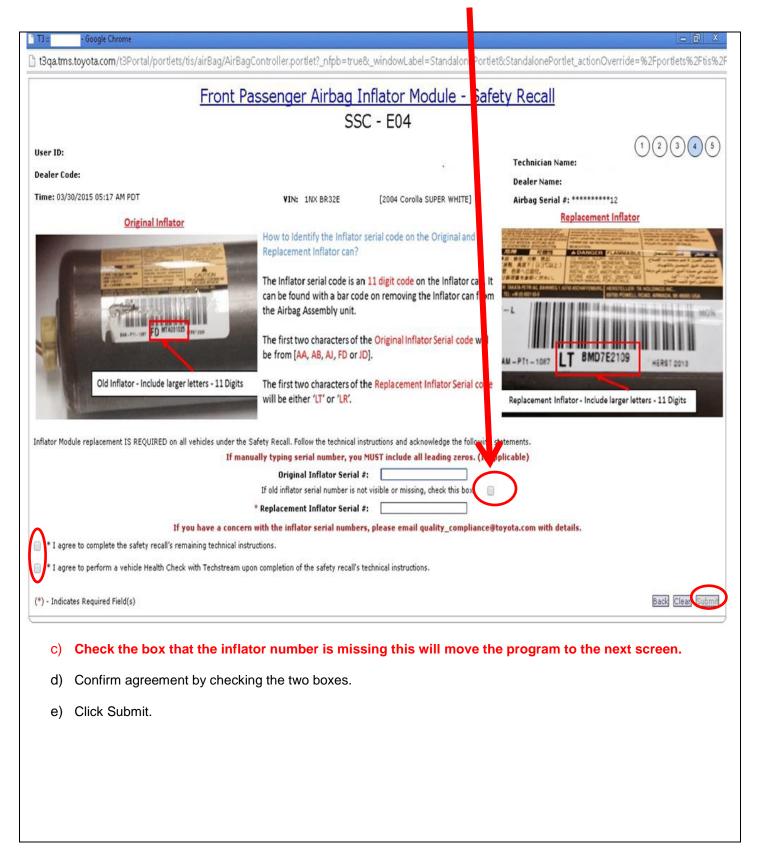
Scan	the New Airbag Assembly Serial Number	
f)	Confirm the cursor is in the serial number box	
g)	Scan the replacement module serial number	
h)	Click next.	
	Front Passenger Airbag Inflator Module - Safety Recall SSC - DSF	
	User ID: SuzukiR Technician Name: Russell	
	Dealer Code: Dealer Name:	
	Time: 06/12/2014 03:43 PM PDT	
	VIN: STD ST44A [2003 Sequoia BELGE M. M.]	
	Record Airbag Serial Number	
	Use of a barcode scanner is strongly recommended when entering Airbag Assembly Serial Number.	
	If manually typing serial number, you HUST include all leading zeros. (If applicable)	
	"New Airbag Assembly Serial Number: 003074902195	
	(*) - Indicates Required Field(s)

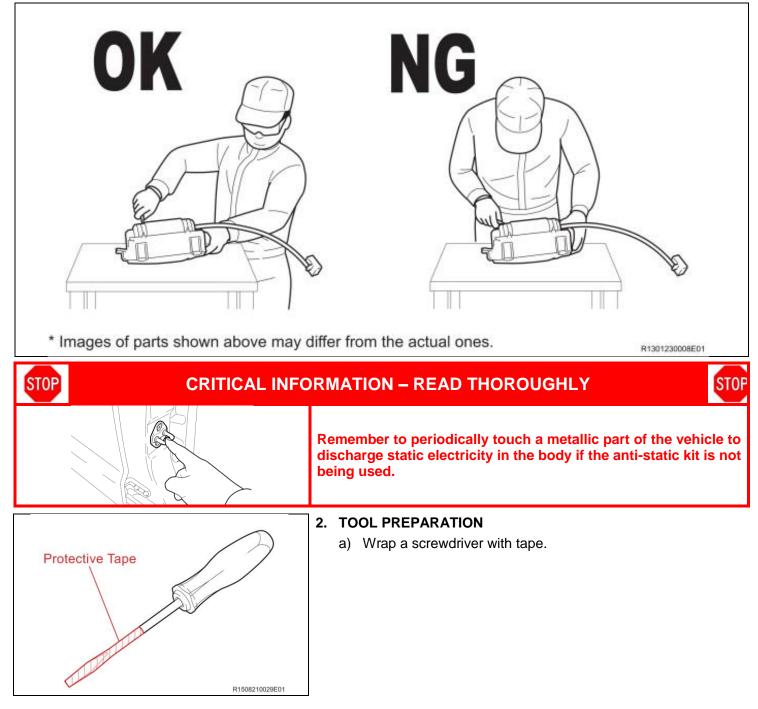
- a) Carefully place the airbag on the bench inflator side up.
  - NOTE: Place clean sheet(s) of paper on the bench to protect the airbag.
- b) Avoid standing directly over the inflator.

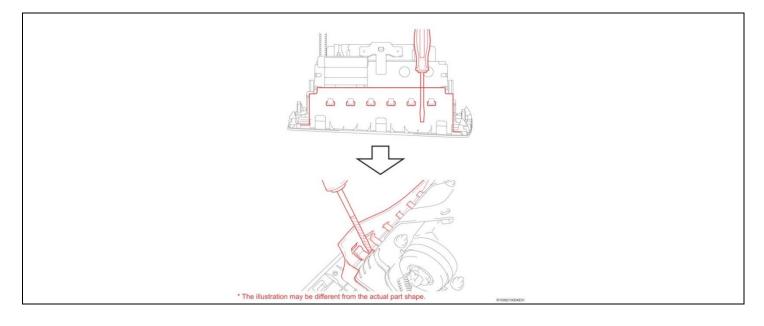
#### 3. REMOVE THE COVER

a) Gently insert the screwdriver between the airbag door and module and disengage the claws holding the door to the module. Please refer to the video below.

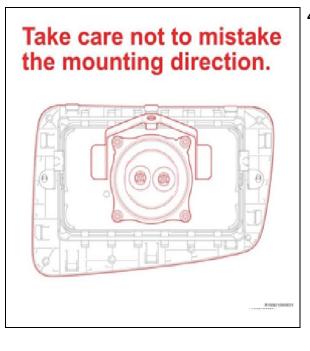
- b) After all the claws have been disengaged separate the module from the door.
- c) Mark the old module so it is not reused.
- d) Inspect the door for damage to the mounting slots.

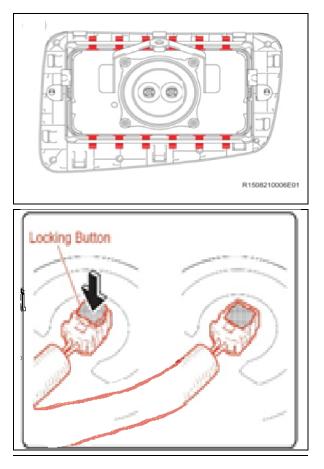
**NOTE: Mounting direction.**

a) Carefully slide the new module into the airbag door.

b) Reengage the tangs of the module into the door using the screwdriver with the shaft wrapped in tape.
