TO: Mercedes-Benz Dealer Principals, General Managers, Sales Managers, Service Managers, Parts Managers	FROM: Heike Scheuble, General Manager, Aftersales
RE: Recall Campaign 2018110007 Mercedes-Benz and Freightliner MY 12-13 Sprinters (906) Replace Takata Passenger-side Airbag	DATE: January, 2019

Campaign No. 2018110007, December 2018

SUBJECT: **Model 906 (Sprinter), Model Years 2012 -2013**
Mercedes-Benz and Freightliner
Replace Front Passenger-side Air Bag

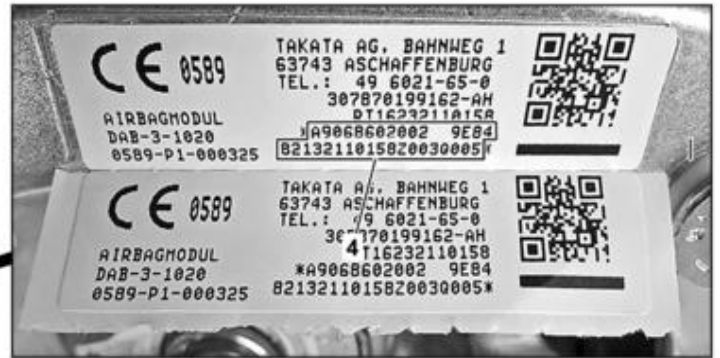
Shown on driver airbag (1)

1 Driver airbag

3 Adhesive label

4 Serial number

1 Document the serial number (4) of the removed driver airbag (1) or of the removed front passenger airbag (2) using "Mercedes-Benz Part Scan".

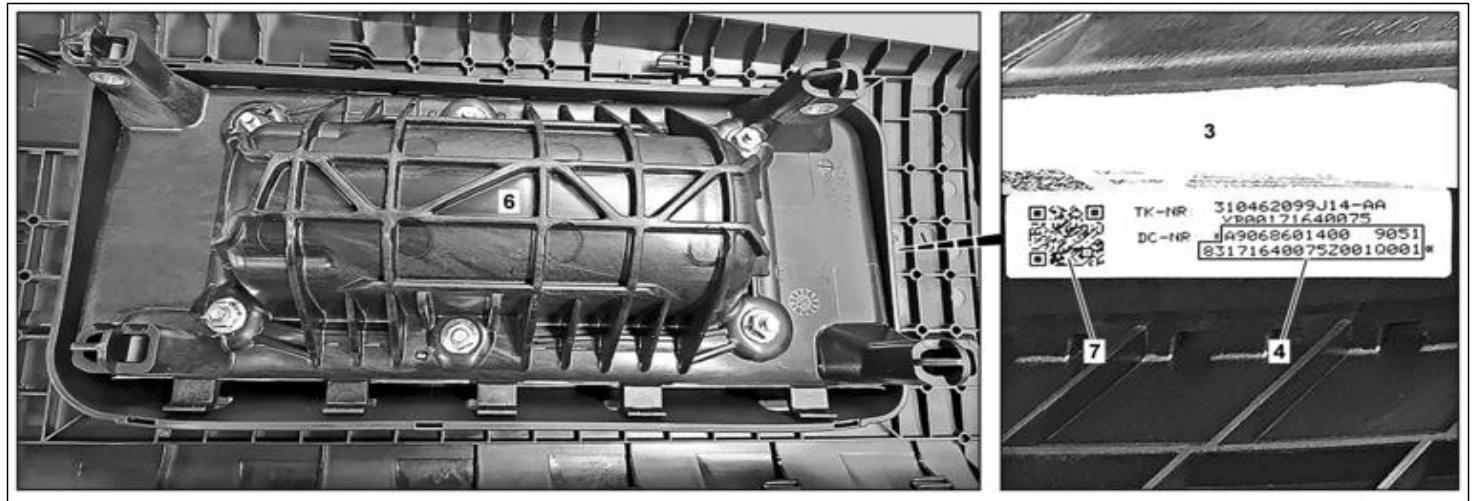
Shown on new front passenger airbag (6)

- 3 Adhesive label
- 4 Serial number

- 6 New front passenger airbag
- 7 QR code

Document the new driver airbag (5) or the new front passenger airbag (6) using "Mercedes-Benz Part Scan".

To do this, scan the serial number (4) on the adhesive label (3) with the QR code (7) on the new driver airbag (4) or the new front passenger airbag (6). If necessary, the serial number (4) of the new driver airbag (5) or of the new front passenger airbag (6) can also be documented manually using the keypad. To do this, read off the serial number (4) on the adhesive label (3) on the new driver airbag (5) or the new front passenger airbag (6) and enter it manually in the application using the keypad.
