Campaign No. 2020040010, April 2020

SUBJECT: **Model W204, X204****Model Years 2013****Replace Front Passenger-side Airbag**

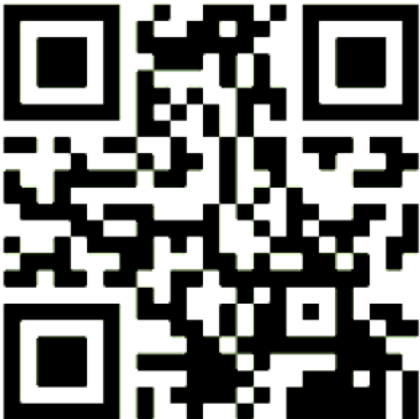
Figure 1

- To install and transmit the data a WiFi connection is required.
- After downloading the App, a one-time security authentication is required by means of encrypted QR code (Figure 1). Verification can be performed by scanning the QR code below (Figure 1), before using the application.

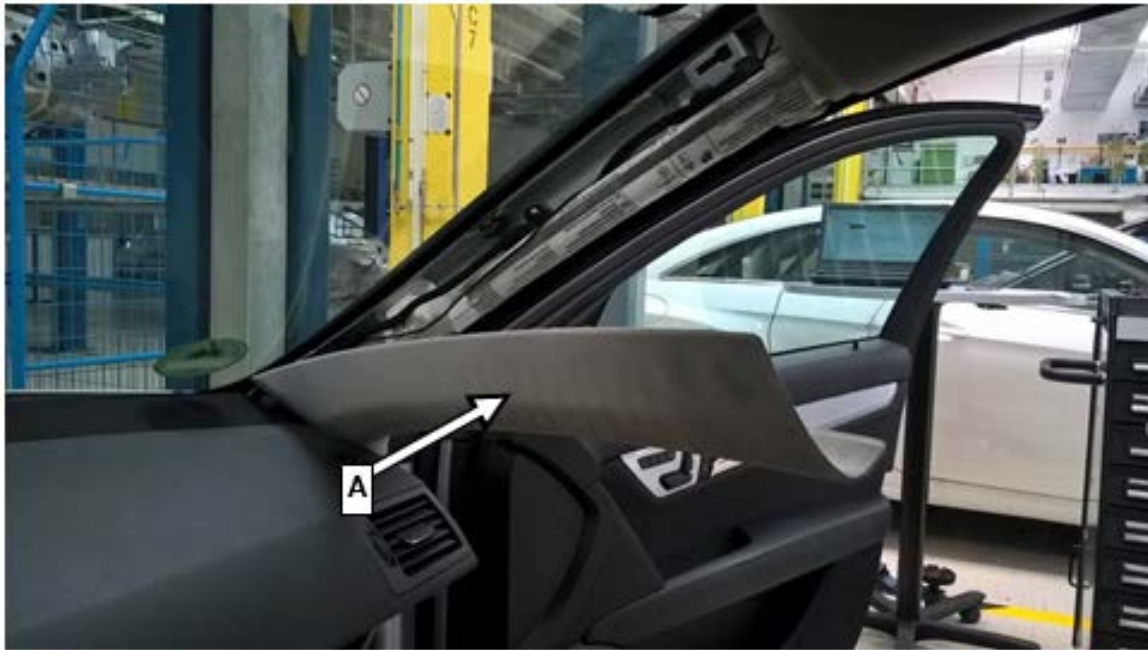
Figure 2

1. Disconnect ground line from the on-board electrical system battery.
2. Remove right A-pillar trim (**A, figure 2**).

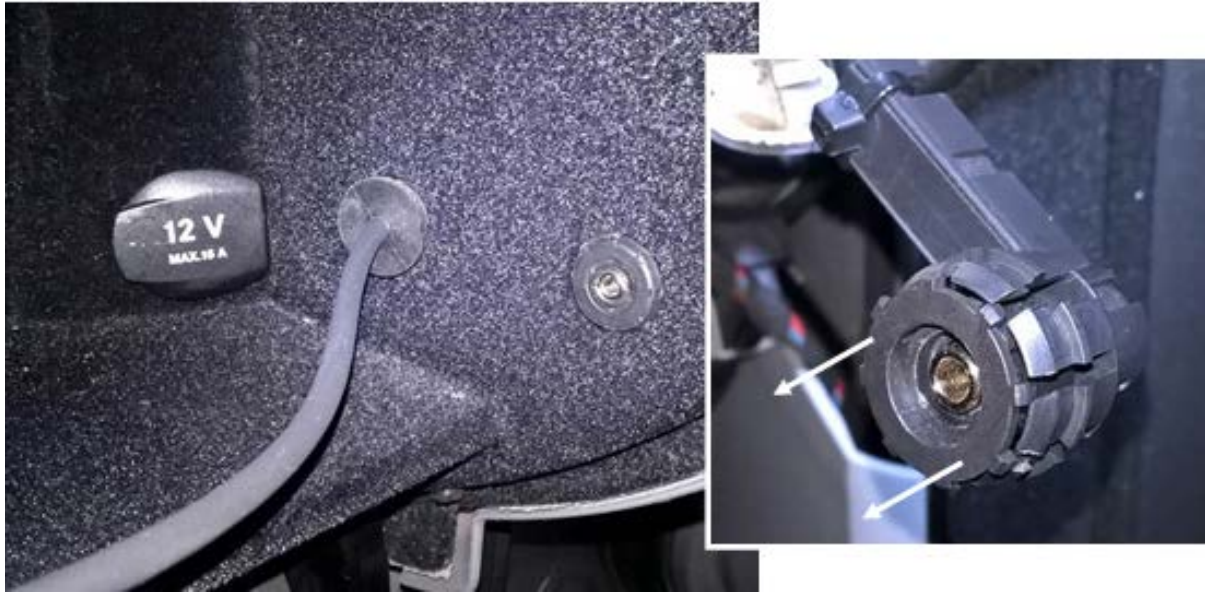
Figure 3

i Release inner retaining ring (**figure 3**) at the AUX connection towards the inside. The connection can then be removed from the glove box housing.

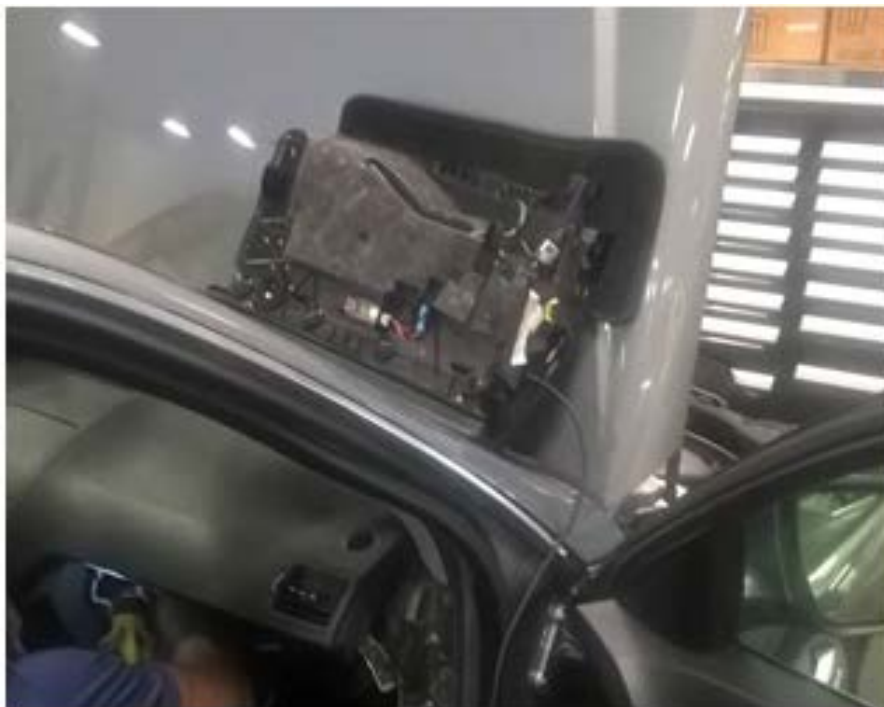
Figure 4

i Pull out the iPod cable as far as possible and set down glove box housing on the windshield **with** exterior iPod cable connected (**figure 4**).

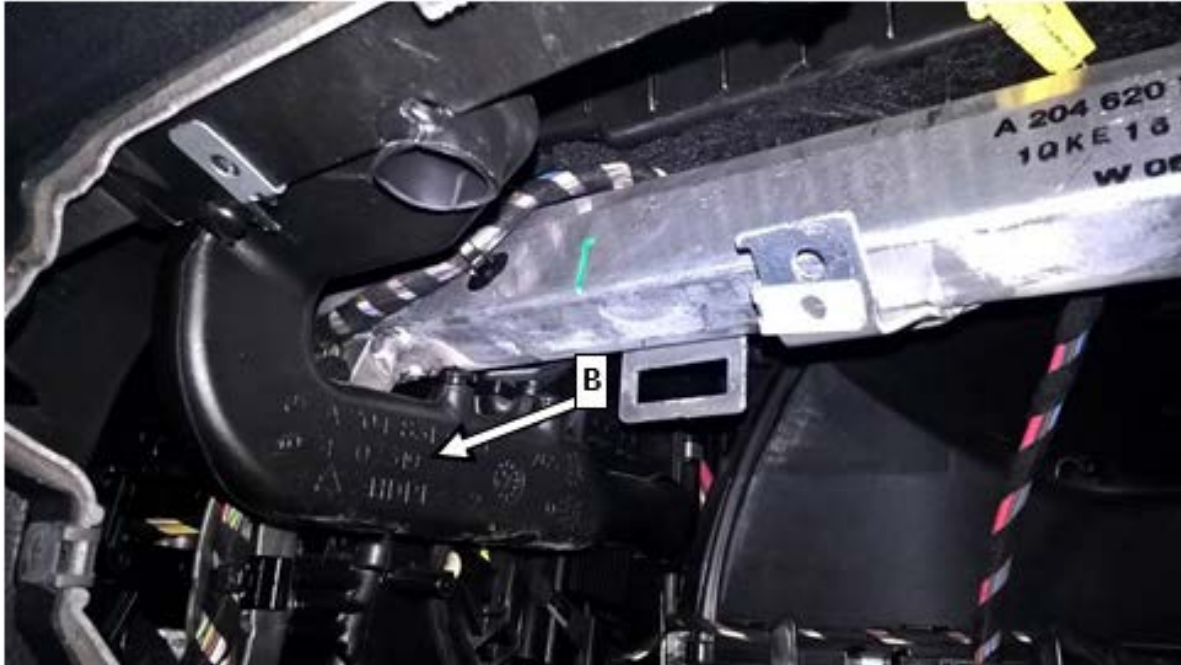
Figure 5

4. Remove air duct (B, figure 5) above the glove compartment.

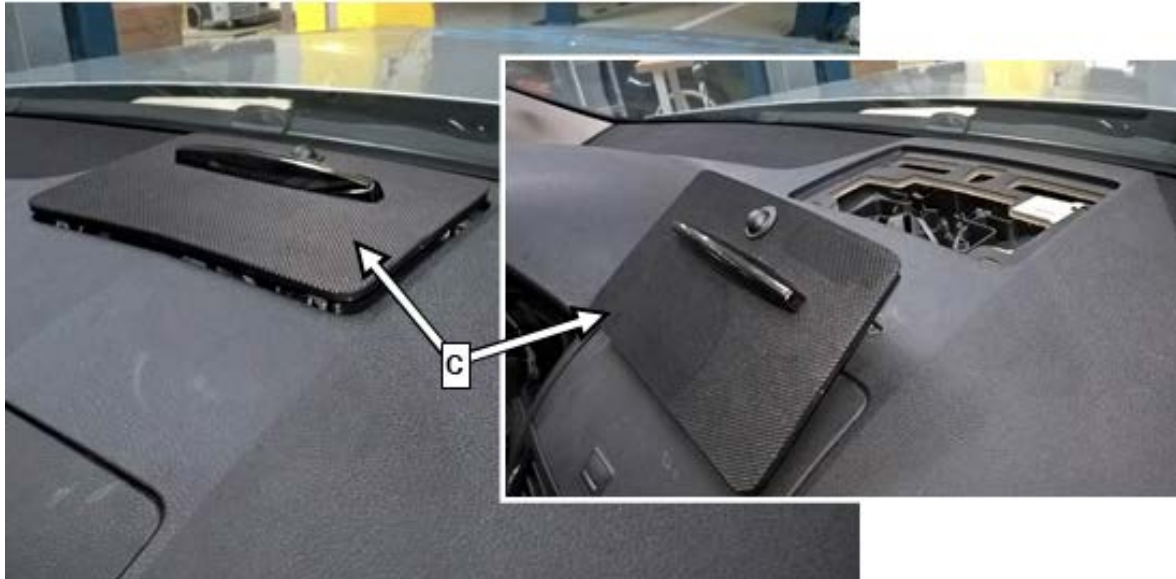
Figure 6

5. Unclip and remove cover (**C, figure 6**) at the instrument panel on top.

i With a sound system, also remove speaker under the cover.

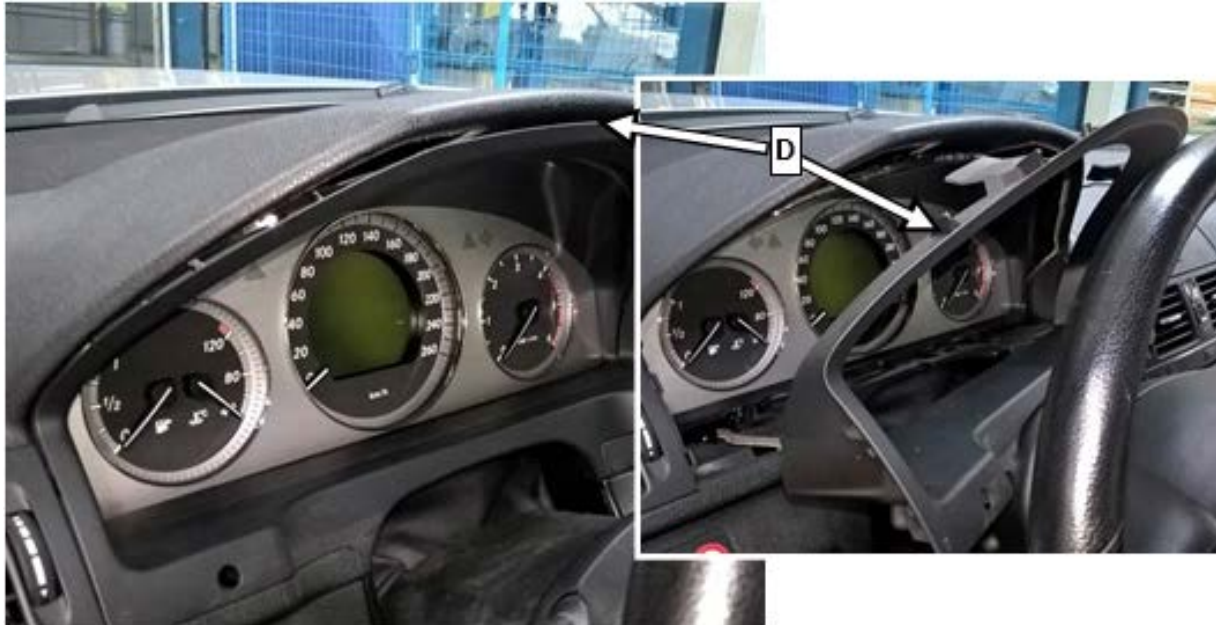
Figure 7

6. Remove center console (**AR68.20-P-2000CW**).
7. Remove automatic climate control and operating unit.
i For basic data of model W204, see **AR83.40-P-6350CW**
8. Remove trim (**D, figure 7**) around the instrument cluster.
i For basic data of model W204, see **AR54.30-P-6015CW**.

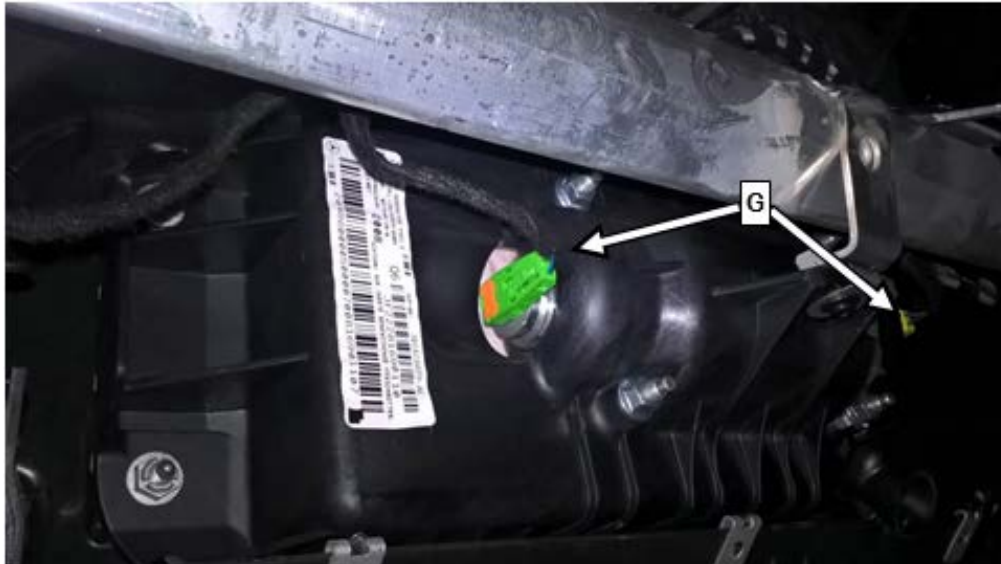
Figure 10

11. Disconnect electrical contacts (G, figure 10) at the front passenger airbag.

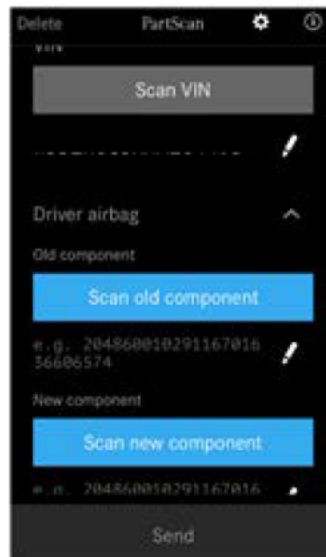
Figure 13

15. Scan the barcodes of the new passenger airbag using the button "Scan new component" (figure 13).
 - i** Ensure that the lower barcode (J, figure 14) is scanned.
 - i** All required data can also be read off and entered manually.

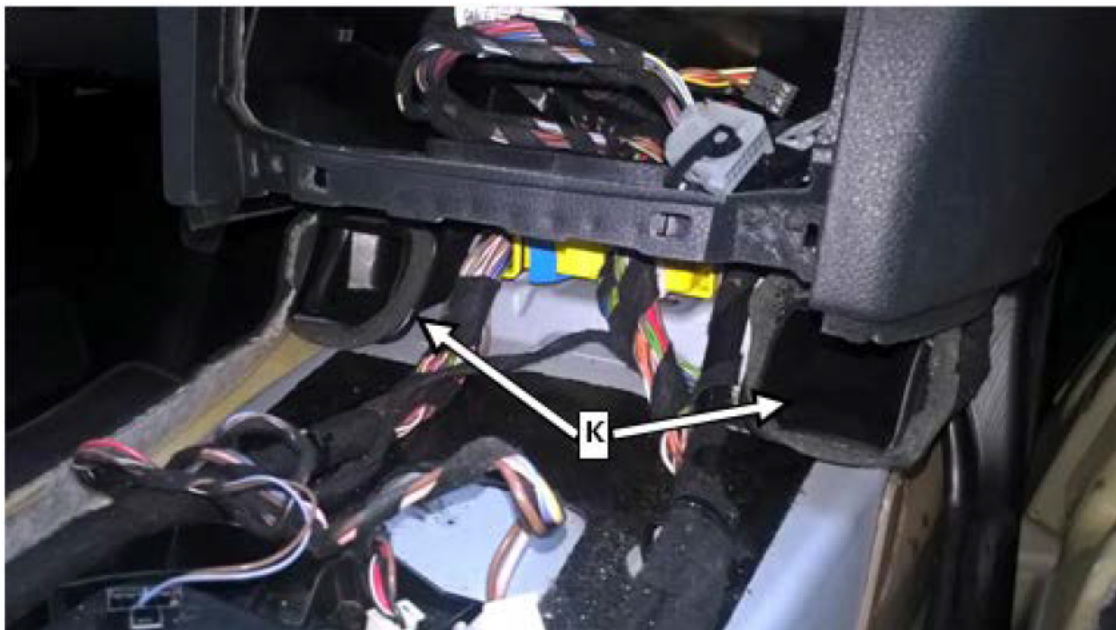
Figure 17

18. Place instrument panel back into position and install the air ducts (**K**, figure 17) correctly.

i The air ducts are pulled out when the instrument panel is raised.

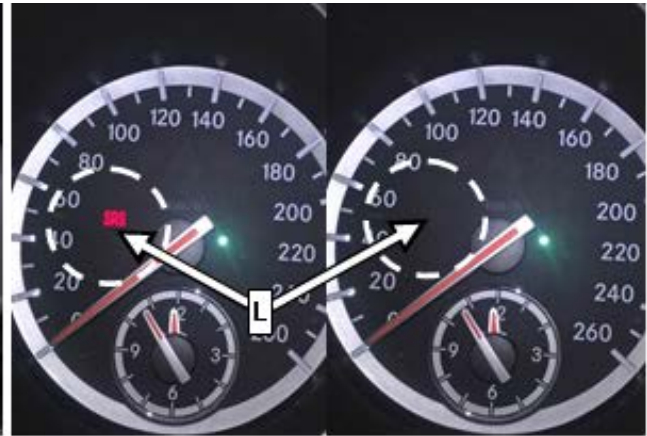
21. Turn the transmitter key in the electronic ignition lock to **position 1** and check whether the airbag indicator lamp (**L, figure 18 or 19**) correctly switches off after a few seconds.

i The SRS check is thus completely ensured after airbag replacement.

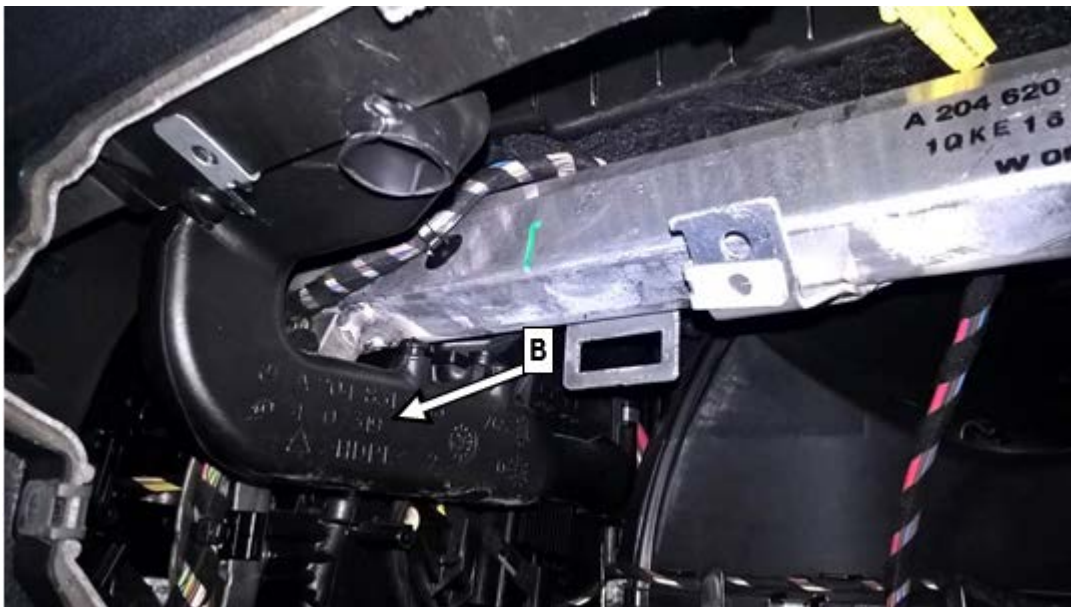
Figure 20

1. Disconnect ground line from the on-board electrical system battery.
2. Remove glove compartment housing (**AR68.10-P-1200CY**).
3. Remove air duct (**B, figure 20**) above the glove compartment.

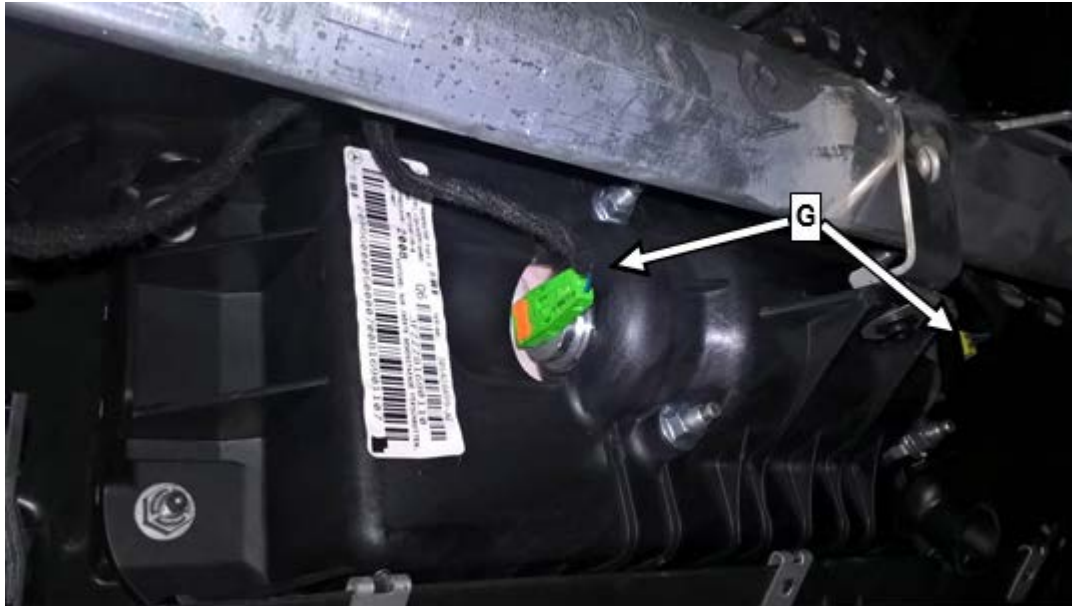
Figure 21

4. Disconnect electrical contacts (**G**, **figure 21**) at the front passenger airbag.

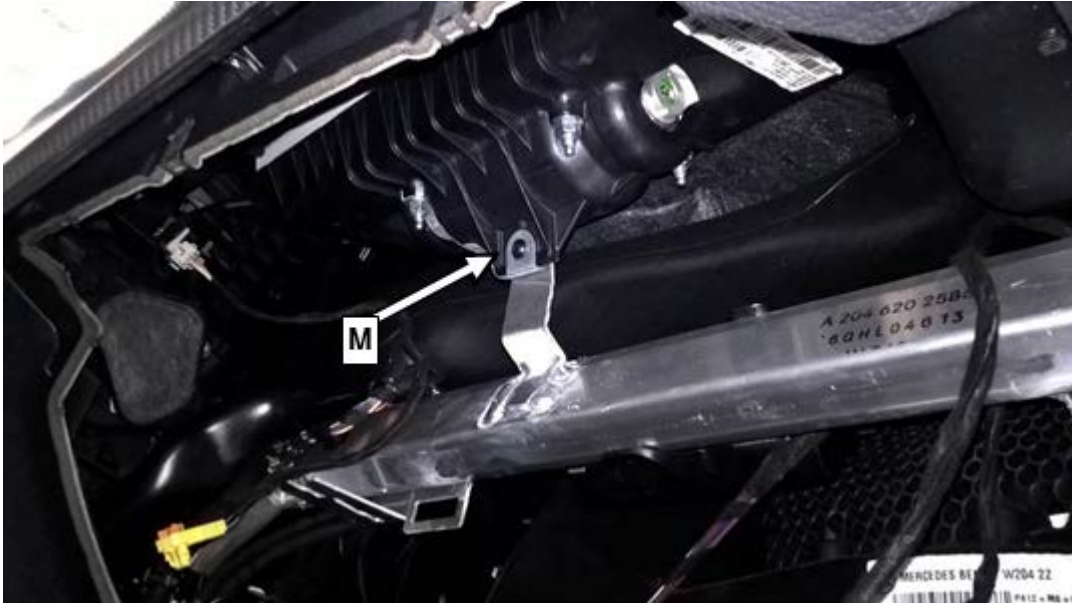
Figure 23

6. Remove Screw (**M**, figure 23) for the front passenger airbag.

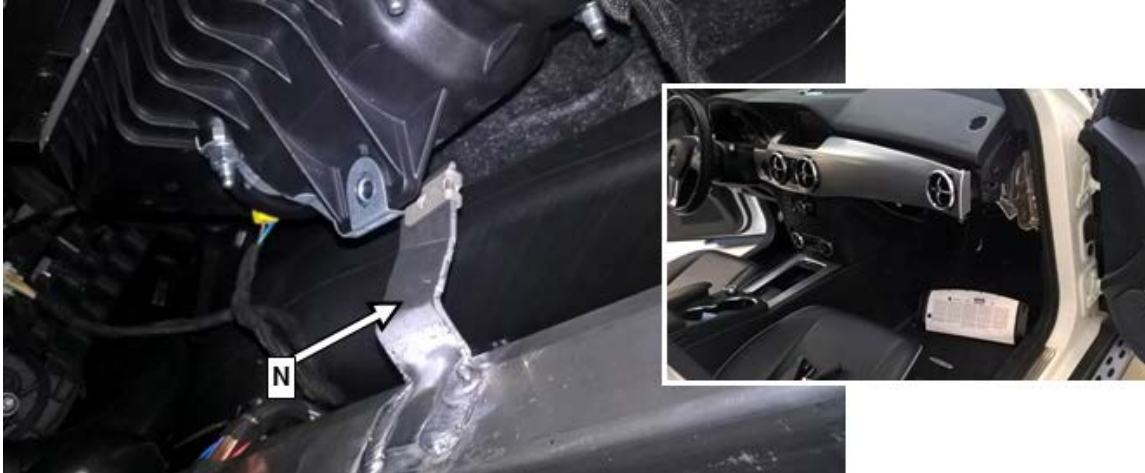
Figure 24

i To remove the front passenger airbag, slightly push the bracket (**N**, figure 24) forward.
