Dealer Service Instructions for:

# Safety Recall UO2 / NHTSA 18V-048 Fuel Supply Jumper Tube

# 2018 (WK) Jeep® Grand Cherokee Trackhawk

# A. Fuel Supply Jumper Tube Inspection

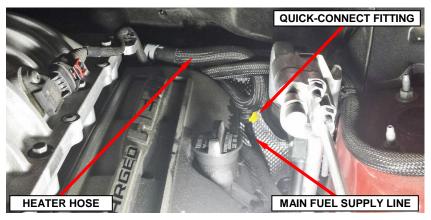
Figure 1 – Fuel Supply Jumper Quick Connect Fitting

- 1. Open the engine compartment hood.
- 2. Locate the fuel supply jumper quickconnect fitting near the cowl behind the left side of the engine (Figure 1).
- 3. Lift the heater hose out of the way in

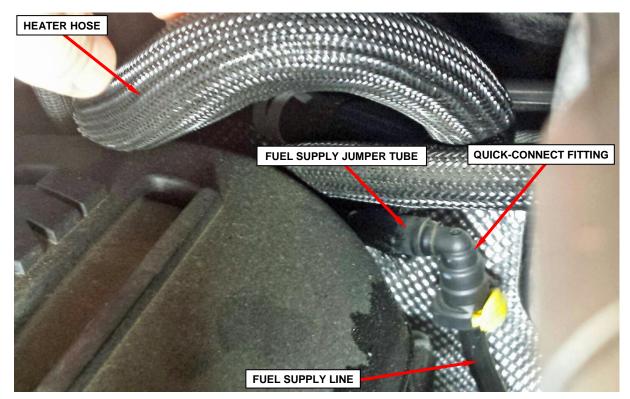
Figure 2 – Fuel Supply Jumper Quick Connect Fitting

order to clearly view the area where the fuel supply jumper tube is attached to the quick-connect fitting (Figure 2).

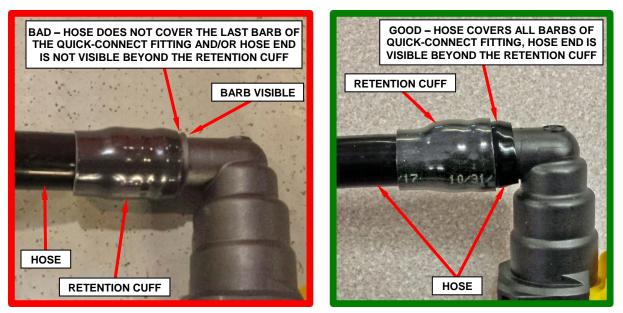
Figure 3 – Fuel Supply Jumper Tube – Inspect Hose Connection

- 4. Inspect the fuel supply jumper tube connection between the hose and quickconnect fitting. The hose must cover all the barbs on the quick connect fitting and hose end must be visible beyond the edge of the retention cuff. If the hose does not cover all barbs and/or is not visible beyond the edge of the retention cuff, then the fuel supply jumper tube must be replaced (Figure 3).

- GOOD Fuel supply jumper tube hose covers all barbs of the quick-connect fitting and hose end is visible beyond the retention cuff. Position the heater hose back into its original location and close the engine compartment hood. This recall inspection is complete; claim the inspection LOP and return the vehicle to the customer.

- BAD Fuel supply jumper tube hose does not cover all barbs of the quickconnect fitting and/or hose end is not visible beyond the retention cuff. The fuel supply jumper tube must be replaced.
    Present to Section P. Fuel Supply Jumper Tube Deplacement.

Proceed to Section B. Fuel Supply Jumper Tube Replacement.

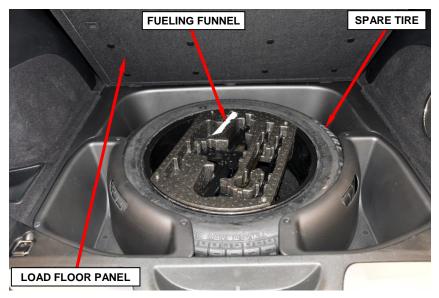
Figure 4 – Fueling Funnel Location

1. Open the liftgate and raise the load floor panel, then locate the fueling funnel stored with the spare tire (Figure 4).

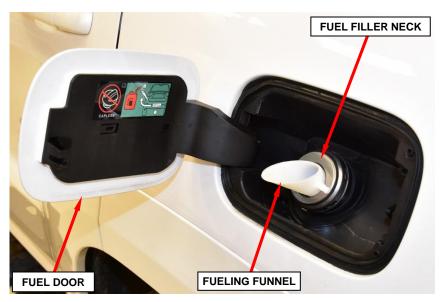
Figure 5 – Fuel Filler

2. Open the fuel door and insert the fueling funnel into the fuel filler neck to release any fuel tank pressure (Figure 5).

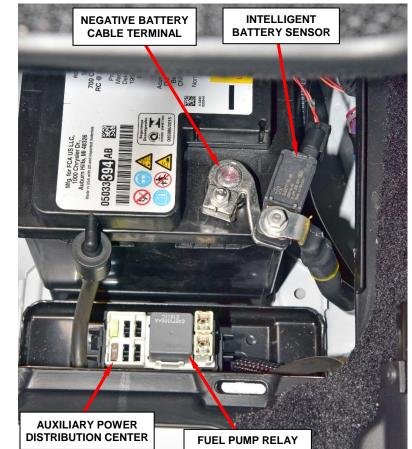
Figure 6 – Fuel Pump Relay and Negative Battery Terminal

- 3. Take note of the customer's preferred seat position then move the front passenger seat fully forward.
- 4. Remove the battery compartment cover.
- 5. Remove the fuel pump relay from the auxiliary power distribution center (Figure 6).
- 6. Start and run the engine until it stalls.
- 7. Attempt restarting the engine until it will no longer run.

10. Install the fuel pump relay in the auxiliary power distribution center (Figure 6).

- 23. Connect the negative battery cable terminal to the battery then tighten the clamp pinch-bolt hex nut to 5.5 N·m (50 In. Lbs.). For vehicles equipped with a supplemental battery, also connect the negative battery cable terminal to the supplemental battery (Figure 6).

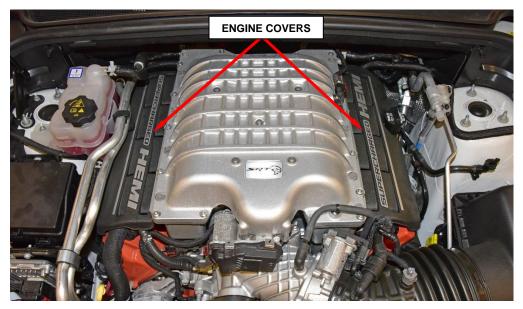
Figure 7 – Engine Covers

11. Gently lift the engine covers vertically to release the engine cover grommets from the ball studs. Then remove the engine covers. The right-side engine cover will need to be slid forward toward the front of the engine to clear the coolant pipes (Figure 7).

- 27. Using hands only, gently push down on the engine covers until the grommets engage with the ball studs (Figure 7). Ensure grommet and ball stud retention by lightly lifting up around the edges of the engine cover to make certain that the cover is not loose and that all of the grommets are securely engaged.
- 28. Close the engine compartment hood.
- 29. Remove the fueling funnel from the fuel filler neck then close the fuel door (Figure 5).
- 30. Return the fueling funnel to the storage area near the spare tire. Lower the load floor panel into position, then close the liftgate (Figure 4).
- 31. Install the battery compartment cover.
- 32. Return the front passenger seat to its original customer preferred position.

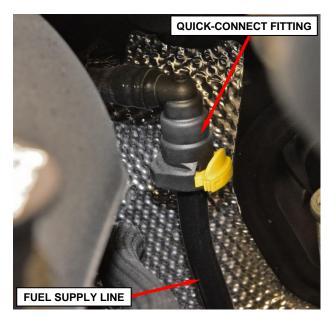
Figure 8 – Fuel Supply Jumper Quick-Connect Fitting Left Side of Engine

12. Place a rag or towel below the fuel supply jumper quick-connect fitting where it connects to the fuel supply line located near the cowl behind the left side of the engine (Figure 8).

> WARNING: The catalytic converter is located directly below this fuel connection. To prevent a possible fire, ensure that the catalytic converter is not excessively hot before disconnecting this fuel connection.

- 22. Connect the fuel supply jumper tube to the fuel supply line, then depress the redundant latch to secure the quick-connect fitting to the fuel supply line (Figure 8).

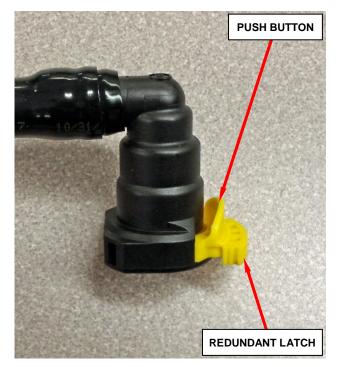
Figure 9 – Quick-Connect Fitting

13. Perform the following steps to release the fuel supply jumper quickconnect fitting from the fuel supply line (Figure 9).

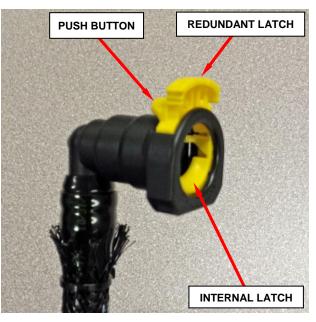
Figure 10 – Quick-Connect Fitting

> NOTE: This type of quick-connect fitting is equipped with a redundant latch and a single push button that releases the internal latch located in the quick-connect fitting. Special tools are not required for removal (Figure 10).

> CAUTION: Do not pry or pull up on the push button as damage to the latch of the quick-connect fitting will occur.

- a. Pull the redundant latch out away from the quick-connect fitting (Figure 10).
- b. Press the push button to release the internal latch, then remove the quick-connect fitting from the fuel system component (Figure 10).

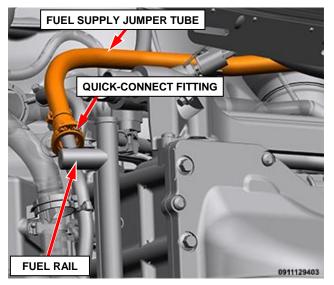
Figure 11 – Fuel Supply Jumper Quick-Connect Fitting Right Side of Engine

- 14. Place a rag or towel below the fuel supply jumper quick-connect fitting where it connects to the fuel rail located near the cowl on the right side of the engine (Figure 11).
- 15. Perform the procedure in **Step 13** to release the fuel supply jumper quick-connect fitting from the fuel rail (Figure 11).
- 16. Release the fuel supply jumper tube from the "C" clip retainer at the back of the engine (Figure 12).

- 20. Ensure that the fuel supply line and fuel rail connections are clean and free of debris before connecting the fuel supply jumper tube.
- 21. Connect the fuel supply jumper tube to the fuel rail, then depress the redundant latch to secure the quick-connect fitting to the fuel rail (Figure 11).

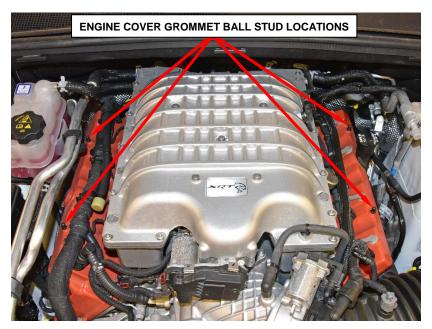
Figure 13 – Engine Cover Studs

26. Position the engine covers with grommets over the ball studs (Figure 13). The right-side engine cover will need to be slid rearward toward the cowl to clear the coolant pipes.
