SAFETY RECALL CAMPAIGNS 2A76 - 2A81

ECM REPAIR SUPPLEMENT FOR CRATED, UNSOLD UNITS

2017 - 2018 GSX-R1000/A and GSXR1000RA/RZ

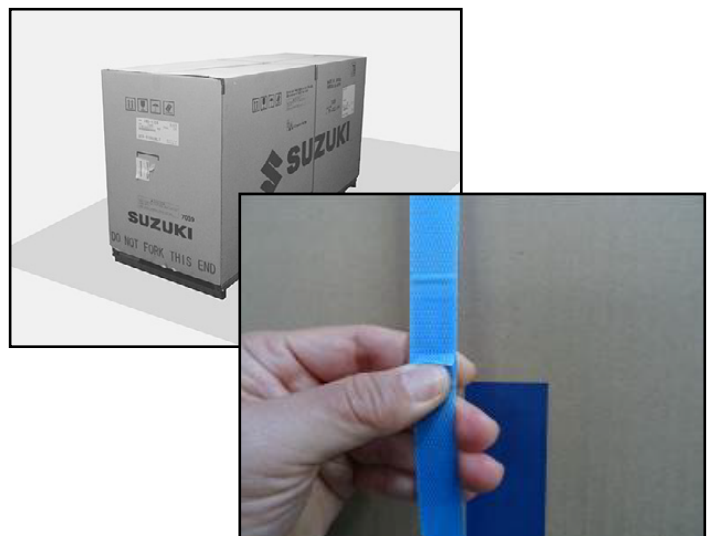
- 1) Peel off the adhesive point of the blue plastic band on the carton covering the crate – do NOT cut the band so you can reuse it later (unless you are equipped to reband the carton).
- 2) Gently lift the carton upward, taking care not to damage or tear it.

- Repair any holes or tears in the carton with packing tape.
- When the repair is complete, be sure the front of the carton faces the same direction as when you removed it.

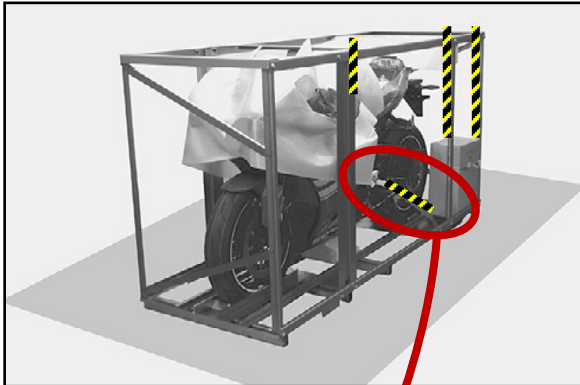
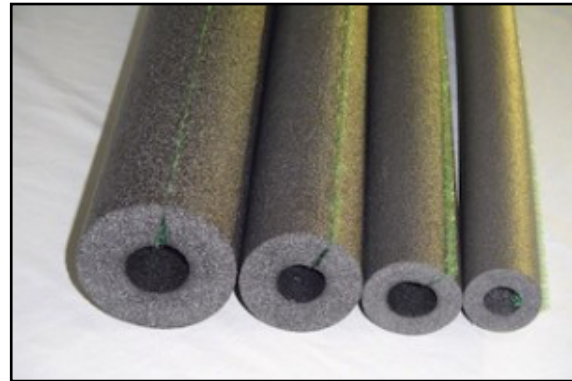
- 3) Remove the top portion of the metal crate.
- 4) Remove the polystyrene foam.
- 5) Wrap a protective material, such as Styrofoam tubing, on the locations of the metal crate as shown below so you can work safely around the unit.

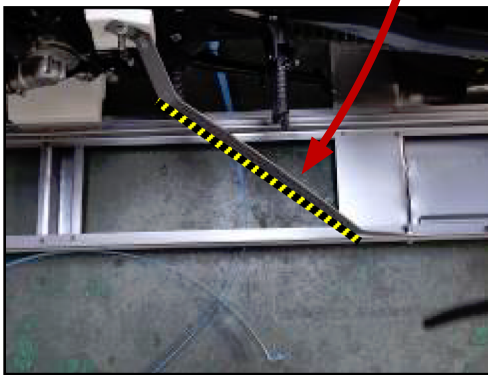
Sample of Protective Material

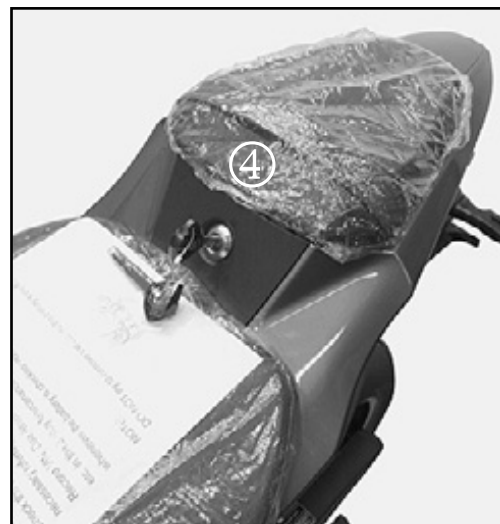
**Write a large number 4
on the plastic covering the passenger seat,
NOT on the seat itself.**

- 1) Write a large number 4 **on the plastic bag covering the passenger seat** and circle it. **Do NOT write on the seat itself.**
- 2) Remove the protective materials you applied to the metal crate earlier.
- 3) Install the polystyrene foam in the appropriate locations.
- 4) Install the top of the metal crate and torque the bolts to **25 N·m (2.5 kgf-m, 18 lbf-ft)**.

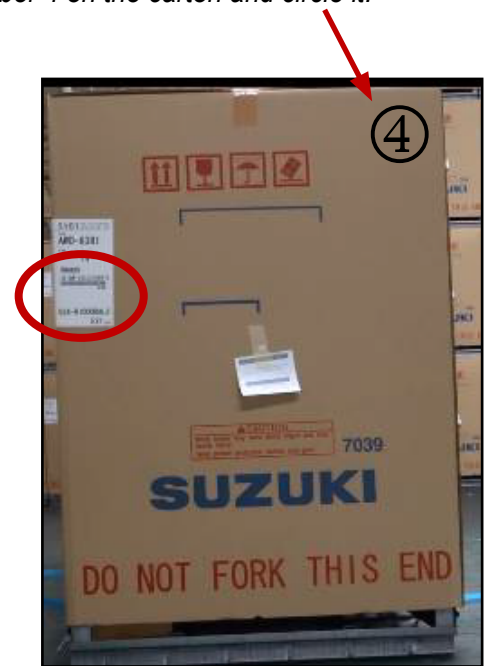
Write a large number 4 on the carton and circle it.

Confirm the VIN on the carton matches the VIN on the unit.

- 5) Install the carton over the metal crate. Be sure to confirm the VIN on the carton matches the VIN on the unit.
- 6) Recrimp the blue plastic band over the carton, or reband it with new banding if your shop is equipped to do so.
- 7) Write a large number 4 on the carton as shown, and circle it.
