Safety Recall

Code: 69R6

Subject Driver Frontal Airbag Inflator (Takata)

Affected Vehicles ***U.S.A. & Canada: Certain 2009-2013 MY Audi vehicles equipped with a Takata driver frontal airbag***

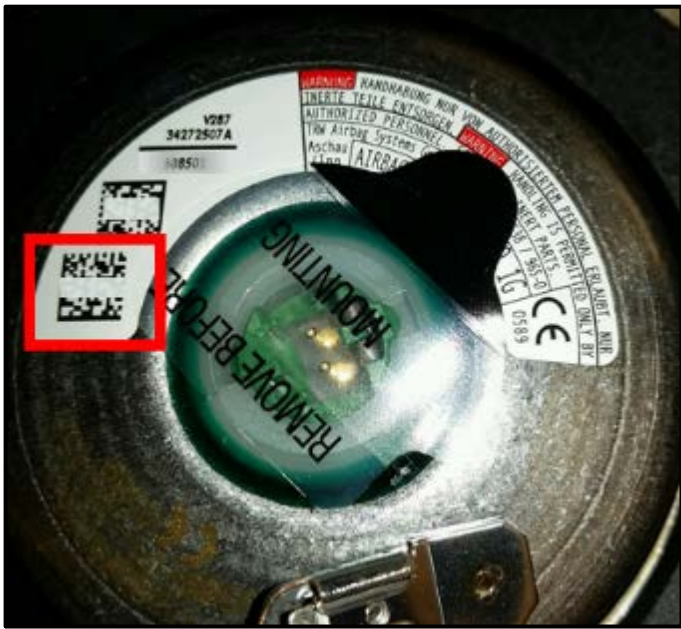
- Place the new inflator on the ESD mat.
- Scan the data matrix code of the new inflator at a distance of about 15 cm.

The photo is for reference only. The inflator that is installed may be either a single stage or dual stage inflator.
