Compliance Recall

Code: 44N9

| Subject | Tire Information Label |

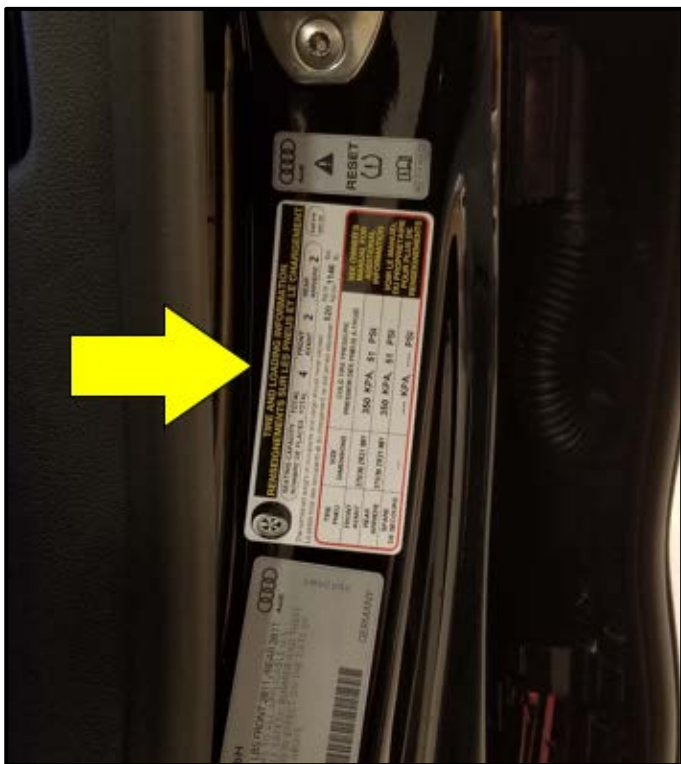
- Open the driver front door.
- Locate the "Tire and Loading Information" label on the B-pillar.
- Clean the surface of the existing label.
- Peel the replacement label off the backing paper.
- Affix the replacement label <arrow> over the existing label.

- Ensure minimal air bubbles are created when installing the new label.

- The surface of the existing label must be clean, dry, and free from oil residue prior to applying the replacement label.
- The replacement label **MUST** cover the existing label completely.
- Handle the replacement label carefully. Do not touch the adhesive backing.
