SAFETY RECALL BULLETIN

SUBJECT: OUTLANDER SPORT WINDSHIELD WIPER LINK – SAFETY RECALL CAMPAIGN – REVISED			No: SR-18-004REV
			DATE: March 2018
			MODEL: 2011–2016 Outlander Sport / RVR
CIRCULATE TO:	<input checked="" type="checkbox"/> GENERAL MANAGER	<input checked="" type="checkbox"/> PARTS MANAGER	<input checked="" type="checkbox"/> TECHNICIAN
<input checked="" type="checkbox"/> SERVICE ADVISOR	<input checked="" type="checkbox"/> SERVICE MANAGER	<input checked="" type="checkbox"/> WARRANTY PROCESSOR	<input checked="" type="checkbox"/> SALES MANAGER

This bulletin provides directions for replacing the windshield wiper link rod.

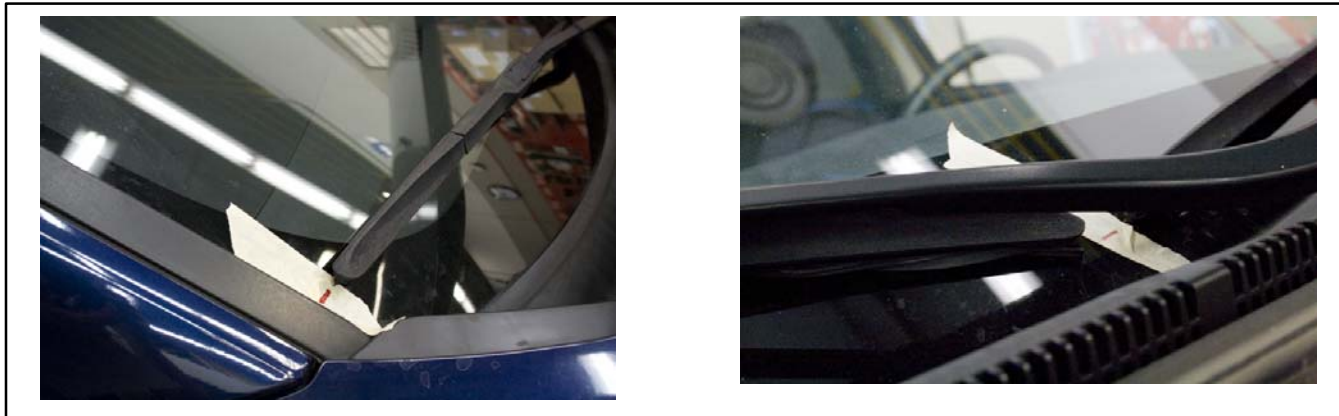
5. Attach masking tape to the windshield and mark the wiper blades' positions as shown.

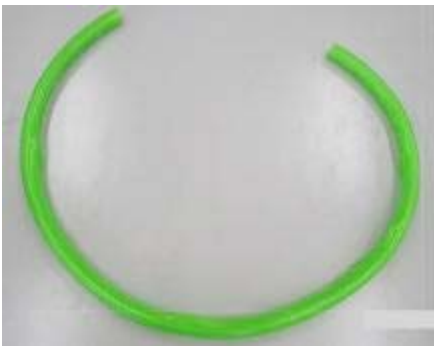
1. Hose Length: Approx. 33 in. (85 cm)

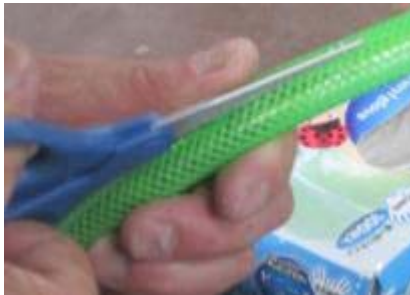
2. Cut entire length of hose

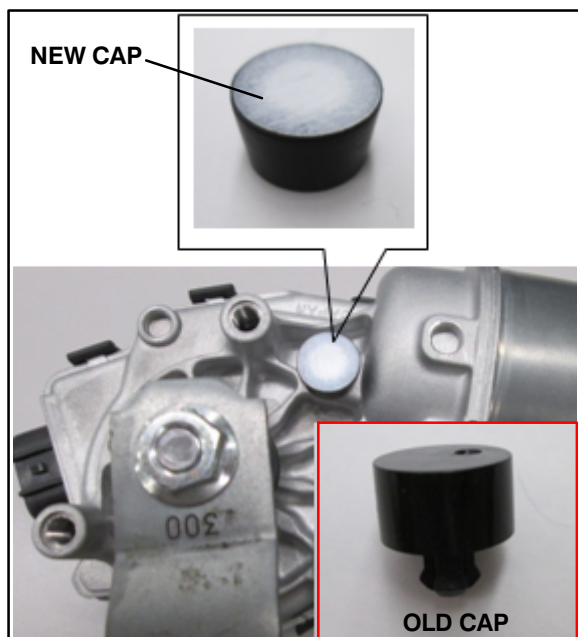
14. Turn the link plate approximately 90 degrees clockwise.

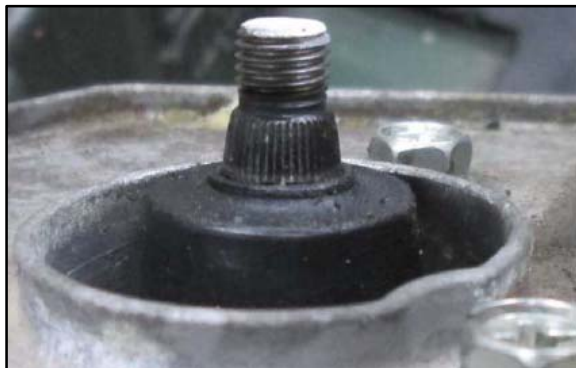
15. Hold the link plate in place with an adjustable wrench while loosening the link plate nut.

16. Remove the link plate and link plate nut.

NOTE: The link plate nut will be reused. Do not discard.

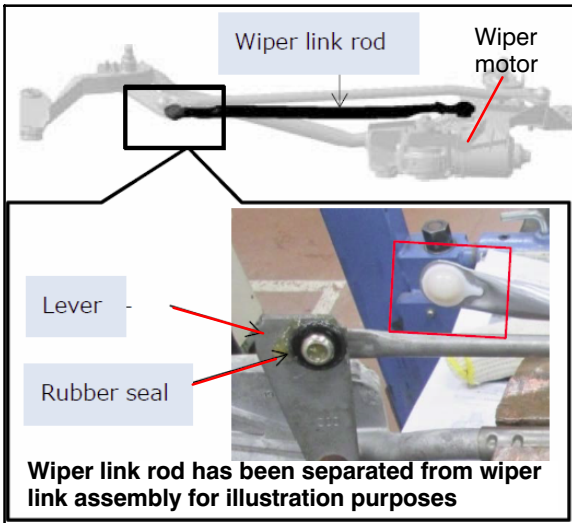
18. Rotate the wiper link assembly 90 degrees upward so that the wiper motor is directly visible from the top.

CAUTION: Clamp **ONLY** the connection pipe section.

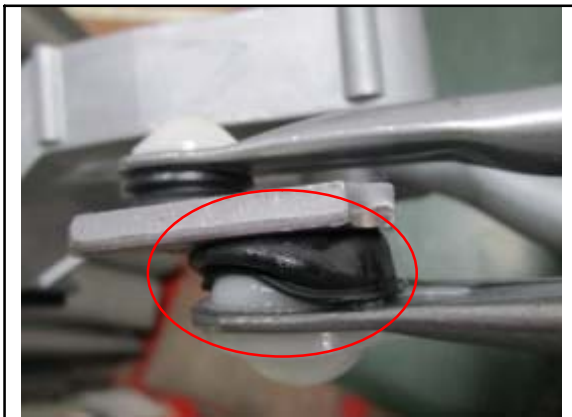
19. Locate the joint to be separated.

Do not remove the wiper motor side joint.

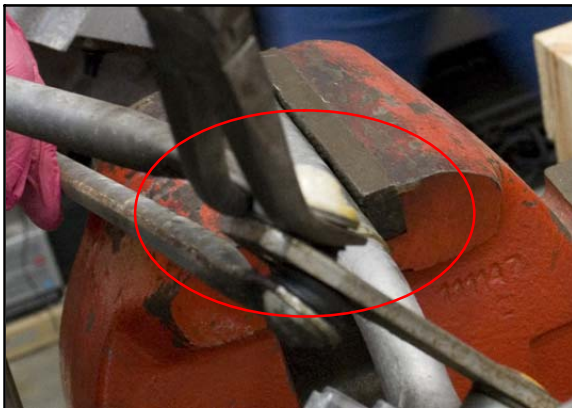
20. Pull back the rubber seal to prevent damage when performing the following steps.

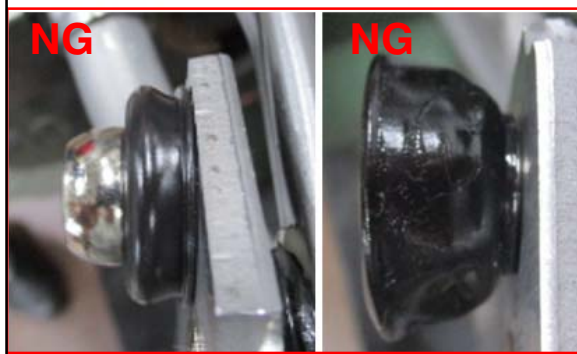
23. Verify that the rubber seal is not damaged. If rubber seal is damaged, replace it with a new rubber seal (part # 8251A098).

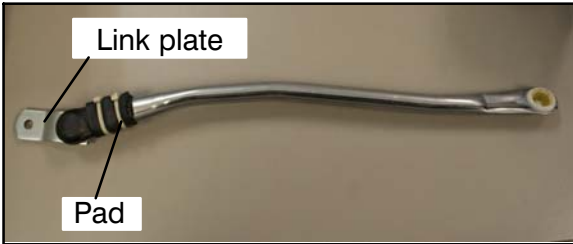
24. Rotate the wiper link assembly 90 degrees down so that the motor axle is facing up.

CAUTION: Clamp ONLY the connection pipe section.

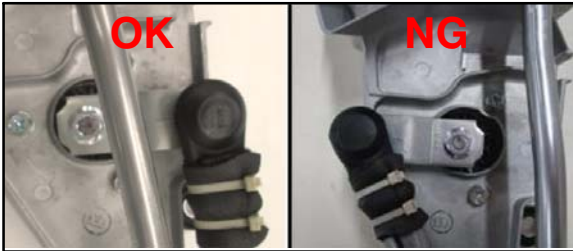
- 25. Obtain new wiper link rod (part # 8251A100).
- 26. Verify that the new wiper link rod appears as illustrated, complete with pad and link plate attached.

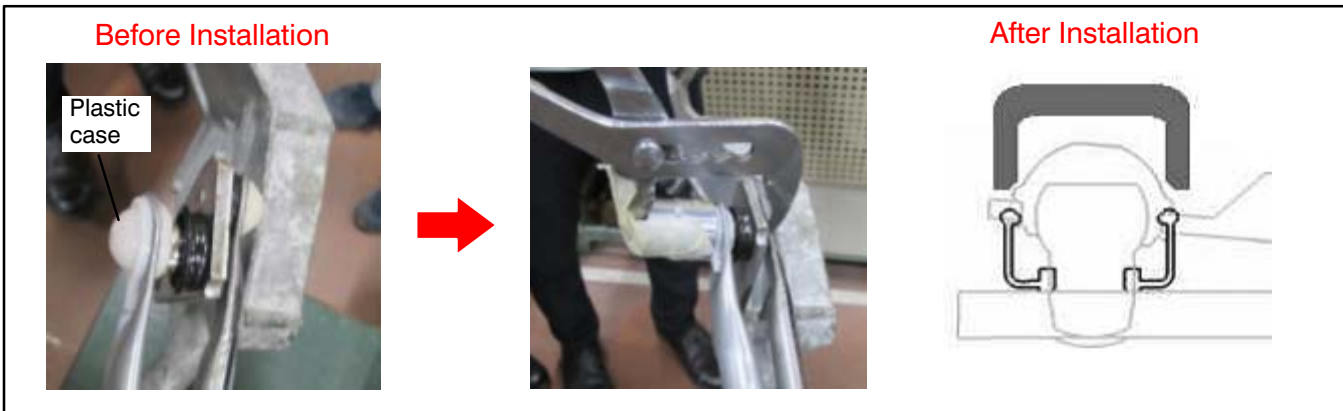
31. Rotate the wiper link assembly 90 degrees upward so that the wiper motor is directly visible from the top.
CAUTION: Clamp ONLY the connection pipe section.

32. Install wiper link rod, using the improvised tool, to the lever end that is opposing the wiper motor.

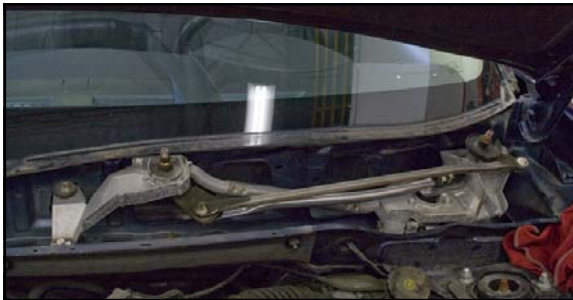
35. Reinstall the wiper link assembly to the vehicle and connect the windshield wiper motor connector.

Torque bolts to $71 \pm 18 \text{ in}\cdot\text{lb}$ ($8.0 \pm 2.0 \text{ Nm}$).

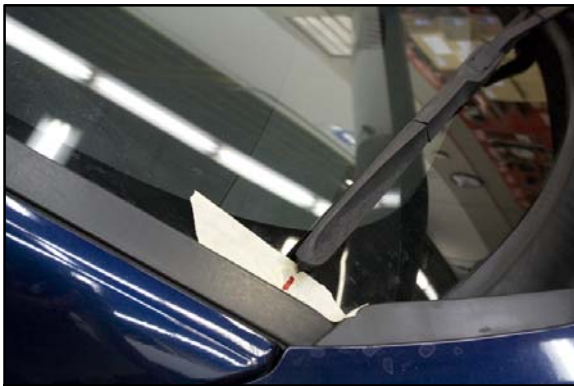
36. Reinstall the Wiper Fuse.

37. Turn the ignition switch to “ACC” or “ON”.

38. Switch the windshield wiper switch to “LO” and back to “OFF” to move wiper link to initial position.

39. Remove protective slit hose from windshield.
