**HYUNDAI**
Technical Service Bulletin

GROUP RECALL	NUMBER 18-01-011
DATE FEBRUARY, 2018	MODEL(S) Santa Fe Sport (AN) Santa Fe (NC)

SUBJECT: 2018 SANTA FE SPORT (AN) AND SANTA FE (NC) STEERING WHEEL INSPECTION AND REPLACEMENT (RECALL CAMPAIGN 173)

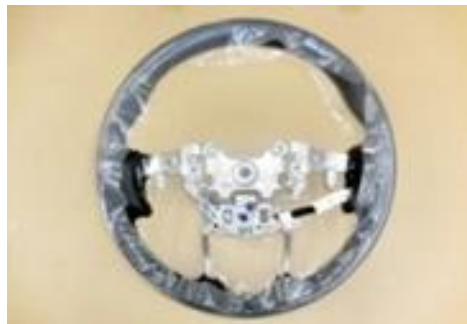
Description: Certain 2018MY Santa Fe Sport (AN) and Santa Fe (NC) vehicles may contain a steering wheel assembly that could potentially not meet specification. The subject vehicles could be equipped with a steering wheel hub assembly that could have been manufactured with insufficient breakage strength, increasing the risk that the steering wheel could separate from the steering column while driving. If the steering wheel separates from the steering column while driving, the driver may lose steering control of the vehicle, increasing the risk of a crash. This TSB provides the procedure to inspect and replace the steering wheel if needed.

4. If the LOT No. (C) is '170609H' or does not have a Lot No., replace the steering wheel per the 2018 Santa Fe Sport or Santa Fe Service Manual (Steering System>Steering Wheel).

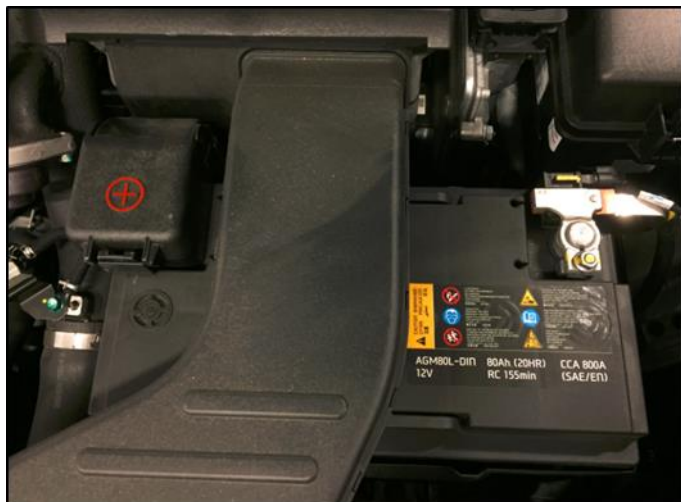
1. Open the hood and disconnect the Negative (-) terminal (J) from the battery.

NOTE: Wait at least 3 minutes before proceeding to make sure voltage is bled off.

Not removing the Negative (-) terminal from the battery may result in accidental airbag deployment and possible physical injury.
