Keystone RV Company

SAFETY ADVISORY # 18-314

Zinger/Longhorn GFCI Ground Wire

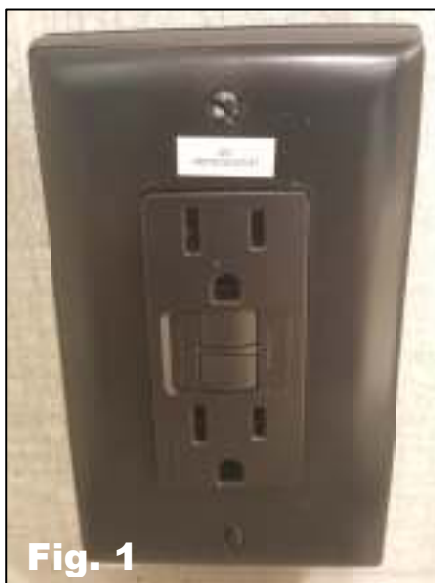
Fig. 1

Locate the GFCI receptacle in the unit that has the test button on the receptacle. There is only one receptacle like this in the unit, Figure 1.

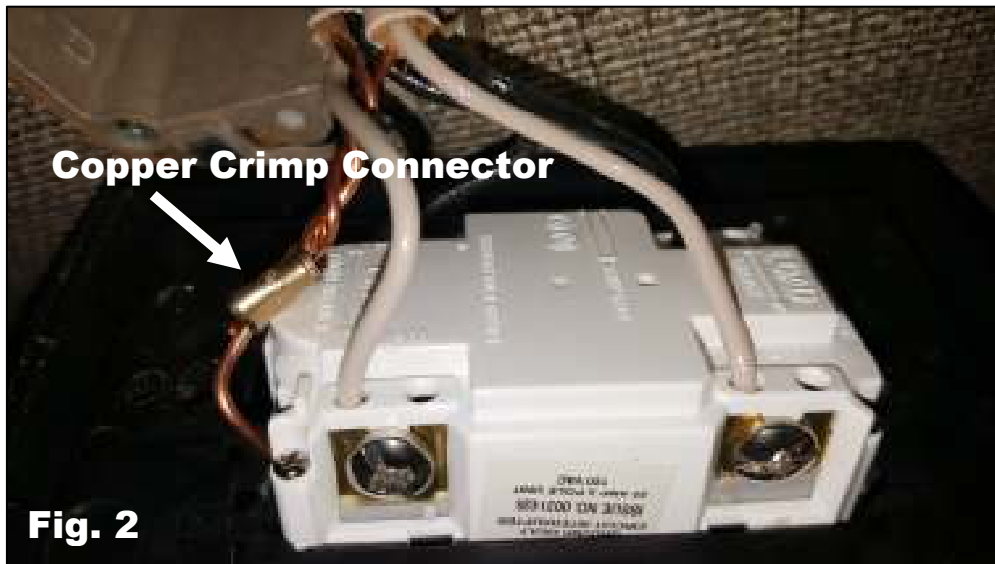
**Fig. 2****Step 3**

Remove the receptacle and inspect the bare copper ground wires for proper installation, Figure 2. There should be a copper crimp connector that crimps the ground wires together.

If there is a copper crimp connector, as in Figure 2, attached to the bare copper wires, proceed to Warranty Reimbursement. If not continue to step 5.

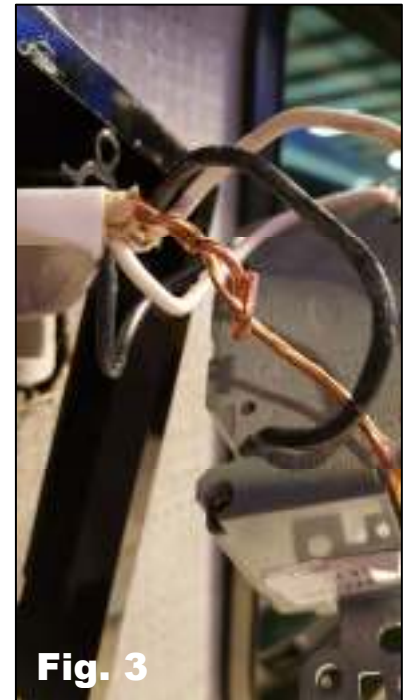
**Fig. 3****WARRANTY REIMBURSEMENT**

If there is no copper crimp connector (see Figure 3), remove the wire from the GFCI receptacle and install an approved connector as listed under the “Parts Required” section above. Reattach the ground wire to the GFCI receptacle and install the GFCI receptacle in receptacle box. Proceed to Warranty Reimbursement.
