## INSTRUCTIONS TO PERFORM RECALL CAMPAIGN 148

Certain 2018 Eras and 2018 Revels. Eras were manufactured between September 12, 2017 and February 21, 2018. Revels were manufactured between August 29, 2017 and February 20, 2018.

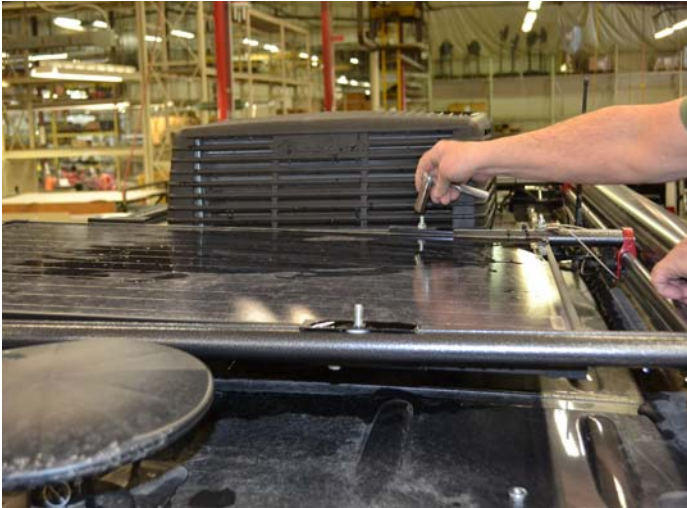
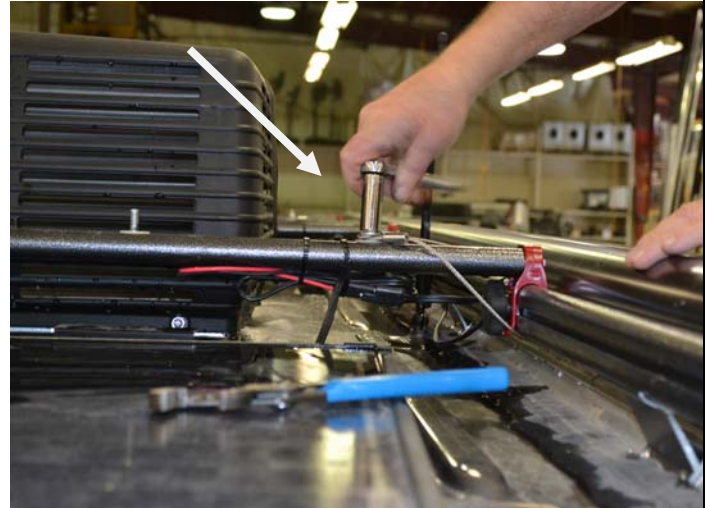
1. Remove bolts from Solar Panels mounted on roof rails.

2. If your motorhome is equipped with security cables, remove cables and discard the cable and two attachment bolts.

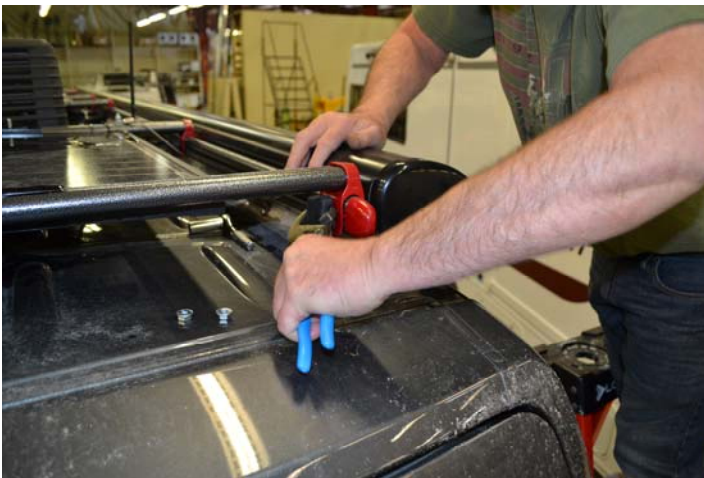
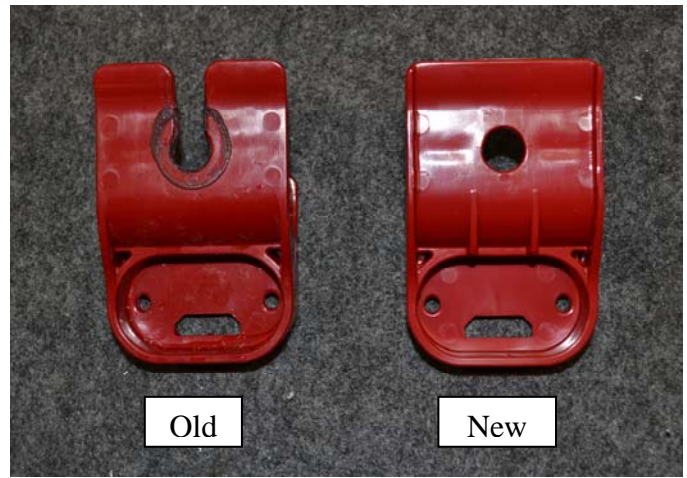
3. Remove hand nuts from side support roof rails and remove adjustable roof rails.

4. "Old" vs. "New" red plastic saddles on roof rails.

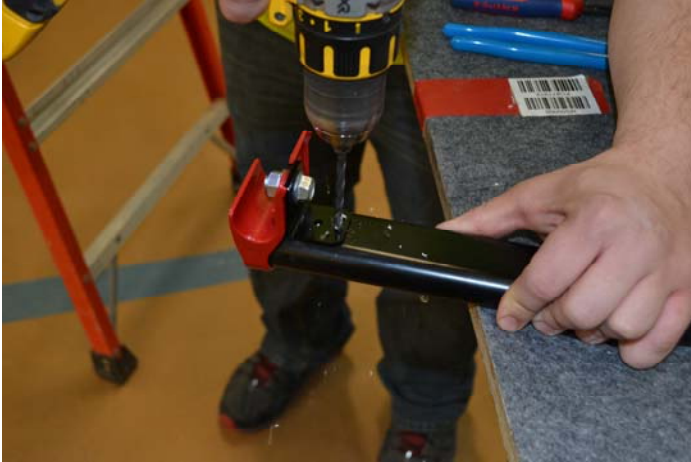
5. Install new metal support bracket by using a bolt to locate and position the support bracket. Once bolted into position, use a 3/16" drill bit to drill holes into the adjustable roof rail.

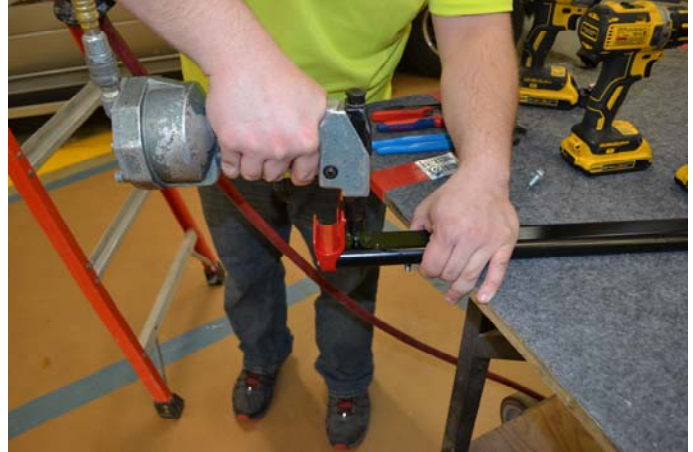
6. Attach the support bracket to the roof rail with two rivets.

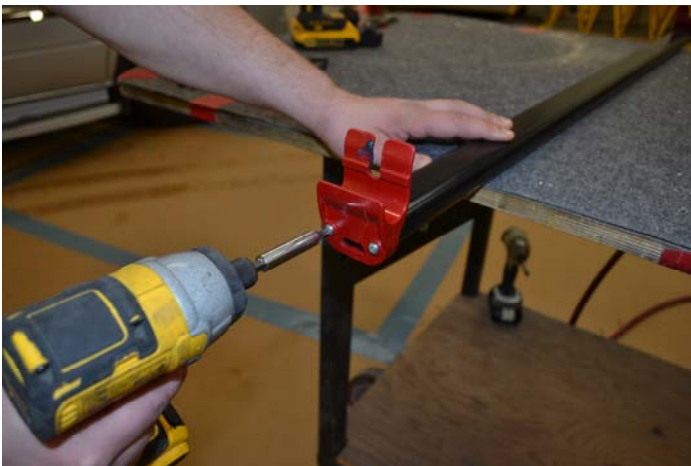
7. Use a screw gun and #2 Philips magnetic tip to remove the "Old" red plastic saddles from ends of adjustable roof rails.

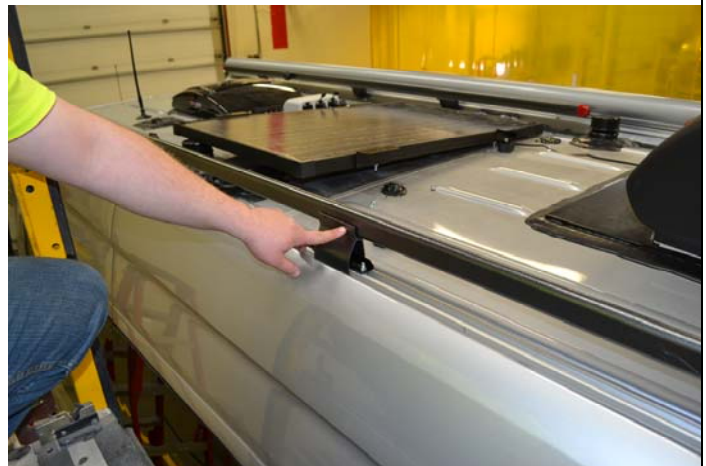
8. To attach the adjustable roof rails to the side support rails, remove screws from side support roof rails on the driver side of the motorhome.

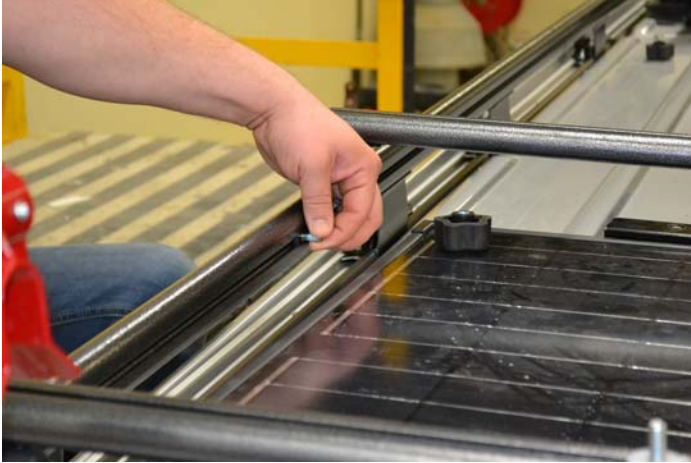
9. On the passenger side of the motorhome. Insert T-bolt that is supplied with the rubber hand nut into the side rails. Rotate to lock into position.

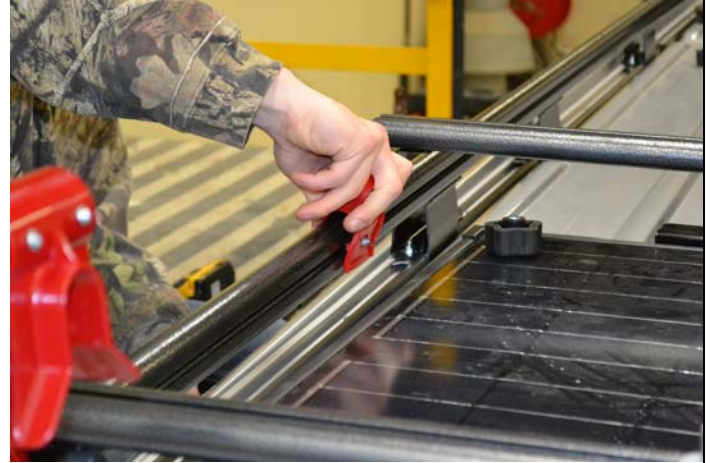
10. Install new red plastic saddles on side support rails by placing hole in saddle over T-bolt and snapping saddle over side support rail. Make sure T-bolt goes through the hole in the red saddle.

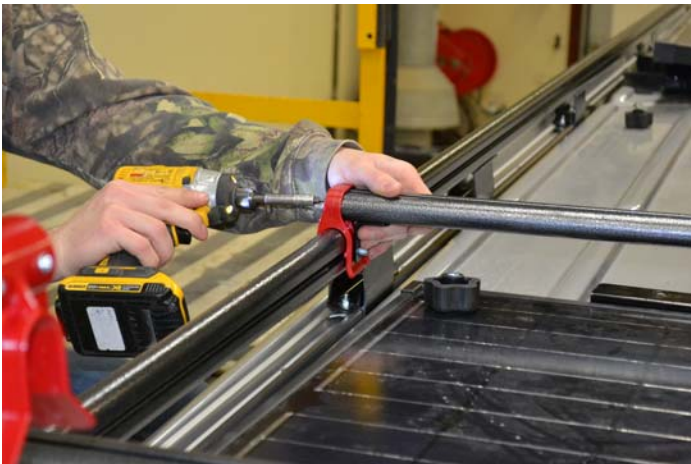
11. Reattach red plastic saddles to adjustable rails. Secure using the two screws from the supplied hardware kit.

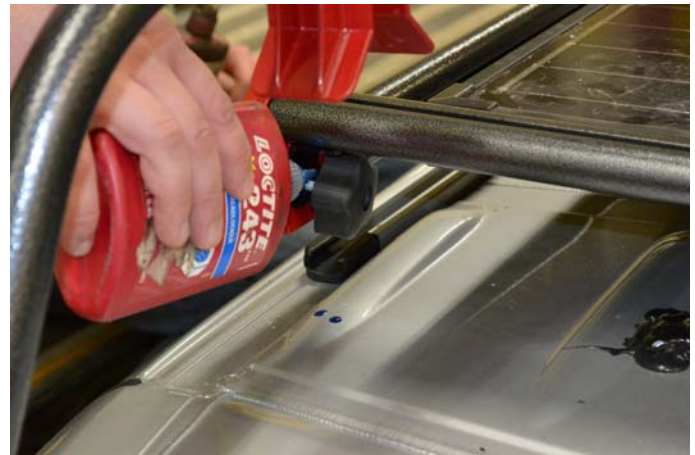
12. Put Loctite on T-bolts when reattaching the hand nuts on side rails. Protect and clean any excess Loctite from motorhome.

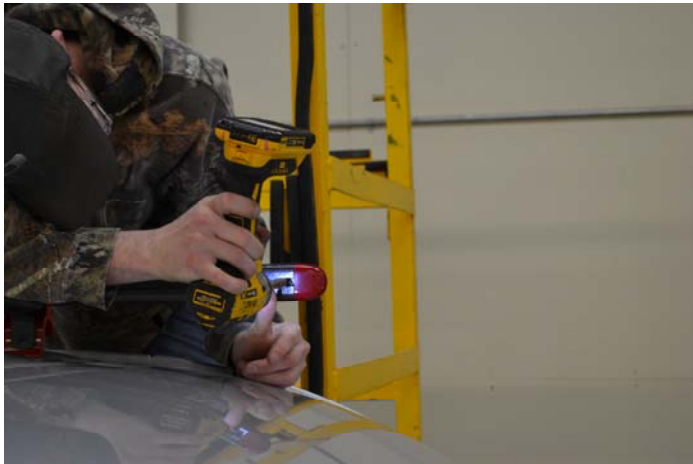
13. Remove the red plastic bullet caps by first removing the screws with a screw gun.

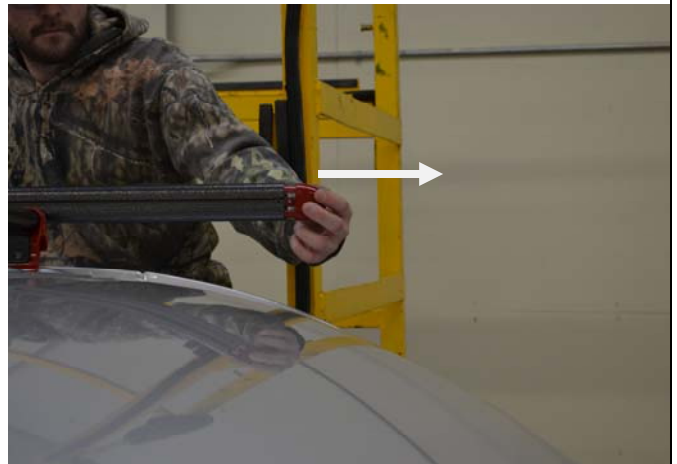
14. Remove the plastic bullet cap by sliding out towards the front of the motorhome.

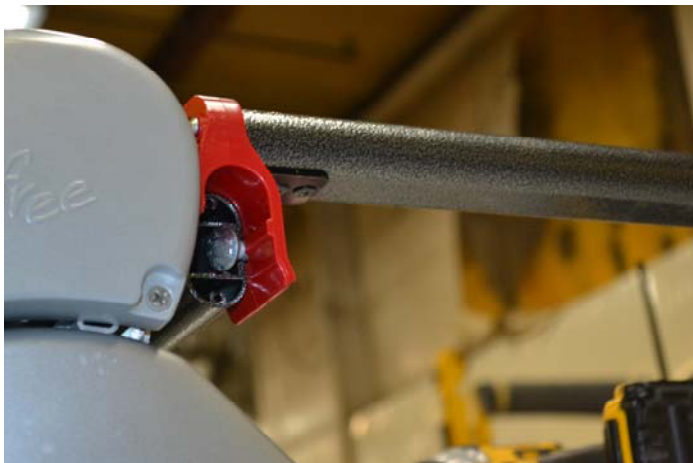
15. On the forward rail: Use a carriage bolt to reattach the red plastic saddles to the side roof rails. Slide the head of carriage bolt through the side roof rails. Tighten down with a washer and nylock nut.

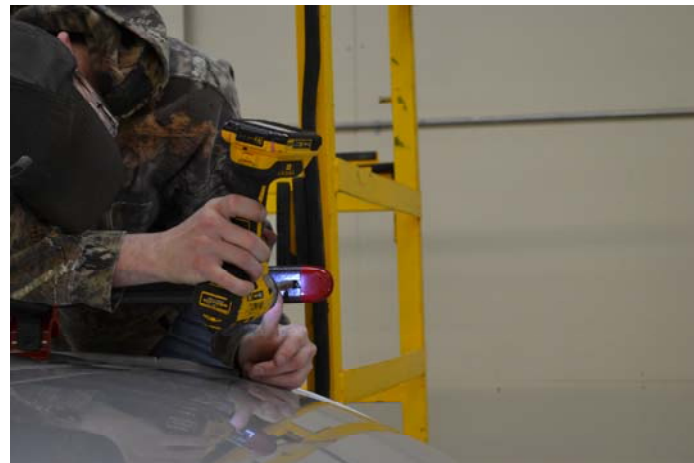
16. Reattach the red plastic bullet caps to the forward rails. Reinsert screws and tighten with a screw gun.
