Safety Recall **Code: 69Q9**

Subject	TAKATA SDI Driver Frontal Airbag Inflator		
Release Date	August 31, 2018		
Revision Summary	Added repair availability for vehicles with Criteria T3		
	 When replacing the airbag assembly for vehicles with Criteria T3, the airbag control module will be coded and parameterized. Instructions specific to this process have been added to work procedure. 		
Affected Vehicles	U.S.A. & CANADA: Certain 2007-2014 MY Volkswagen vehicles equipped with a Takata SDI driver frontal airbag		
	Check Campaigns/Actions screen in Elsa on the day of repair to verify that a VIN qualifies for repair under this action. Elsa is the <u>only</u> valid campaign inquiry & verification source.		
	✓ Campaign status must show "open."		
	 If Elsa shows other open action(s), inform your customer so that the work can also be completed at the same time the vehicle is in the workshop for this campaign. 		
Problem Description	The driver airbag may explode in a crash with airbag deployment. Sharp metal fragments can hit people and cause serious injury or death.

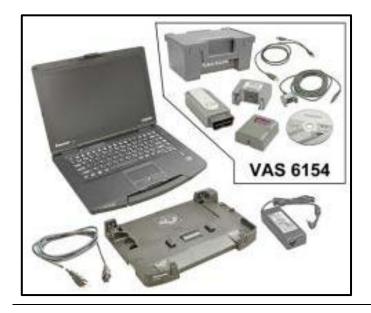
- Clamp Airbag Support T10568 <2> into the vice. •
- Connect crocodile clip <1> to airbag support <2> • and ESD workplace -VAS 6613-.

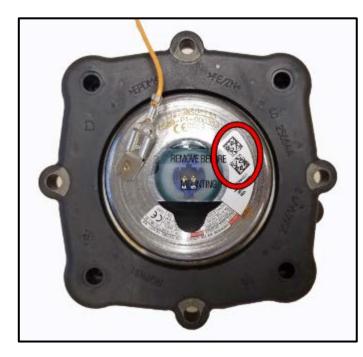
- There are two types of inflator. One version is • "with vibration absorption" and one is "without vibration absorption".
- Airbags with vibration absorption may be • identified by the word "TILGER" on the label found on the airbag.

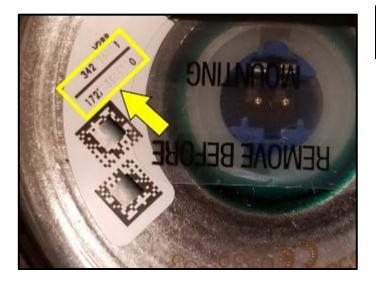
- Place the new inflator on the ESD mat. •
- Scan the data matrix code of the new inflator at a distance of about 15 cm.

The photo is for reference only. The inflator that is installed may be either a single stage or dual stage inflator.

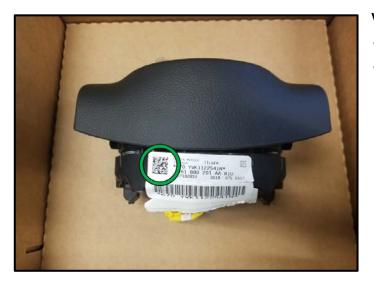
The data matrix code includes the values as shown.

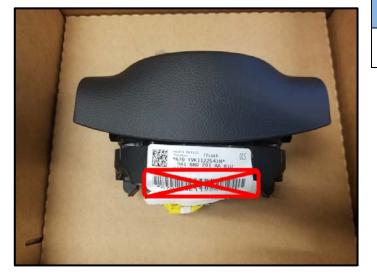
- Place the new airbag on the ESD mat. •
- Scan the data matrix code <circle> of the new • airbag at a distance of about 15 cm.

Scanning the bar code on the new airbag will result in an "implausible barcode" message.

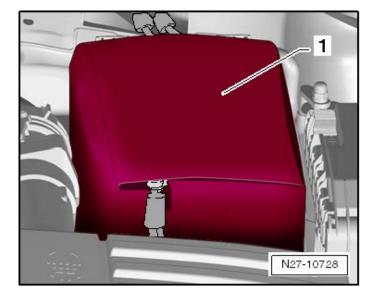
Battery in Engine Compartment:

Accident risk. When working on pyrotechnic components (such as airbags and belt tensioners), the battery must be disconnected with the ignition switched ON.

- Open the battery protective covering <1>.
- Loosen the nut <1>.
- Remove and isolate the battery ground cable terminal from the battery terminal.

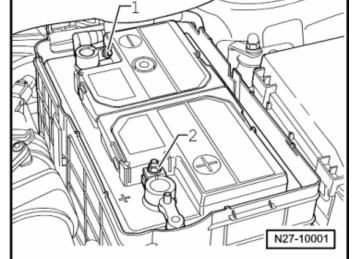
Battery in Luggage Compartment:

- Loosen the nut <1>.
- Remove and isolate the battery ground cable • terminal from the battery terminal.

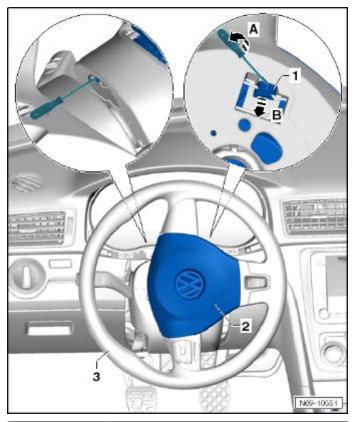
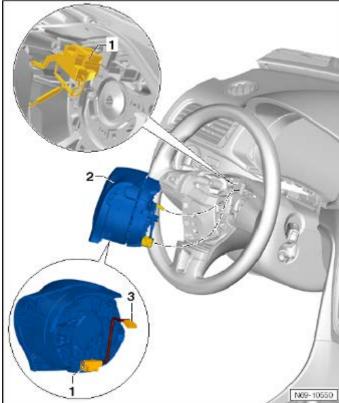
Procedure illustrated is for a three spoke steering wheel. The procedure for a four spoke steering wheel is the same.

- Lower the steering wheel <3> as far as possible.
- Adjust steering wheel depth (reach) <3> so it is in the fully extended position.
- Turn the steering wheel <3> to the position illustrated.
- Insert a screwdriver all the way into the hole on the back of the steering wheel (approximately 8 mm).
- Turn the screwdriver toward the driver door <arrow A>. This will unlock the airbag unit <2> locking mechanism <1> in direction of <arrow>, on the right side of the steering wheel.
- Turn the steering wheel 180° and repeat the procedure on the opposite side.

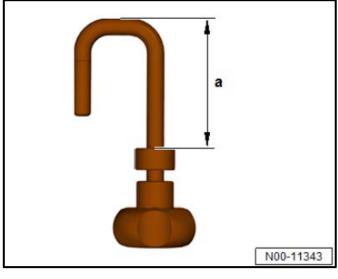
- The three spoke steering wheel has three • mounting points.
- Tighten mounting by hand to prevent damage.
- Adjust three knurled nuts of securing hooks to <dimension a> 50mm.

The clamps must be placed in the positions shown <arrows> to prevent damage to the airbag. Damage to the airbag is not covered under this action.

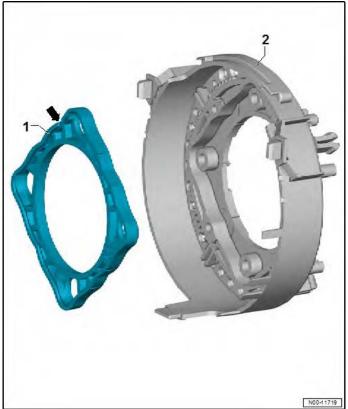
The inflator must NOT be placed on the studs <arrows>.

Included in the replacement parts kit is an insert ٠ ring <1>. This must be used when installing a new inflator and placed in the horn ring <2>.

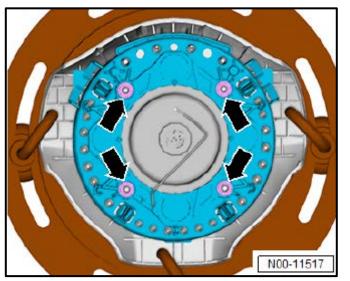
The nuts are self-locking and must be replaced

Fit cover for inflator and tighten 4 nuts <arrows> • to 5 Nm ± 0.4 Nm.

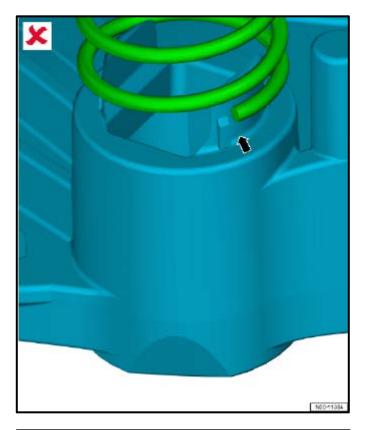
- If one of the springs is damaged or has been lost, • it can be replaced with a spring from the bag of spares included.
- Note the examples shown for reference of proper spring seating.
- Spring seated incorrectly <arrow>. •

Spring seated correctly <arrow>.

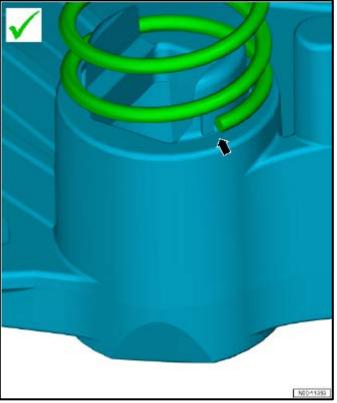
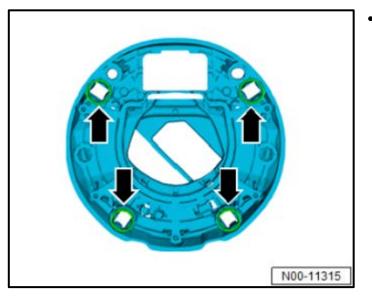
• Fit springs <arrows> for horn ring again and allow to engage audibly.

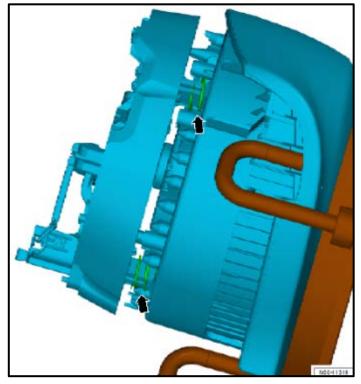
• Position horn ring <arrows> with springs on securing clips and press firmly in place. Ensure that springs are seated correctly on both sides.

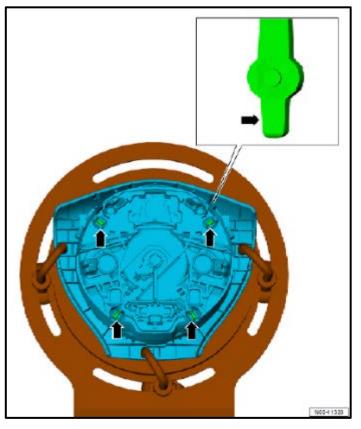
If a pin is damaged or has been lost, it can be replaced with a locking pin from the bag of spares included.

Using long-nose pliers, insert four locking pins in retaining lugs with narrow side facing downwards <arrow in magnification>. Pins must engage audibly.

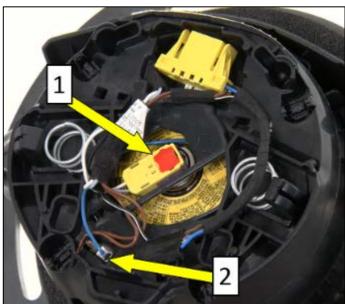
Connect central connector <1> on inflator.

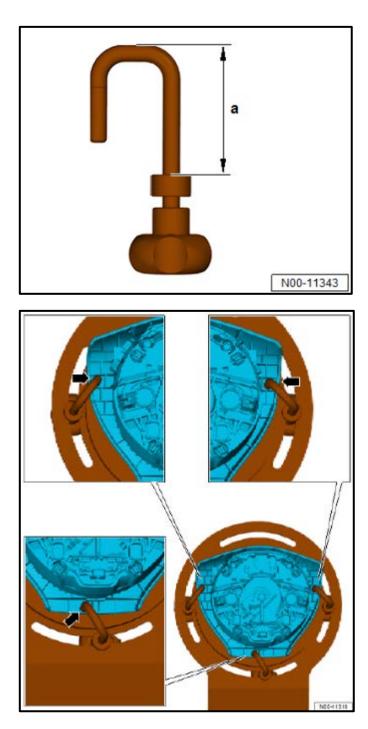
Removal Procedure:

- The three spoke steering wheel has three • mounting points.
- Tighten mounting by hand to prevent damage.
- Adjust three knurled nuts of securing hooks to <dimension a> 50mm.

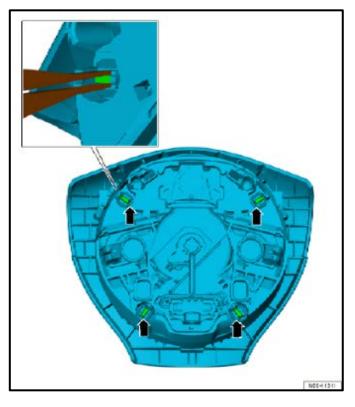
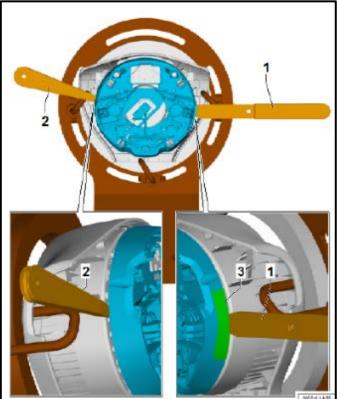
• Remove locking pins <arrows> for horn ring with aid of longnose pliers.

- Apply lever -T10571- <1> in shaded area <3>. At the same time, apply removal wedge -3409- on the other side <2> and lever off horn ring.
- Repeat work steps on other side.

Use extreme care when removing the horn ring. If horn ring is damaged during remove, airbag replacement will be necessary. Replacement of the airbag due to damage during horn ring removal will not be covered under this action.

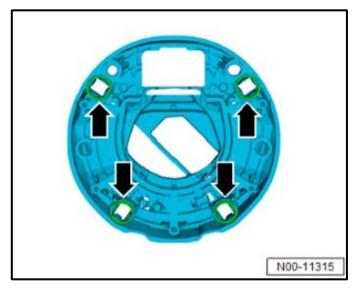
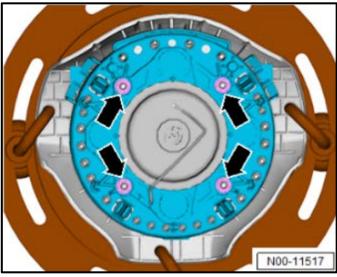
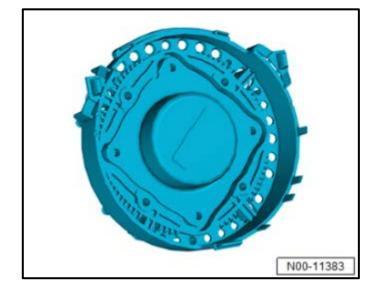
Remove horn ring with springs <arrows>.

- When removing the horn ring, take care that the • springs are not lost as they are not available sepereately.
- **ONE** replacement spring is included in the inflator kit in the event a spring is lost or damaged.
- If more than one spring is lost, replacement of the airbag is required. Replacement of the airbag is required if a spring is lost and is not covered under this action.
- Remove and discard nuts <arrows>.

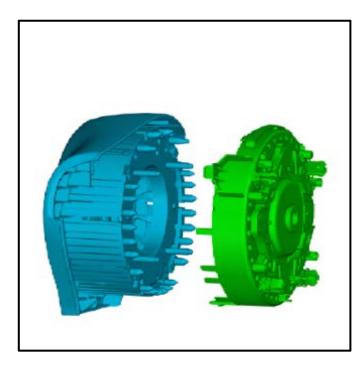
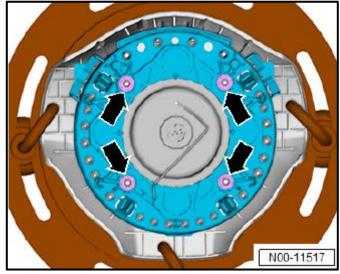
• Set new inflator in installation position.

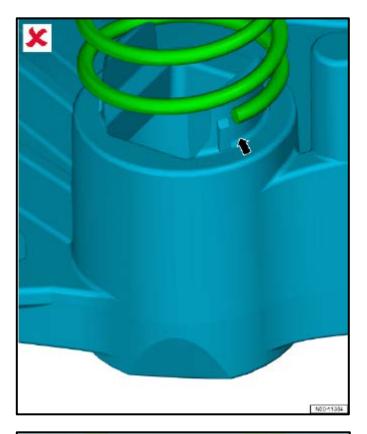
- If one of the springs is damaged or has been lost, • it can be replaced with a spring from the bag of spares included.
- Note the examples shown for reference of proper spring seating.
- Spring seated incorrectly <arrow>. •

Spring seated correctly <arrow>.

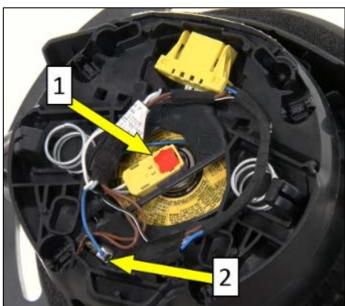
Connect central connector <1> on inflator.

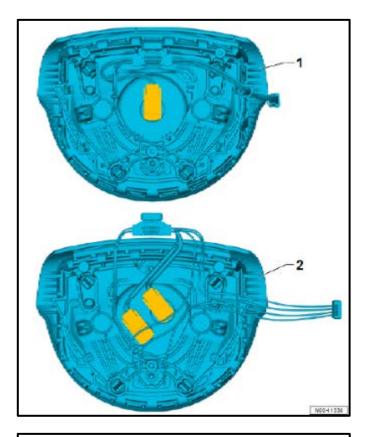
The inflator comes as a single-stage <1> or two-stage <2> version. The work steps for inflator renewal are the same.

- The four spoke steering wheel has two mounting points.
- Tighten mounting by hand to prevent damage.
- Adjust three knurled nuts of securing hooks to <dimension a> 50mm.

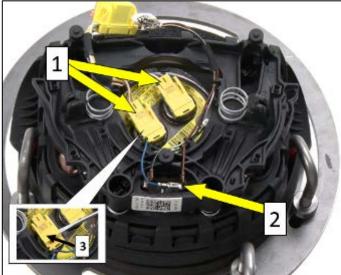
Clamp airbag centrally in airbag support. Securing points on the sides <arrows> and parallel, opposite each other.

The clamps must be placed in the positions shown <arrows> to prevent damage to the airbag. Damage to the airbag is not covered under this action.

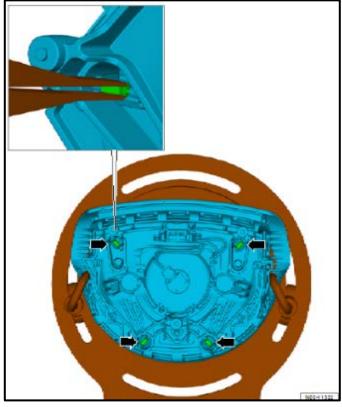
- The locking pins are to be reused. •
- There may be instances in which short locking • pins are fitted. These can be levered out with a small screwdriver.

Remove locking pins <arrows> for horn ring with • aid of longnose pliers.

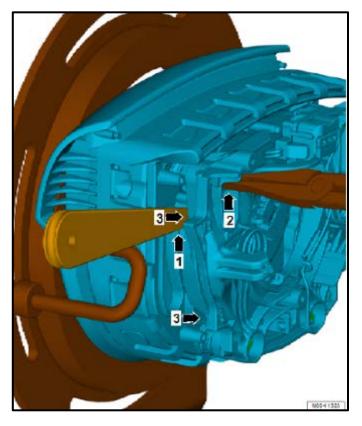
• Apply removal wedge -3409- between horn ring and inflator <1> and press together locking elements using longnose pliers <2>. Lever off horn ring at plastic lugs <3>.

- Position the removal wedge -3409- on the plastic lugs to prevent damage to the conductor strip.
- Insert the removal wedge -3409- between the inflator and horn ring to prevent the horn ring from engaging again.
- Repeat work steps on other side.

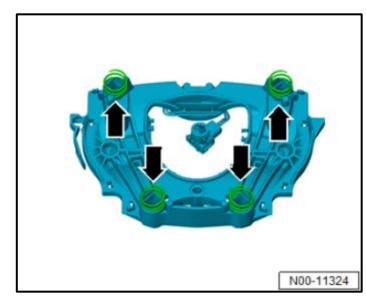
Remove horn ring with springs <arrows>.

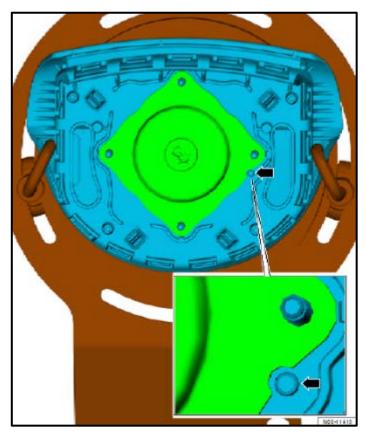
• Insert new inflator and check to ensure it is seated correctly. Note the recess <arrow>.

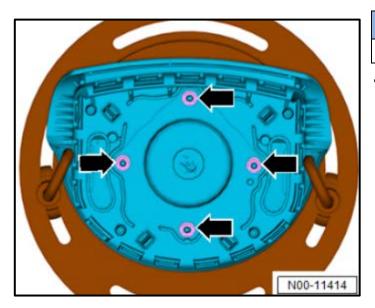
The nuts are self-locking and must be replaced

Install new nuts <arrows> and torque to 5 Nm ± 0.4 Nm.

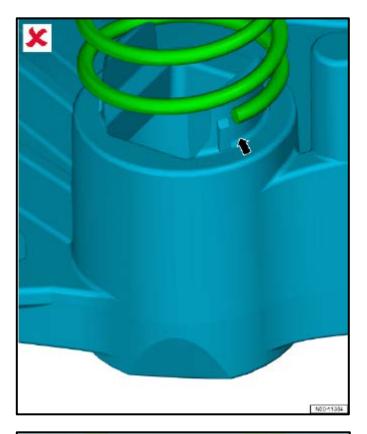
- If one of the springs is damaged or has been lost, • it can be replaced with a spring from the bag of spares included.
- Note the examples shown for reference of proper spring seating.
- Spring seated incorrectly <arrow>. •

Spring seated correctly <arrow>.

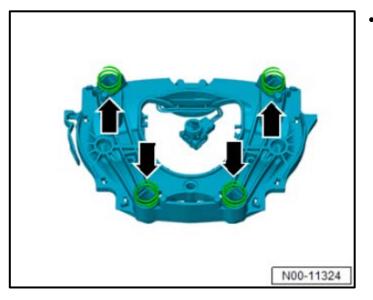
Fit springs <arrows> for horn ring again if necessary.

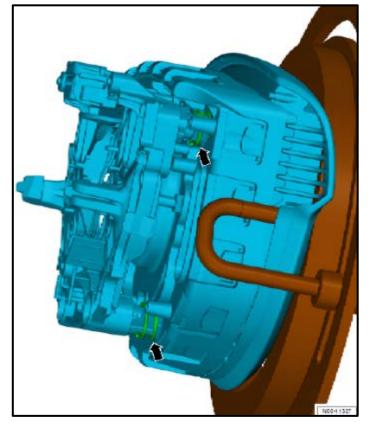
Position horn ring with springs on securing clips • and press firmly in place. Ensure that springs are seated correctly on both sides <arrows>.

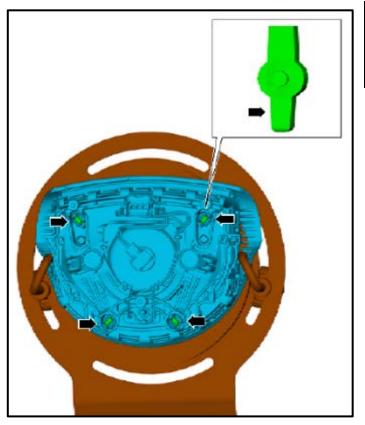
If a pin is damaged or has been lost, it can be replaced with a locking pin from the bag of spares included.

Using long-nose pliers, insert four locking pins in retaining lugs with narrow side facing downwards <arrow in magnification>. Pins must engage audibly.

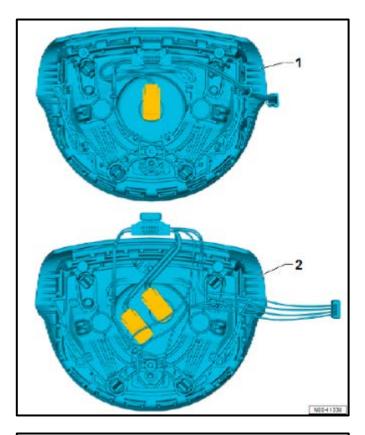
- The inflator comes as a single-stage <1> or • two-stage <2> version. The work steps for inflator renewal are the same.
- Tighten mounting by hand to prevent • damage.

- The four spoke steering wheel has two mounting • points.
- Tighten mounting by hand to prevent damage.
- Adjust three knurled nuts of securing hooks to • <dimension a> 50mm.

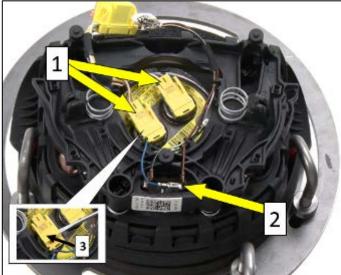
• Clamp airbag centrally in airbag support. Securing points on the sides <arrows> and parallel, opposite each other.

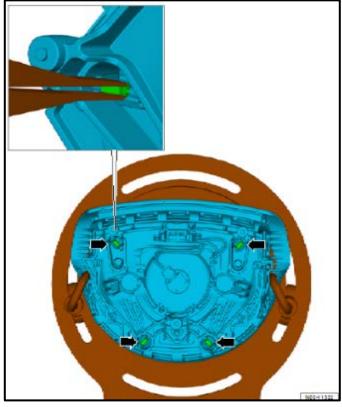
- The locking pins are to be reused. •
- There may be instances in which short locking • pins are fitted. These can be levered out with a small screwdriver.

Remove locking pins <arrows> for horn ring with • aid of longnose pliers.

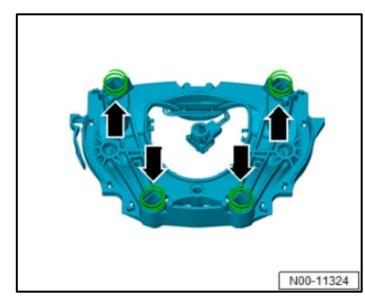
Remove horn ring with springs <arrows>.

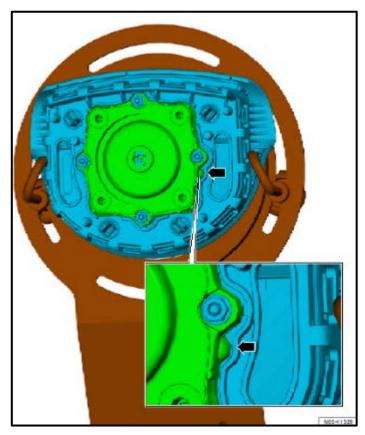
Insert new inflator and check to ensure it is • seated correctly. Note the recess <arrow>.

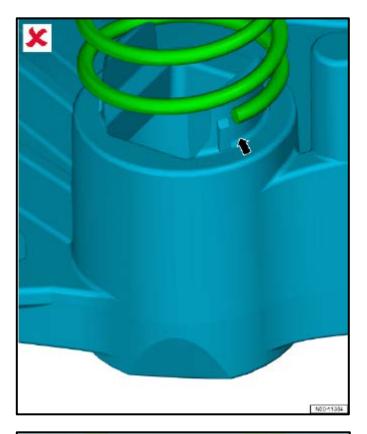
- If one of the springs is damaged or has been lost, • it can be replaced with a spring from the bag of spares included.
- Note the examples shown for reference of proper spring seating.
- Spring seated incorrectly <arrow>. •

Spring seated correctly <arrow>.

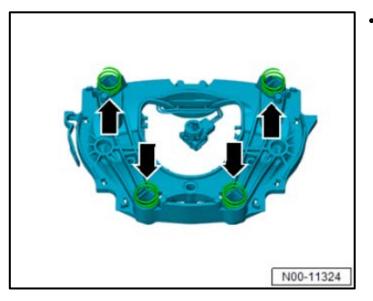
Fit springs <arrows> for horn ring again if necessary.

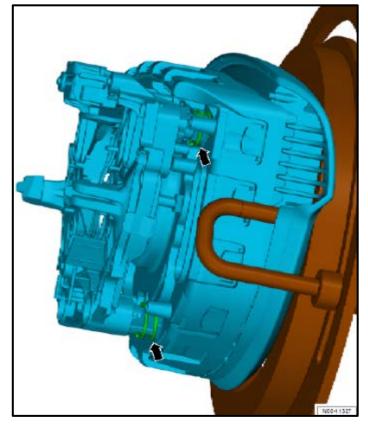
• Position horn ring with springs on securing clips and press firmly in place. Ensure that springs are seated correctly on both sides <arrows>.

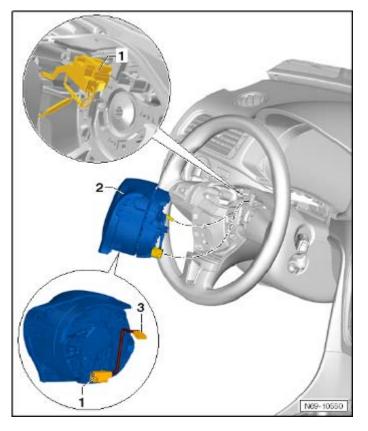
- The battery must be disconnected before • installing the airbag back into the vehicle.
- Before handling pyrotechnic components (for example, disconnecting the connector), the person handling it must "discharge static electricity". This can be done by touching the door striker, for example.
- Connect the connector <1>. The connector must click into place during this.
- Press the connector lock on the connector <1>. •
- Connect the connector <3> (if equipped).
- Insert the airbag unit <2> into the steering wheel but do not press on it.

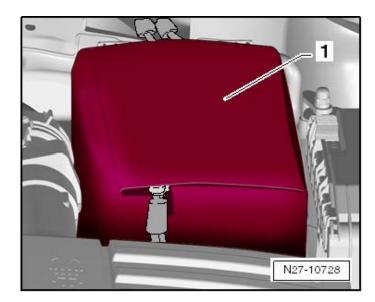
- Close the cover <1>.
- Cycle the ignition off and back on. •
- Bring driver seat to an upright position. •
- Store previously recorded radio presets (if • necessary).
- Set clock to local time. •
- Activate the power window regulator one-touch • up/down function.
- Check the DTC memories of all the control units • and erase under-voltage faults if necessary.
- After completing repairs, verify the horn is operational.
