Safety Recall Code: 69Q9

TAKATA SDI Driver Frontal Airbag Inflator

March 15, 2018

U.S.A. & CANADA: Certain 2007-2014 MY Volkswagen vehicles equipped with a Takata SDI driver frontal airbag

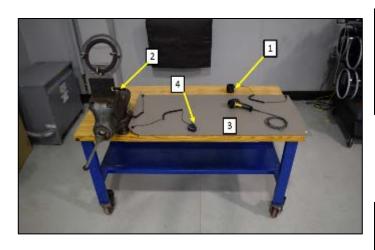
- Clamp Airbag Support T10568 <2> into the vice.
- Connect crocodile clip <1> to airbag support <2> and ESD workplace -VAS 6613-.

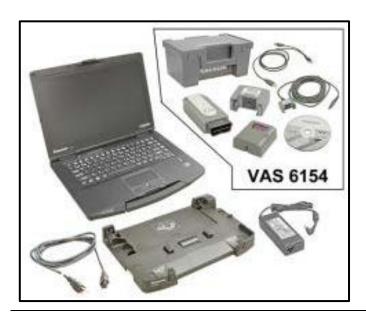
- Ensure ODIS is updated to the latest version.
- Connect vehicle diagnostic tester.
- Select Start Diagnosis function and identify vehicle.
- After identification of control units, Guided Fault Finding is started automatically.
- Follow the instructions on screen.

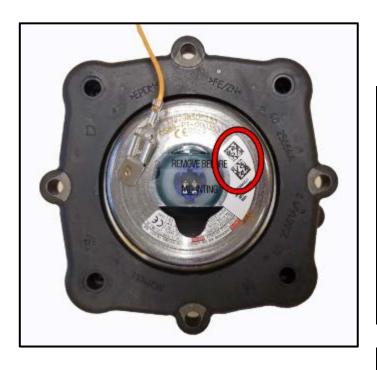
- Place the new inflator on the ESD mat.
- Scan the data matrix code of the new inflator at a distance of about 15 cm.

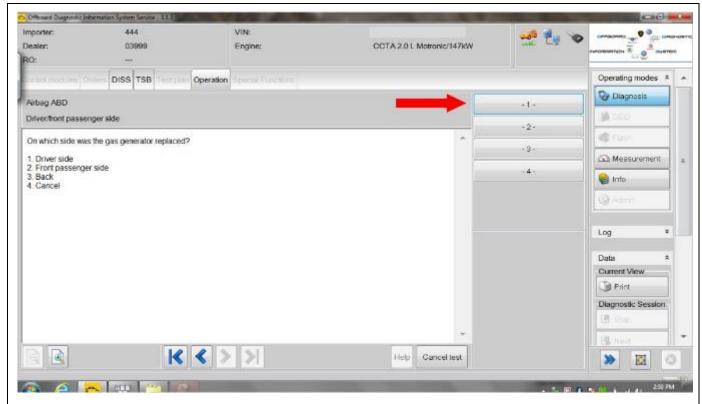
- Select option 1 indicating that the Driver side inflator was replaced.
- After selecting option 1, a valid GeKo ID will need to be entered in order to upload the new inflator identification.

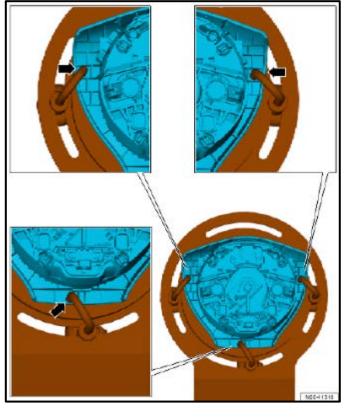
Clamp airbag centrally in airbag support. There are securing points on the sides <arrows>, parallel, opposite each other, and below.

The clamps must be placed in the positions shown <arrows> to prevent damage to the airbag. Damage to the airbag is not covered under this action.

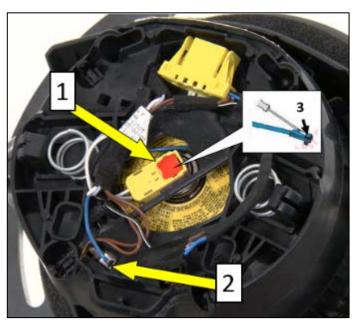
- Disengage connector lock <3> using a small flat bladed screwdriver.
- Remove connector <1> using needle nose pliers.

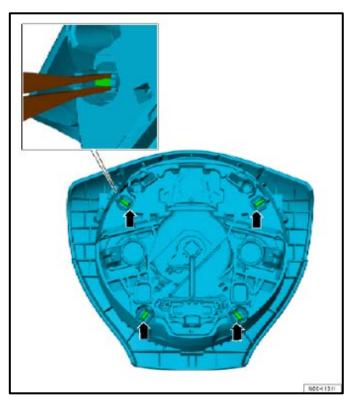
Remove locking pins <arrows> for horn ring with aid of longnose pliers.

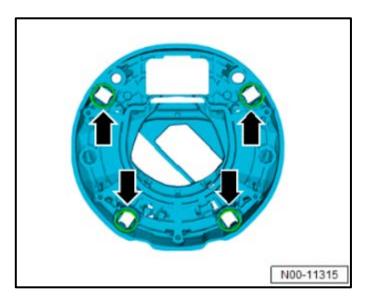
• Remove horn ring with springs <arrows>.

- When removing the horn ring, take care that the springs are not lost as they are not available sepereately.
- **ONE** replacement spring is included in the inflator kit in the event a spring is lost or damaged.
- If more than one spring is lost, replacement of the airbag is required. Replacement of the airbag is required if a spring is lost and is not covered under this action.

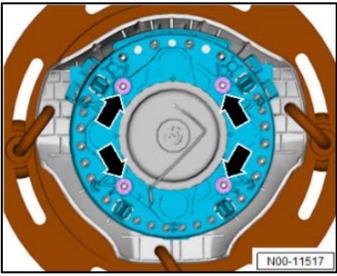
- Remove and discard nuts <arrows>.
- Remove cover for inflator.

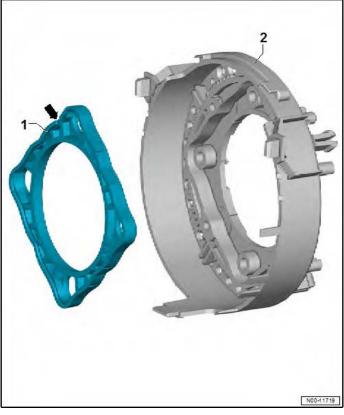
• Included in the replacement parts kit is an insert ring <1>. This must be used when installing a new inflator and placed in the horn ring <2>.

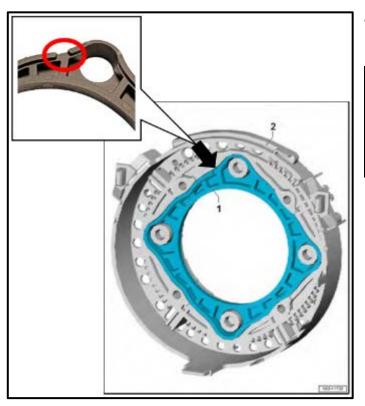
Fit insert ring <1> into horn ring <2>. The notch (circle) in the insert ring must be at top <arrow> when doing this.

- It should be possible to fit the insert ring from the replacement parts kit with ease.
- It is essential to adhere to the installation position.
- The notch must be at the top <arrow>.

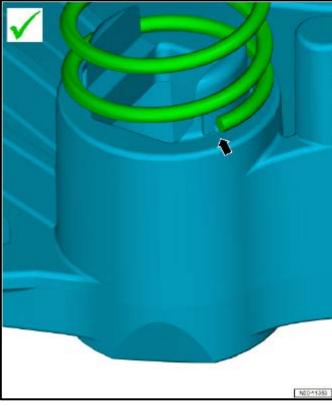
• Spring seated **correctly** <arrow>.

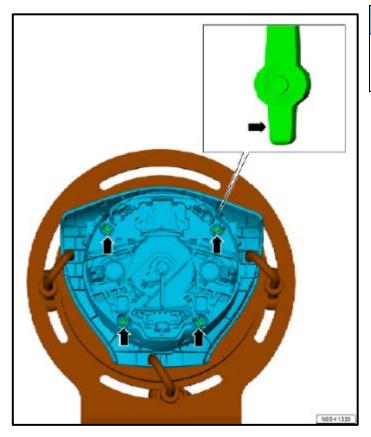
Using long-nose pliers, insert four locking pins in retaining lugs with narrow side facing downwards <arrow in magnification>. Pins must engage audibly.

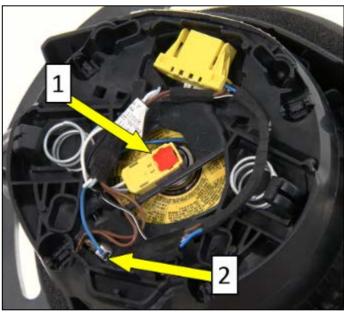
• Connect central connector <1> on inflator.

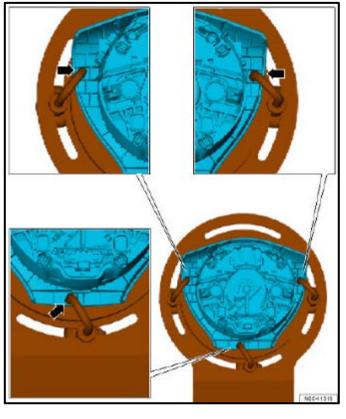
Clamp airbag centrally in airbag support. There are securing points on the sides <arrows>, parallel, opposite each other, and below.

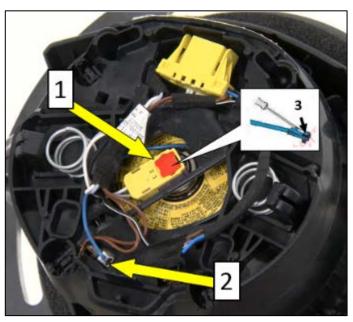
- Disengage connector lock <3> using a small flat bladed screwdriver.
- Remove connector <1> using needle nose pliers.

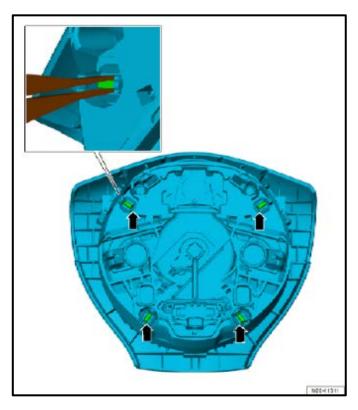
Remove locking pins <arrows> for horn ring with aid of longnose pliers.

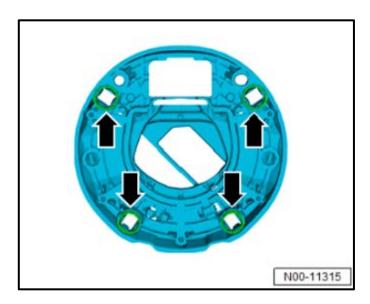
• Remove horn ring with springs <arrows>.

- When removing the horn ring, take care that the springs are not lost as they are not available sepereately.
- **ONE** replacement spring is included in the inflator kit in the event a spring is lost or damaged.
- If more than one spring is lost, replacement of the airbag is required. Replacement of the airbag is required if a spring is lost and is not covered under this action.

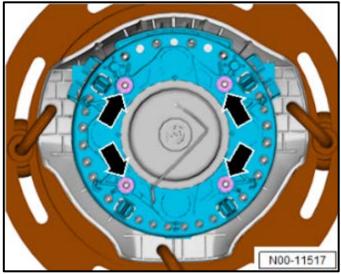
Remove and discard nuts <arrows>.

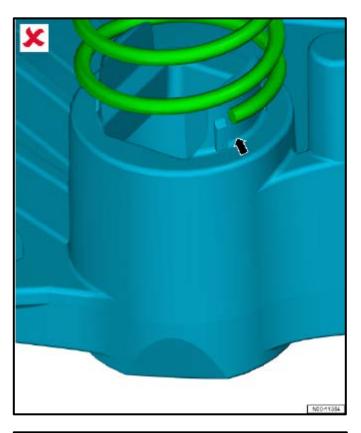
- If one of the springs is damaged or has been lost, it can be replaced with a spring from the bag of spares included.
- Note the examples shown for reference of proper spring seating.
- Spring seated incorrectly <arrow>.

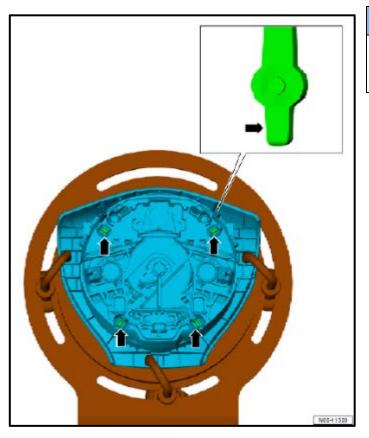
Using long-nose pliers, insert four locking pins in retaining lugs with narrow side facing downwards <arrow in magnification>. Pins must engage audibly.

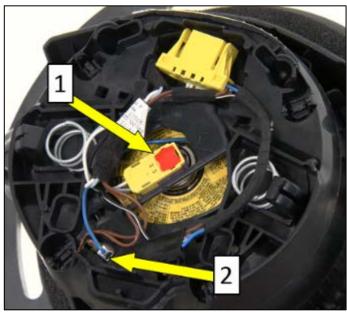
Connect central connector <1> on inflator.

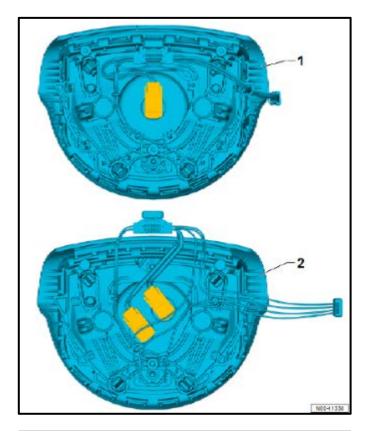
The inflator comes as a single-stage <1> or two-stage <2> version. The work steps for inflator renewal are the same.

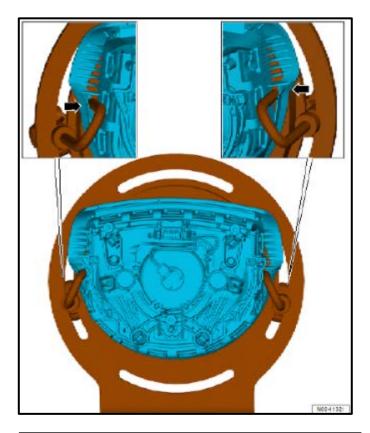
Clamp airbag centrally in airbag support. Securing points on the sides <arrows> and parallel, opposite each other.

The clamps must be placed in the positions shown <arrows> to prevent damage to the airbag. Damage to the airbag is not covered under this action.

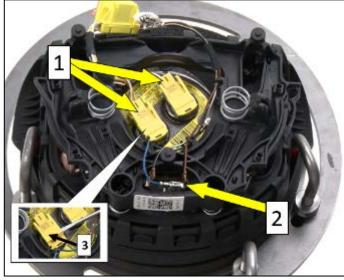
- Disengage connector lock(s) <3> using a small flat bladed screwdriver.
- Remove connector(s) <1> using needle nose pliers.

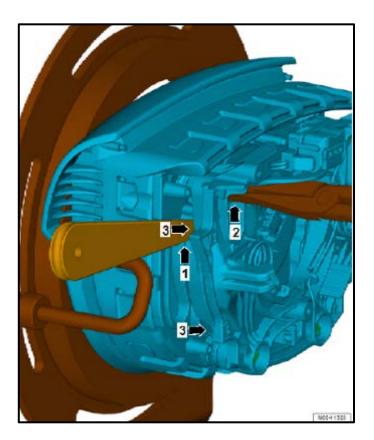
Apply removal wedge -3409- between horn ring and inflator <1> and press together locking elements using longnose pliers <2>.
 Lever off horn ring at plastic lugs <3>.

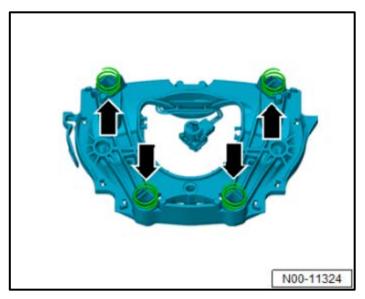
Remove horn ring with springs <arrows>.

- When removing the horn ring, take care that the springs are not lost as they are not available sepereately.
- **ONE** replacement spring is included in the inflator kit in the event a spring is lost or damaged.
- If more than one spring is lost, replacement of the airbag is required. Replacement of the airbag is required if a spring is lost and is not covered under this action.

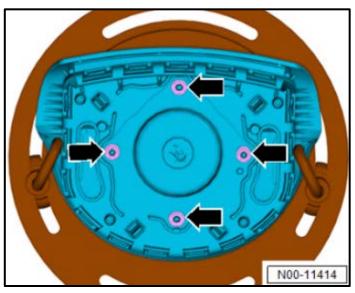
- Remove and discard nuts <arrows>.
- Remove the inflator and place in the original packaging.

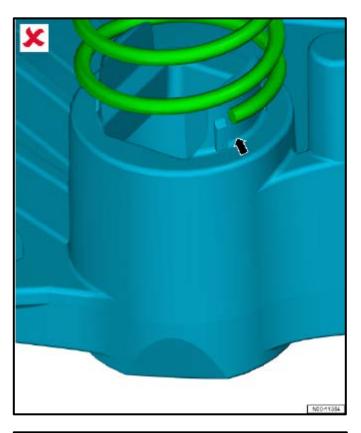
- If one of the springs is damaged or has been lost, it can be replaced with a spring from the bag of spares included.
- Note the examples shown for reference of proper spring seating.
- Spring seated incorrectly <arrow>.

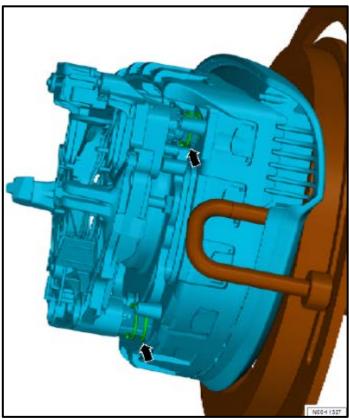
Position horn ring with springs on securing clips and press firmly in place. Ensure that springs are seated correctly on both sides <arrows>.

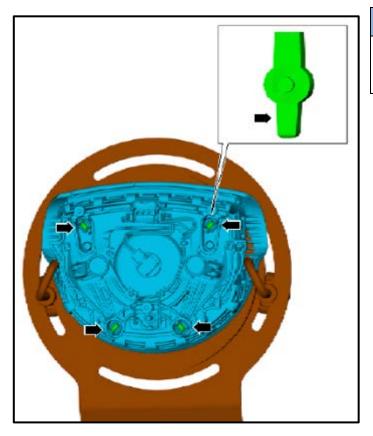
Using long-nose pliers, insert four locking pins in retaining lugs with narrow side facing downwards <arrow in magnification>. Pins must engage audibly.

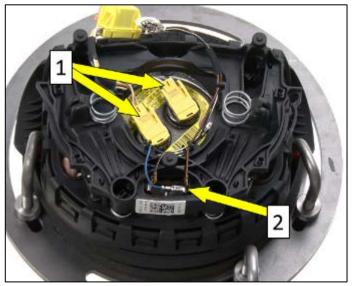
- Connect central connector(s) <1> on inflator.
- Press central connector lock(s) in until fully locked.
- Connect ground cable <2>.

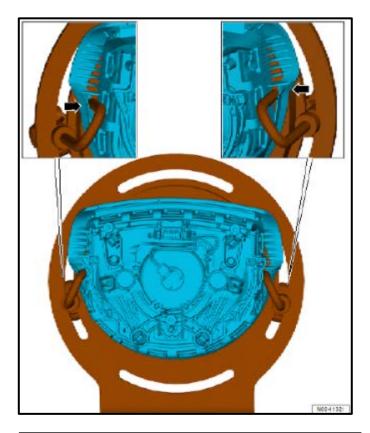
Clamp airbag centrally in airbag support. Securing points on the sides <arrows> and parallel, opposite each other.

The clamps must be placed in the positions shown <arrows> to prevent damage to the airbag. Damage to the airbag is not covered under this action.

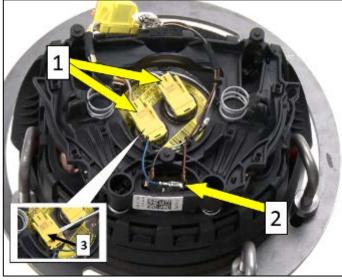
- Disengage connector lock(s) <3> using a small flat bladed screwdriver.
- Remove connector(s) <1> using needle nose pliers.

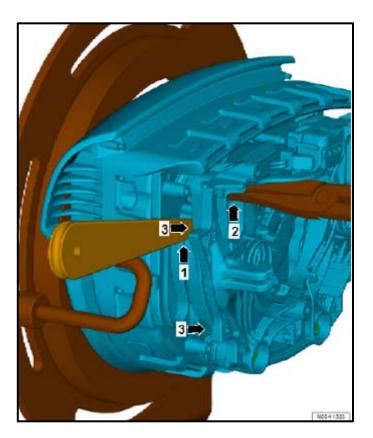
Apply removal wedge -3409- between horn ring and inflator <1> and press together locking elements using longnose pliers <2>.
 Lever off horn ring at plastic lugs <3>.

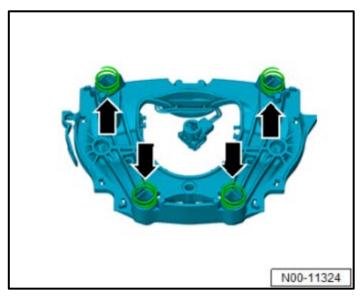
Remove horn ring with springs <arrows>.

- When removing the horn ring, take care that the springs are not lost as they are not available sepereately.
- ONE replacement spring is included in the inflator kit in the event a spring is lost or damaged.
- If more than one spring is lost, replacement of the airbag is required. Replacement of the airbag is required if a spring is lost and is not covered under this action.

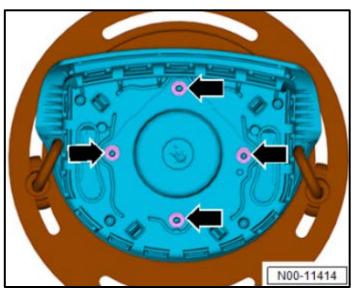
- Remove and discard nuts <arrows>.
- Remove the inflator and place in the original packaging.

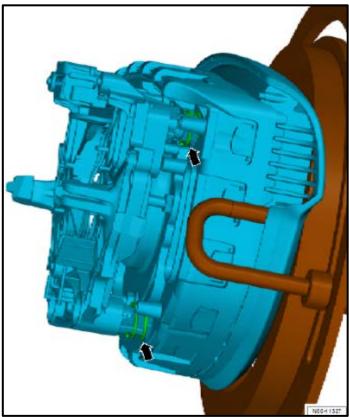
Position horn ring with springs on securing clips and press firmly in place. Ensure that springs are seated correctly on both sides <arrows>.

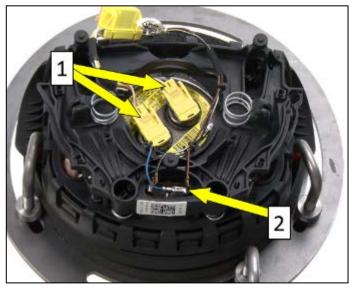
- Connect central connector(s) <1> on inflator.
- Press central connector lock(s) in until fully locked.
- Connect ground cable <2>.

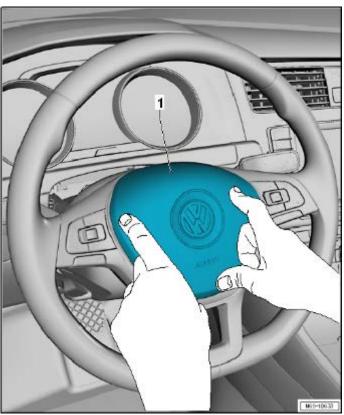
- Press on the edge of the airbag unit <1> with both hands until it locks into place.
- Gently pull on the airbag unit to make sure the airbag unit is secured correctly at all three attachment points in the steering wheel.

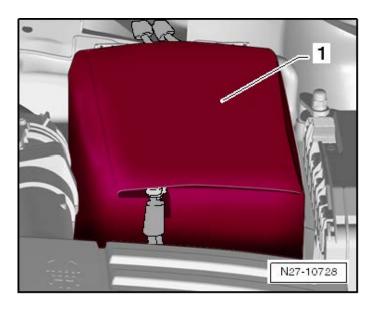
- Close the cover <1>.
- Cycle the ignition off and back on.
- Bring driver seat to an upright position.
- Store previously recorded radio presets (if necessary).
- Set clock to local time.
- Activate the power window regulator one-touch up/down function.
- Check the DTC memories of all the control units and erase under-voltage faults if necessary.
- After completing repairs, verify the horn is operational.
