# RECALL CAMPAIGN BULLETIN

NTB18-021

## VOLUNTARY RECALL CAMPAIGN 2018 370Z COUPE; DRIVER CURTAIN AIR BAG MODULE

**CAMPAIGN ID #:** R1802

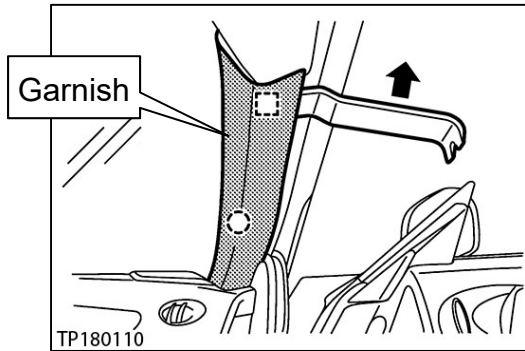
Figure 5

7. Remove the LH and RH pillar garnishes (A pillar finishers).

- a. Disengage the clips with a plastic trim tool.
  - b. Cut the front pillar garnish fixing clips with "side" cutters or other suitable tool.
- NOTE:** The fixing clips will be replaced with new ones (see Parts Information).

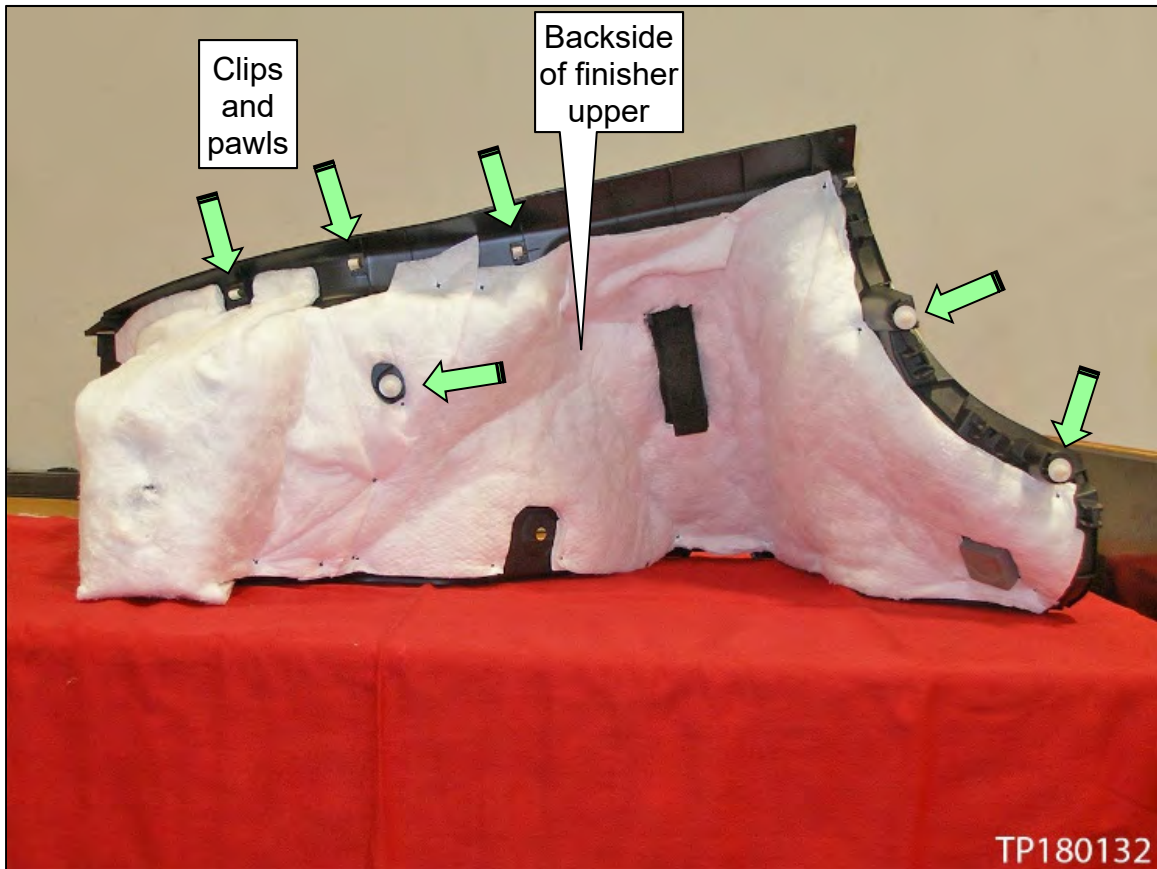
Figure 30

- Pawl and clip locations are shown in Figure 30. Locations are the same on the LH & RH luggage side finishers upper.

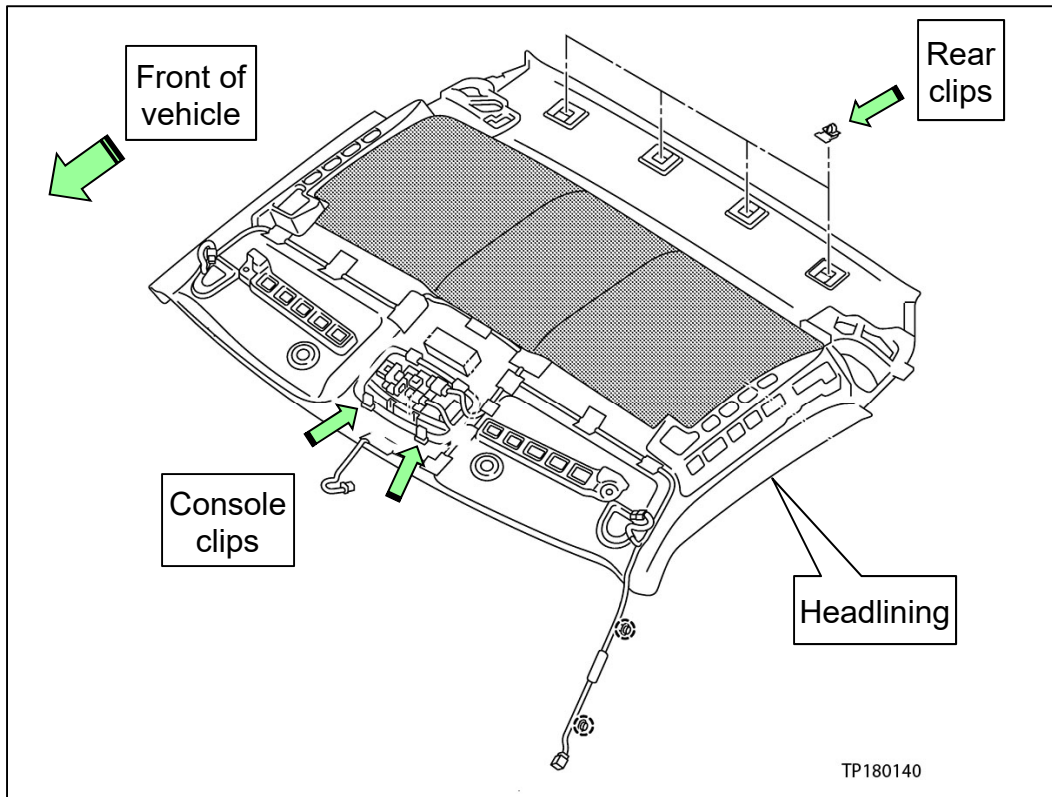
**NOTE:** When performing steps 30 and 31, the headlining will start to drop down.

30. Unfasten the roof center console clips (see Figure 37 and 38).

31. Unfasten the rear headlining clips (see Figure 37 and 39).

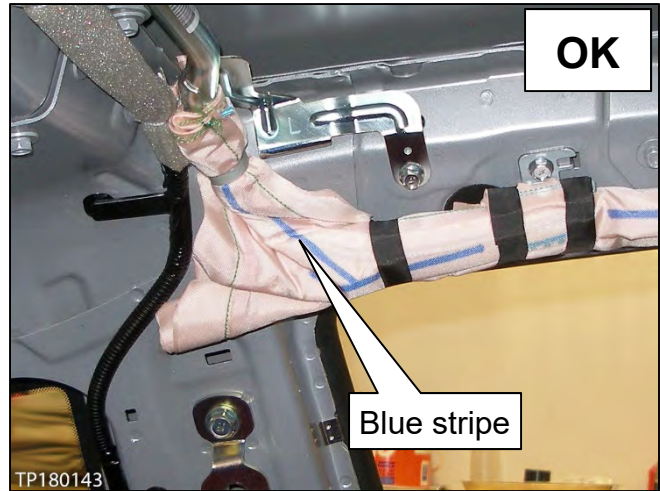
Figure 40

33. Inspect the rear section of the driver curtain air bag module:

- See Figure 40, 41, and 42 for examples of OK and NG inspection results.
- If the blue line does not wrap around the backside of the curtain, the driver air bag module is OK. Reassemble the vehicle (go to “Installation: Headlining”).

35. Untwist the curtain until all of the blue line is visible or not wrapped around the backside of the curtain (see page 18, Figure 40).

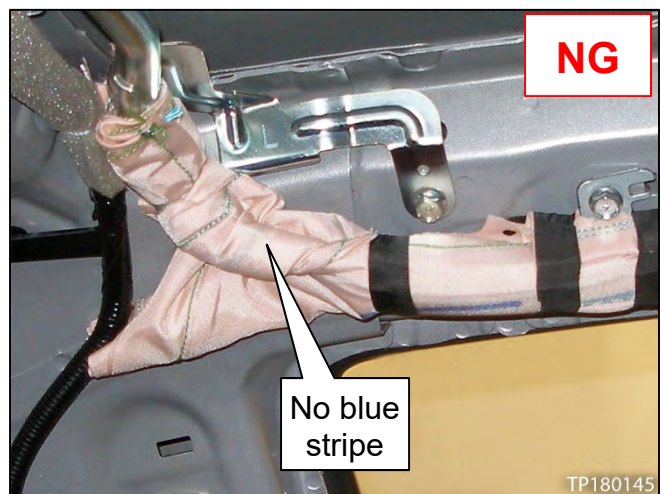
Figure 42

- If the blue line wraps around the backside of the curtain or wrapped where no blue line can be seen (the curtain is twisted), the curtain fails inspection. Go to step 34.

34. Unbolt the four (4) bolts (see Figure 43).

36. Secure the driver curtain air bag module with four (4) new bolts (see Parts Information).

- Bolts torque: 10.8 N•m (1.1 kg-m, **8.0 ft lbs**)

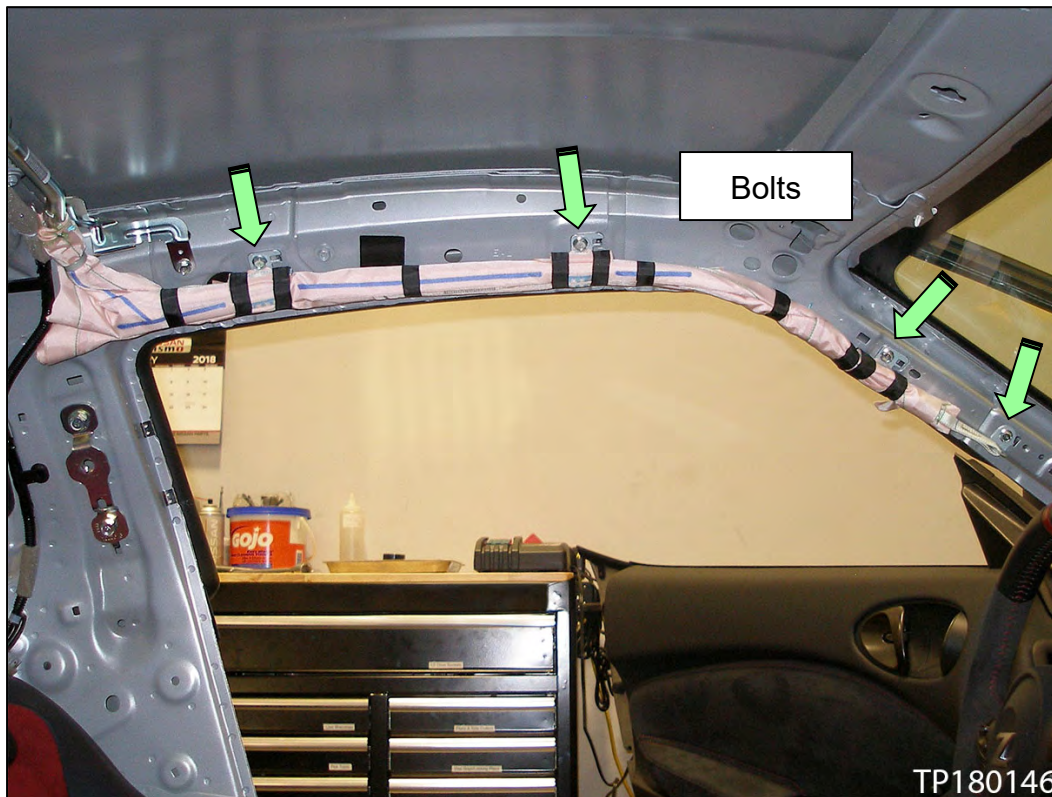
Figure 43

- Do not reuse these bolts, they will be replaced with new ones (see Parts Information).
