INSTRUCTION TO SERVICE

ITS: 6777	
SECTION:	219 ENGINE & TRANSMISSION
WRITTEN BY:	Curtis Matthews
SUBJECT:	Driveshaft P/N: (540795) Inspection and Replacement

PART 1 – INSPECT DRIVESHAFT:

PART 2 – REMOVE AND REPLACE DRIVESHAFT:

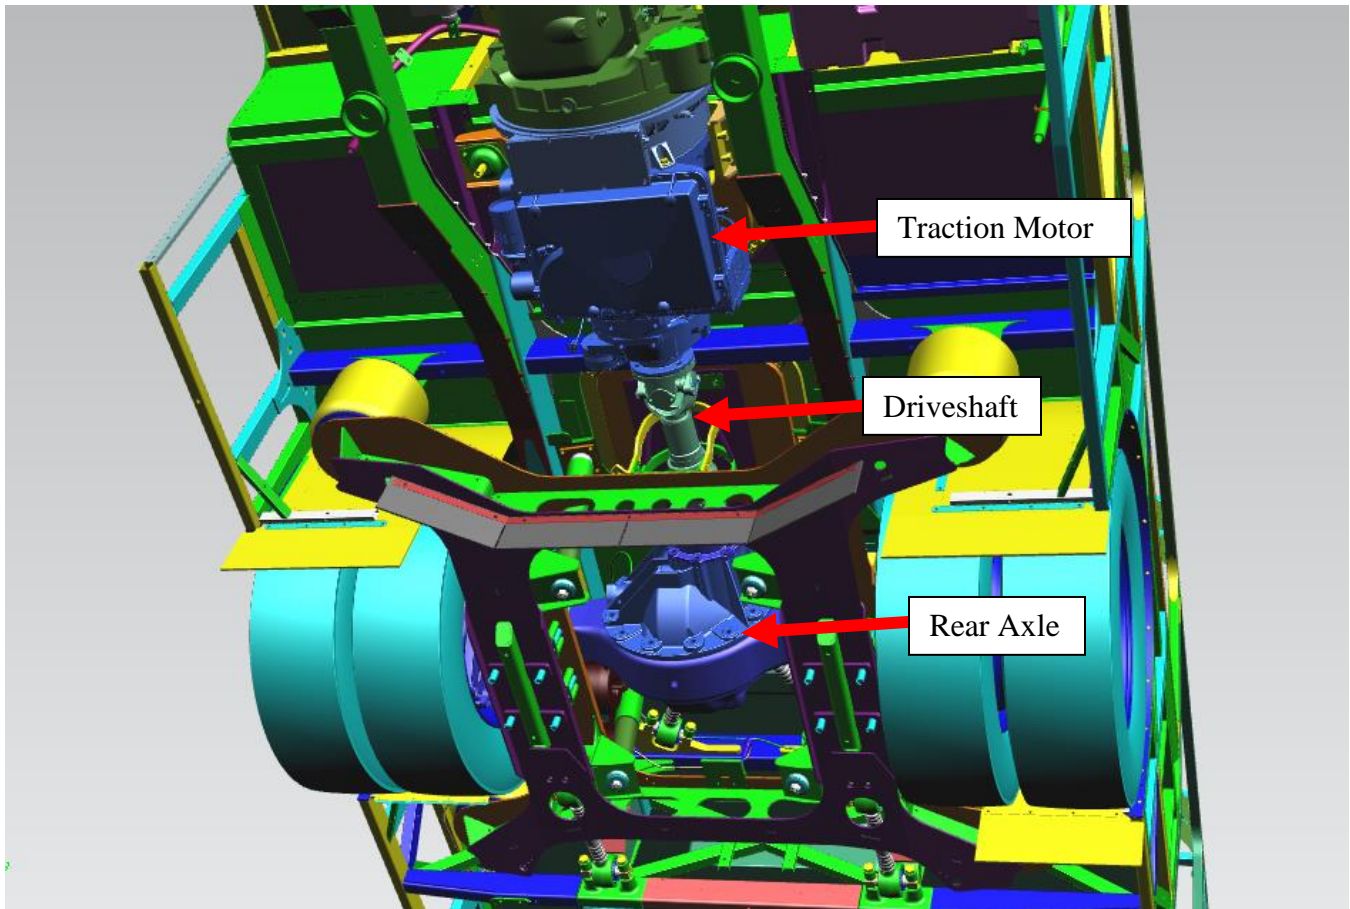
Figure 1: Rear underside of bus

1. Turn the main battery disconnect switch to the “OFF” position.
2. Raise bus in accordance with the New Flyer Service Manual.
3. Locate the driveshaft under the bus between the rear axle and the traction motor in figure 1.

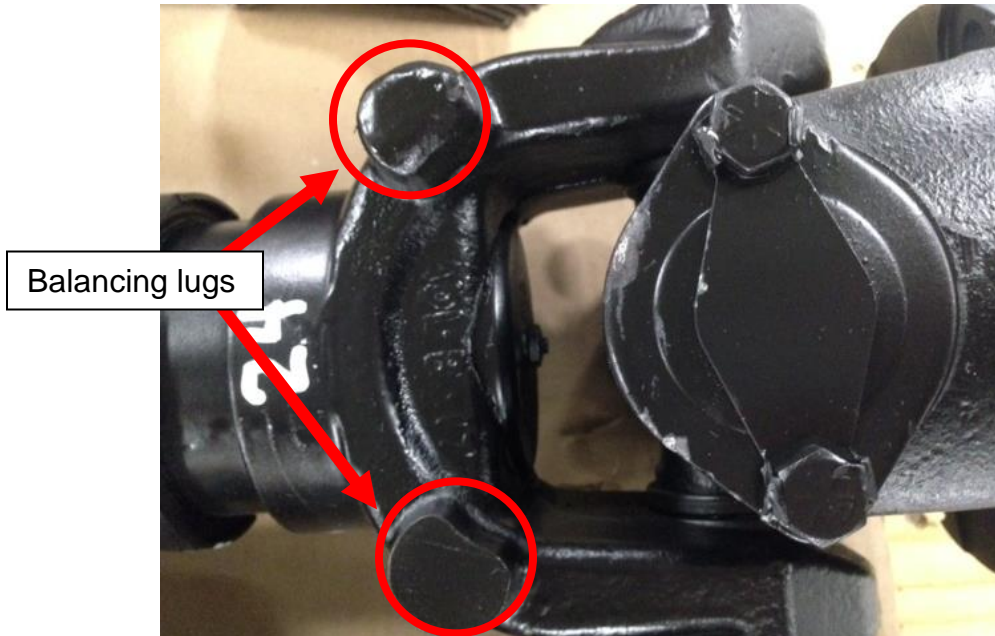
Figure 4: Style A driveshaft

6. If plastic cap is present, visually check for style of yoke and record on inspection sheet. Replace the driveshaft when materials are available.
- Style A – Plastic dust cap with balancing lugs. **NOT APPROVED**

Item	Inspection Item	Result
1.	Dust cap material. See figures 2 and 3.	Metal - APPROVED <input type="checkbox"/>
		Plastic - Go to item 2 <input type="checkbox"/>
2.	Driveshaft style. (See figures 4 through 9. Caps are not approved only if they are plastic)	Style A - NOT APPROVED <input type="checkbox"/>
		Style B - NOT APPROVED <input type="checkbox"/>
		Style C - NOT APPROVED <input type="checkbox"/>
		Style D - APPROVED <input type="checkbox"/>
		Style E - APPROVED <input type="checkbox"/>
		Style F - APPROVED <input type="checkbox"/>
3.	Date code from sticker (If legible). See figure 10 and 11.	Date Code: WO#:
4.	Inspect the yokes for cracks, see figure 12. Are cracks visible?	Yes <input type="checkbox"/> No <input type="checkbox"/>

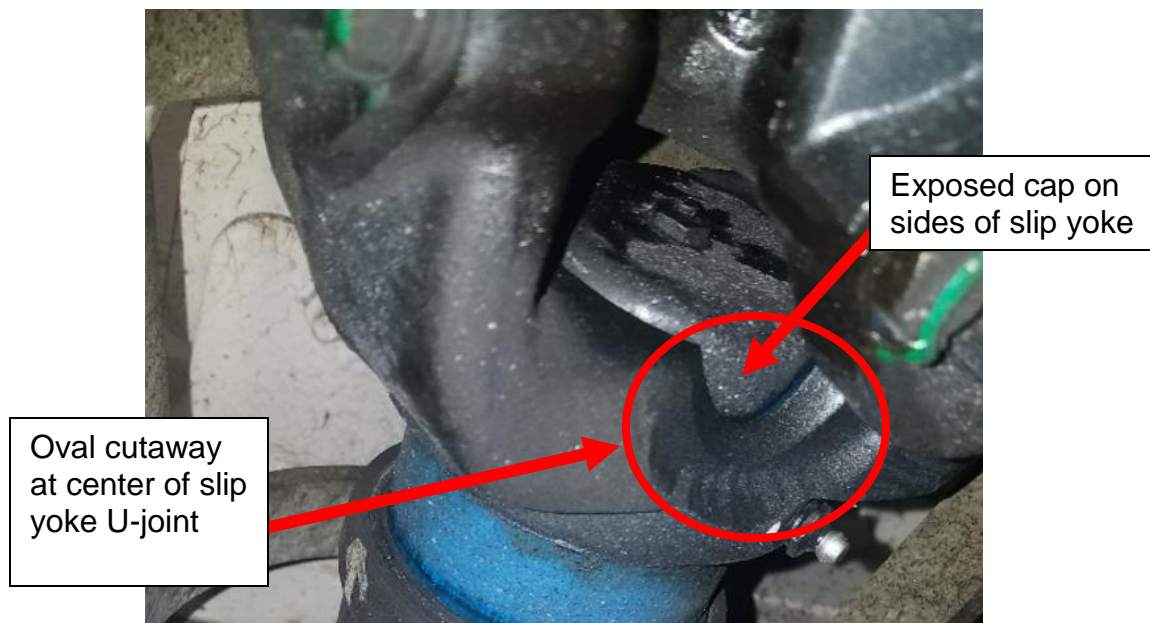
Figure 9: Style F driveshaft

- Style F – Plastic dust cap and oval cutaway. **APPROVED**

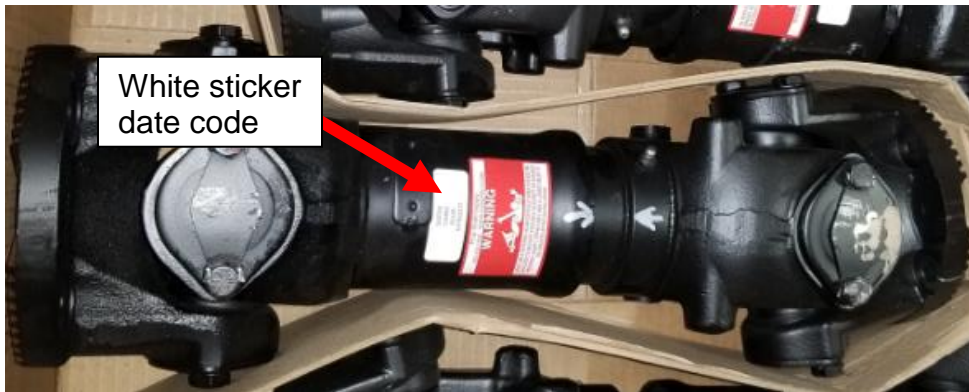
Figure 10: Date code sticker

- Record the date code and work order (W/O) number seen in figures 10 and 11 (if legible).
