Driveshaft Inspection and Replacement

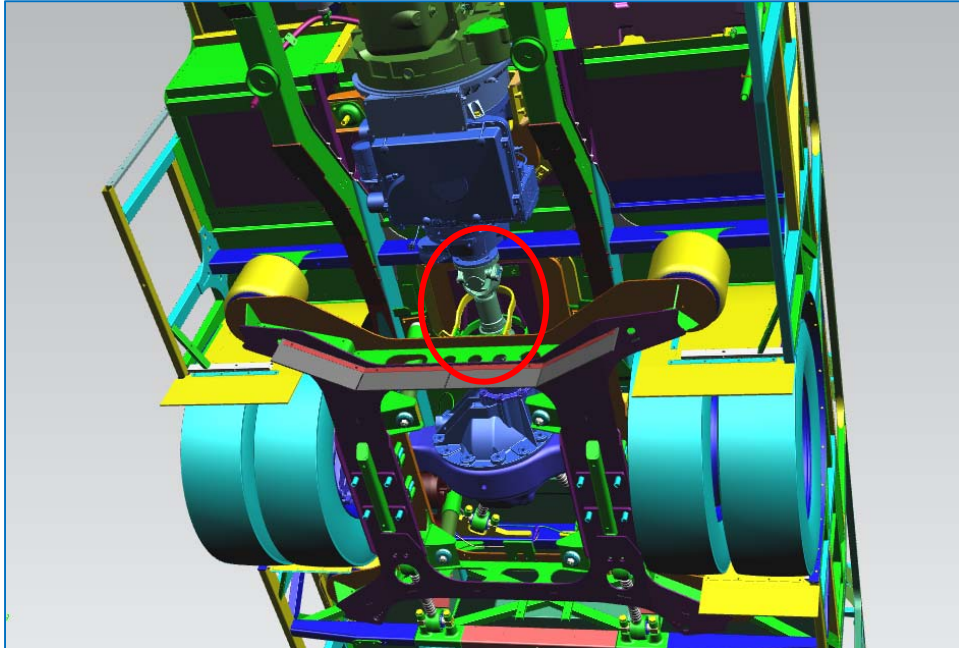
Figure 1: Rear Underside of Bus

Step 1: Locate the driveshaft between the traction motor and rear axle.

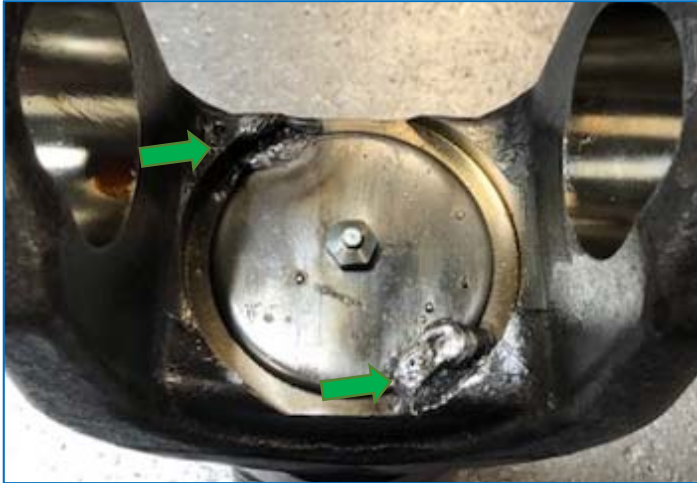
Figure 2: Top View of Metal Cap

- Tack welds on the top of the cap. See figures 2 and 3.
- There are no raised letters on the top of the cap.
- The cap attracts a magnet.

If the cap is metal, then the driveshaft is **APPROVED**. Record that the cap is metal on the inspection sheet and proceed to step 7.

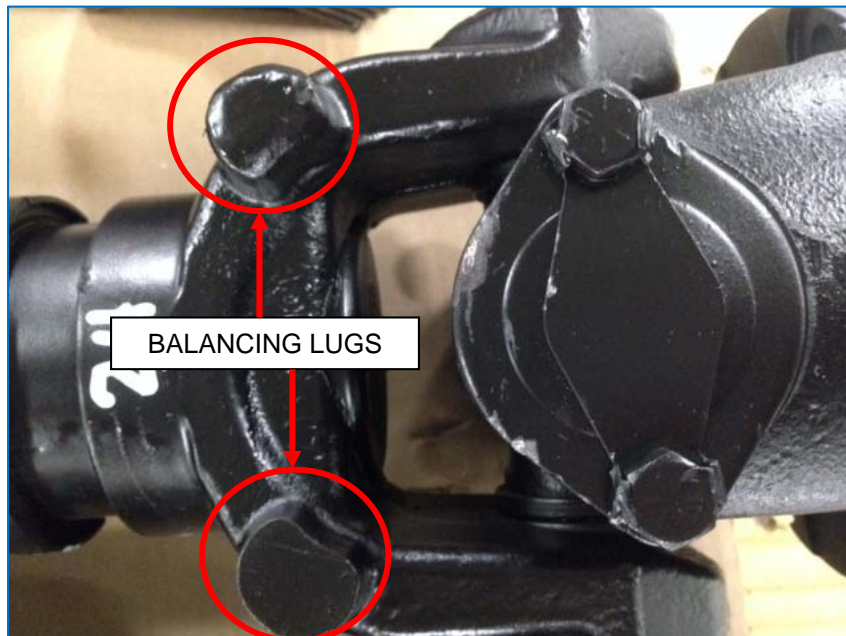
Figure 4: Style A Driveshaft

Style A – Plastic dust cap with balancing lugs on driveshaft yoke = **NOT APPROVED**

Step 4: If plastic cap is present, visually check for style of yoke and record on inspection sheet. Replace the driveshaft when materials are available.

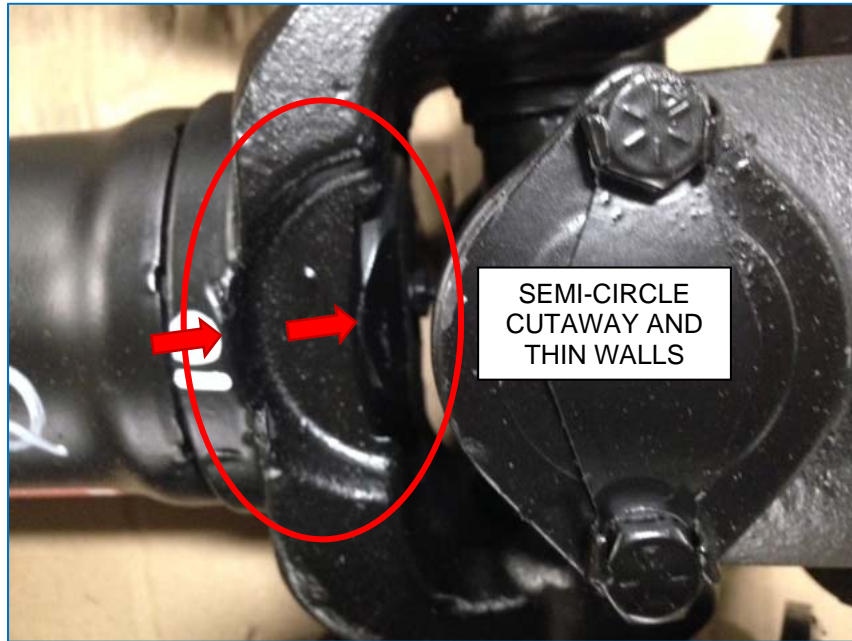
Figure 5: Style B Driveshaft

Style B – Plastic dust cap and thin wall = **NOT APPROVED**

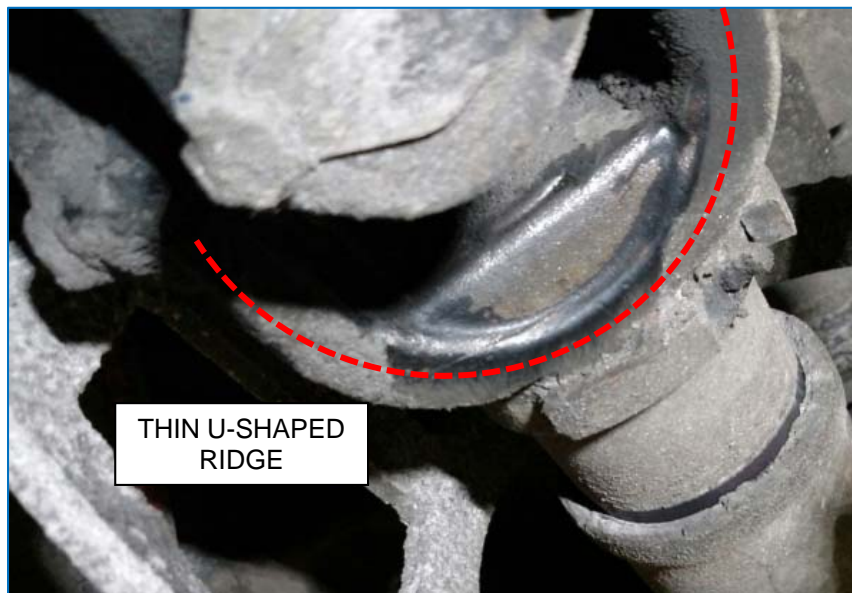
Figure 6: Style C Driveshaft

Style C – Plastic dust cap with U-shaped yoke = **NOT APPROVED**

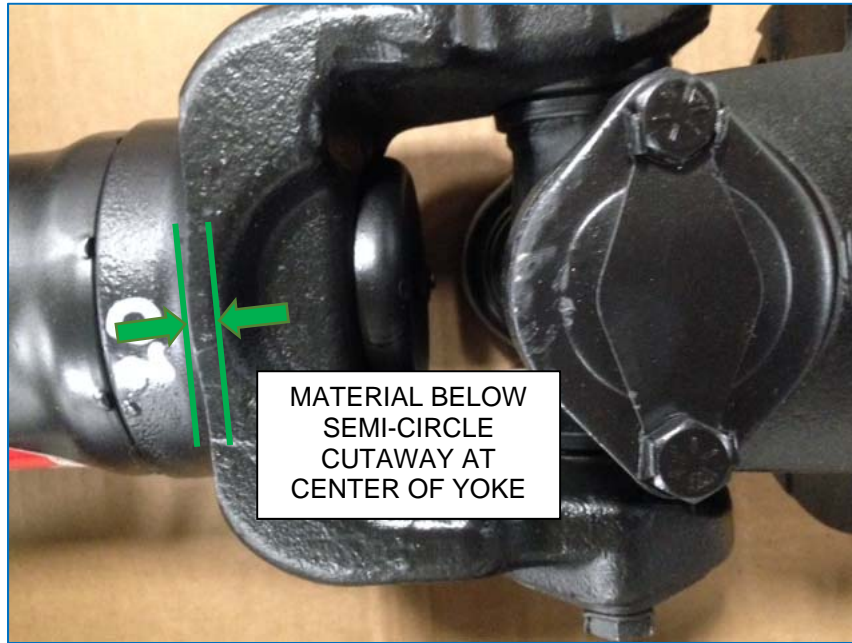
Figure 7: Style D Driveshaft

Style D – Plastic dust cap and thick wall = **APPROVED**

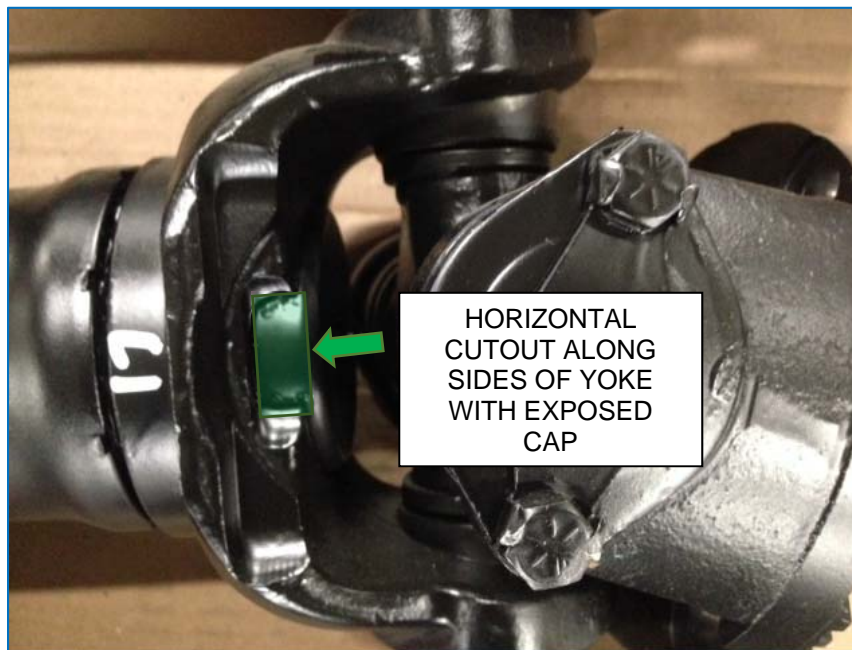
Figure 8: Style E Driveshaft

Style E – Plastic dust cap with horizontal cutout = **APPROVED**

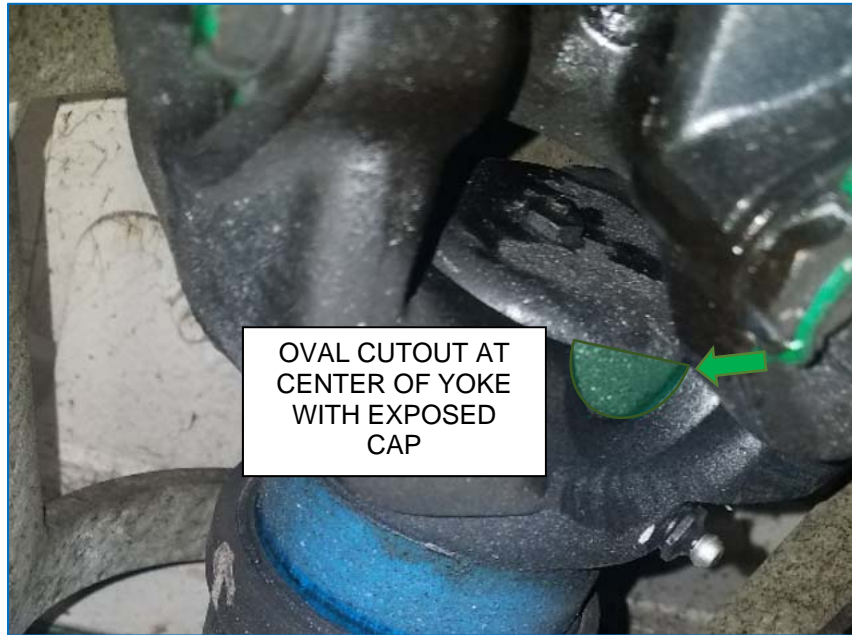
Figure 9: Style F Driveshaft

Style F – Plastic dust cap with oval cutout = **APPROVED**

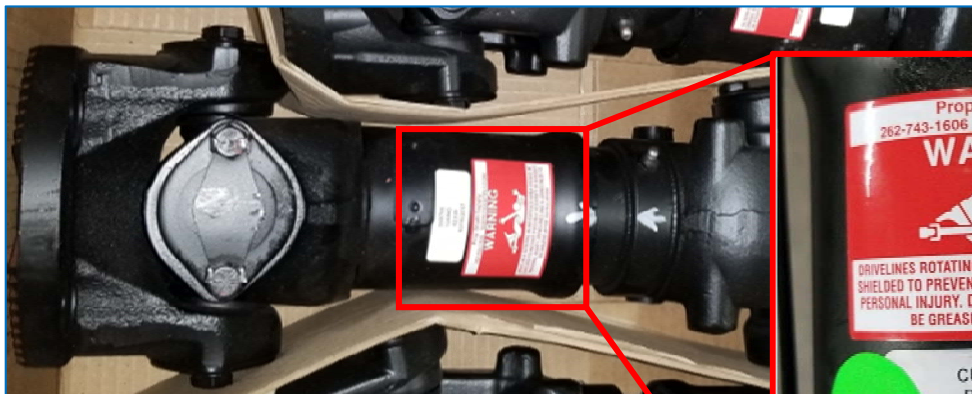
Figure 10: White Label

Step 5: In all cases and if legible, record the date code and work order (W/O) number located on a white label on the body of the driveshaft per Figure 10 and 11.

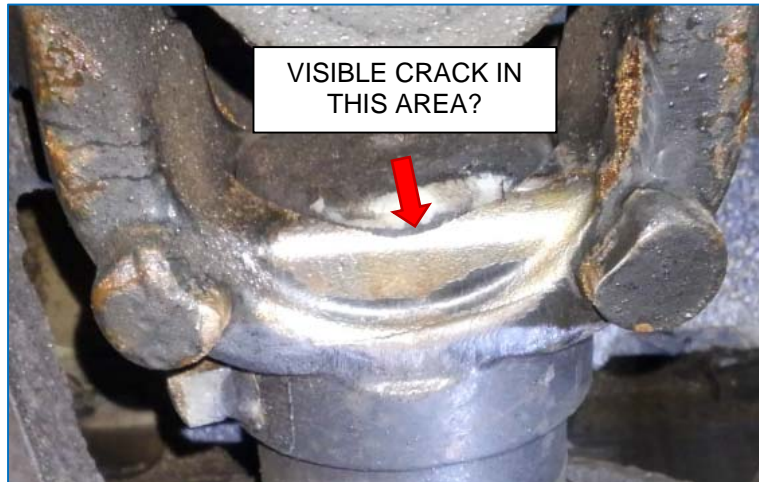
Figure 12: Potential Crack Area

Step 6: Where the driveshaft is **NOT APPROVED**, inspect the yoke for cracks at the center of the U-joint per Figure 12.

NOTE! Where the driveshaft is **NOT APPROVED** bus has no visible crack, it can continue to be used in service until a replacement driveshaft is available. If it is visibly cracked, the bus must be held from service until a replacement driveshaft can be installed.
