SUBJECT: TBB FL763 – Advance Notice and Dealer Actions

April 2018
FL763
Interim Recall Notice
NHTSA #18V-192 (School Buses)
NHTSA #18V-193 (Non-School Buses)

Subject: TBB SynTec S3B Seat Frames

Interim Repair FL763

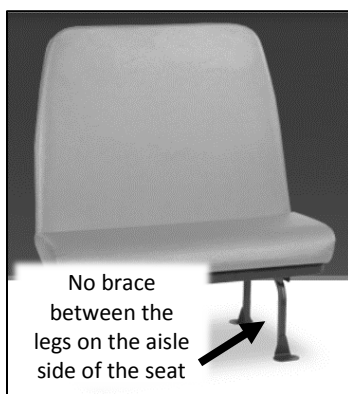
Figure 1

Look at the aisle side of the seat. There is **no** brace between the legs on the aisle side. See **Figure 1**. (If there is a brace, the seat does not need to be inspected.)

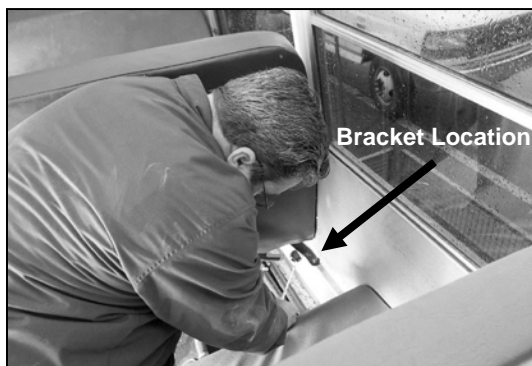
Figure 2

1. Look at the seat mounting bracket. It is behind the seat, at the seat rail along the wall. See **Figure 2**. (A flashlight may be helpful.)

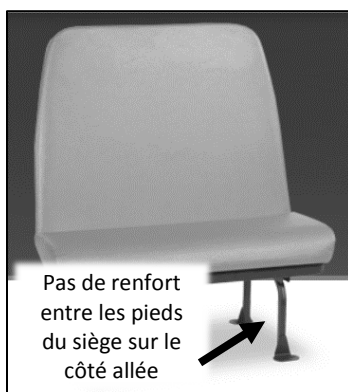
Figure 1

Examinez le côté allée du siège. Il n'y a **pas** de renfort entre les pieds du siège sur le côté allée. Reportez-vous à la **figure 1**. (S'il existe un renfort, le siège ne doit *pas* être inspecté)

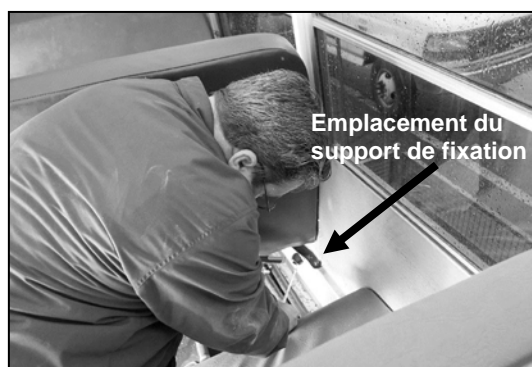
Figure 2

1. Examinez le support de fixation du siège. Il est situé derrière le siège, au niveau du rail de fixation des sièges, sur la paroi de l'autobus. Reportez-vous à la **figure 2**. (Une lampe de poche peut s'avérer utile.)

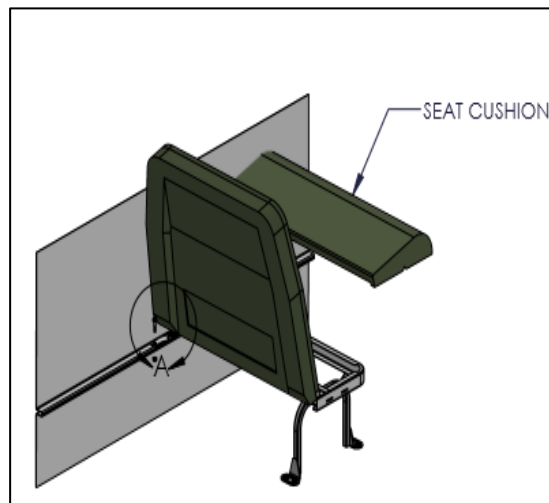
Figure 1: Remove Seat Cushion

1. Confirm the VIN is included in the recall. See ICI18-012. Use Ctrl-F to search for the VIN or body serial number.
2. Park the vehicle, shut down the engine, make sure the shifter is in Park or Neutral, set the parking brake, chock the tires.
3. Remove the seat cushion. See **Figure 1**.
