# **Keystone RV Company**

## **SAFETY ADVISORY # 18-316**

## CrossRoads Brake Wiring

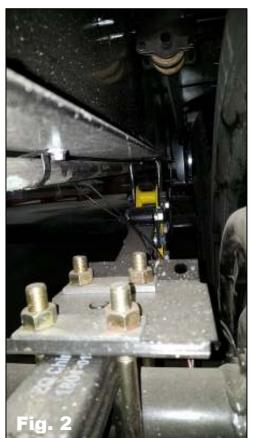
**Step 2**Inspect the wiring to see if it is zip tied to the spring packs, see Figure 1. If it is zip tied to the spring packs, proceed to step 3. If it is not zip tied to the spring packs, proceed to Warranty Reimbursement.

Step 3
Cut the zip tie attachment and route the wiring through the underbelly so that it is clear of any pinch points, Figures 2 & 3. Proceed to Warranty Reimbursement.
