# SAFETY RECALL BULLETIN

<b>SUBJECT:</b> <b>LANCER PASSENGER SIDE FRONTAL AIR BAG INFLATOR – SAFETY RECALL CAMPAIGN</b>			No: <b>SR-18-005</b>
			DATE: <b>April 2018</b>
			MODEL: <b>2004–06 Lancer, Lancer Sportback, and Lancer Evolution</b>
<b>CIRCULATE TO:</b>	<input checked="" type="checkbox"/> GENERAL MANAGER	<input checked="" type="checkbox"/> PARTS MANAGER	<input checked="" type="checkbox"/> TECHNICIAN
<input checked="" type="checkbox"/> SERVICE ADVISOR	<input checked="" type="checkbox"/> SERVICE MANAGER	<input checked="" type="checkbox"/> WARRANTY PROCESSOR	<input checked="" type="checkbox"/> SALES MANAGER

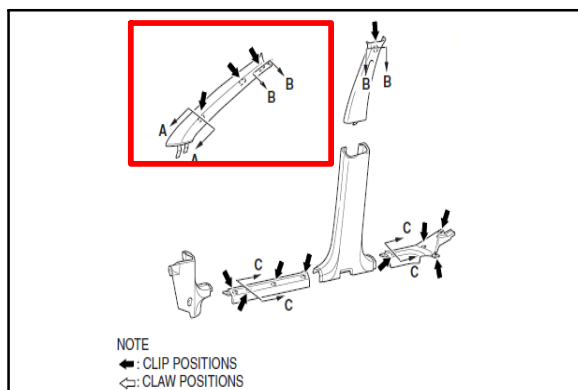
2. Remove the front left and right A-pillar trims.

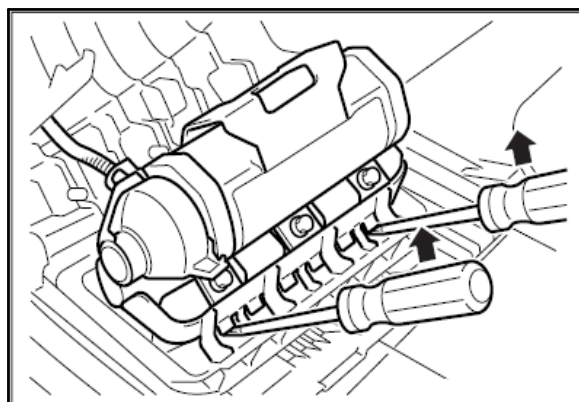
5. The front passenger side air bag module is secured to the instrument panel in a flexible plastic enclosure. Insert a flat head screwdriver and disengage the mounting hooks to dislodge the module from the enclosure.

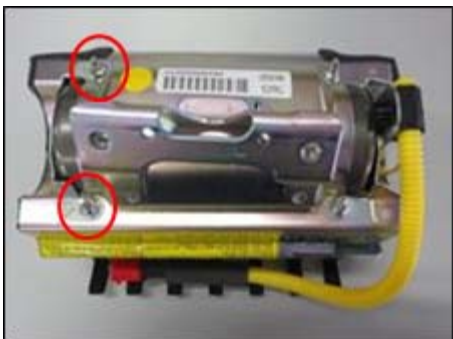
3. Remove and discard the 2 circled nuts.

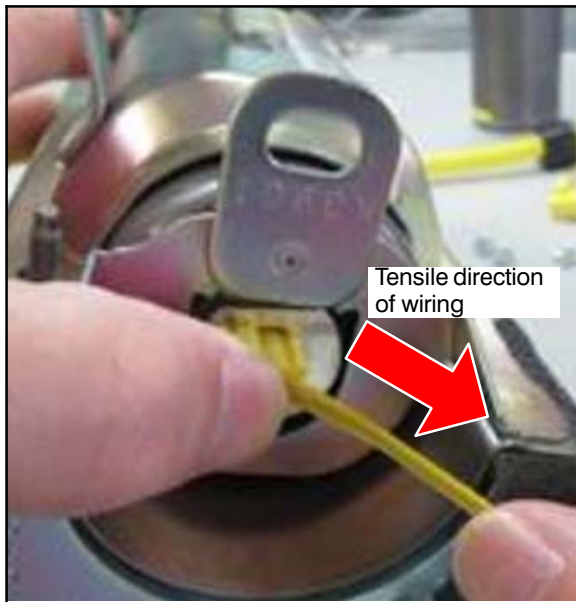
6. Gently pull and straighten the wires so it is in line with the inflator. This will prevent the wire from contacting the edges of the inflator housing during removal.

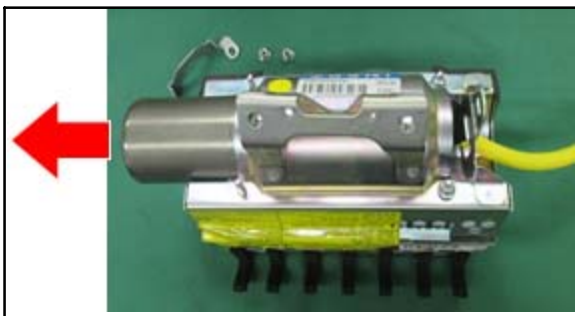
7. Gently push the inflator with your finger in the indicated direction while gently pulling (straightening) the wire to remove the inflator.

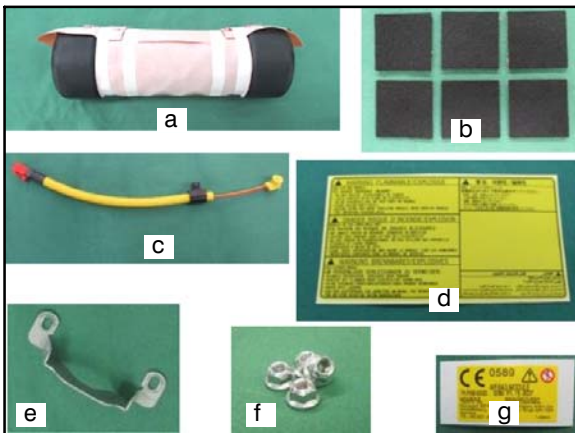
8. Unpackage the air bag inflator kit, remove and verify the contents:
- a. (1) Replacement inflator with tapes and cloth cover.
  - b. (6) Felt tapes
  - c. (1) Replacement wiring harness
  - d. (1) Caution label
  - e. (1) Old stopper plate (not in box) from Step 4
  - f. (4) Replacement nuts – M5
  - g. (1) CE certification label

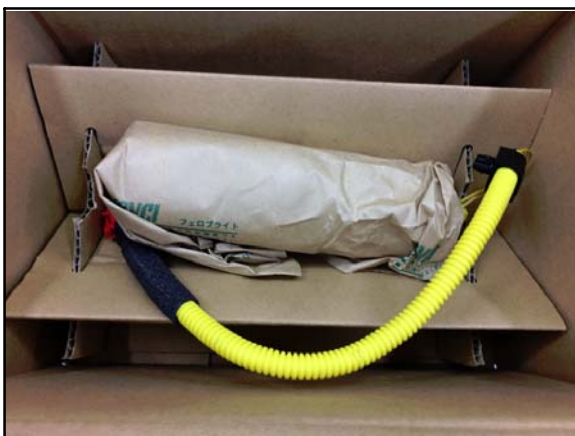
9. Package the old inflator, with its wiring harness still attached, into the box that previously contained the new inflator. Ensure the old inflator is correctly wrapped, using the wrapping that came with the new inflator, to protect the old inflator from damage during shipping.

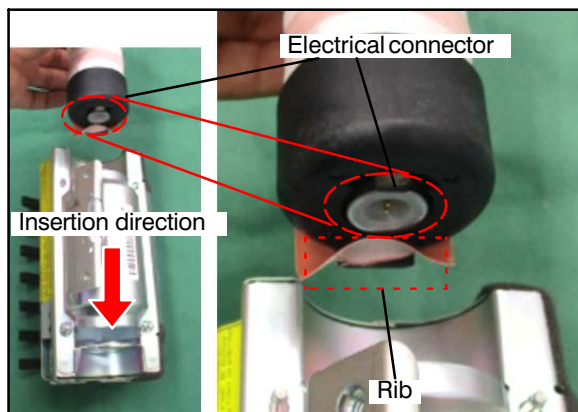
10. Begin insertion of the replacement inflator into the housing as shown, with the electrical connector side going in first.

**NOTE:** Make sure that the rib faces down.

**NOTE:** Make sure that the cloth and tapes do not fall off.

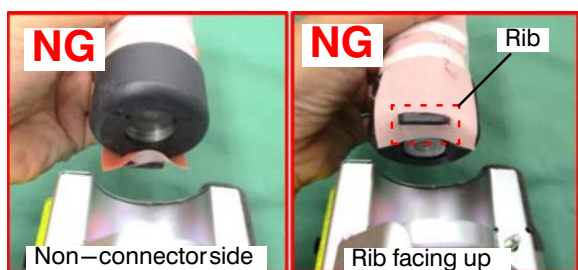
**CAUTION:** Do NOT incorrectly insert the inflator.

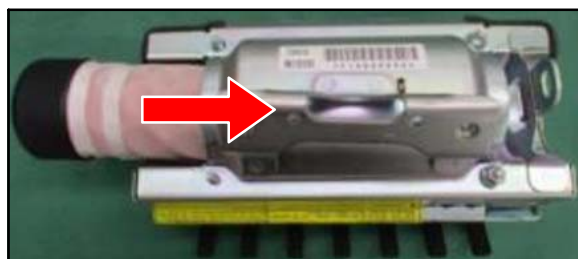
11. Fully insert the inflator.

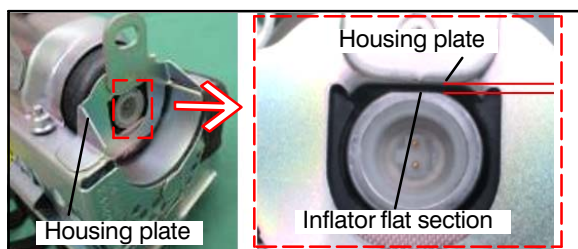
12. Ensure that the inflator makes complete contact with the housing plate. If needed, rotate the inflator so that the inflator's flat section is parallel with the housing plate.

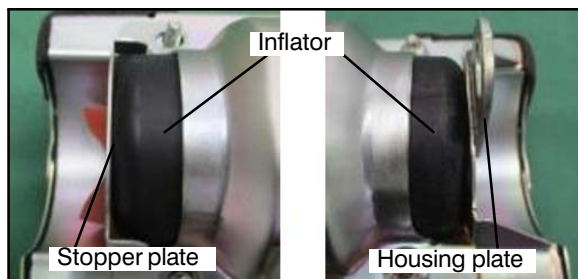
13. Reinstall the stopper plate.

14. Ensure the inflator is seated correctly in the housing, and there are no gaps on either end.

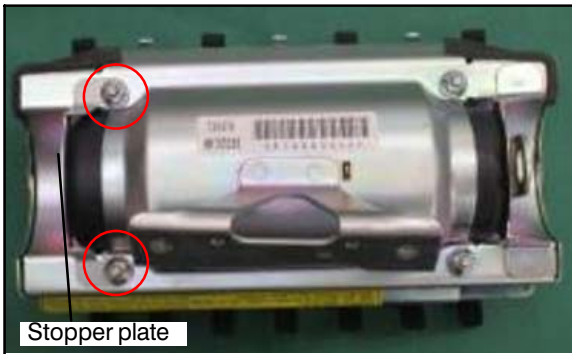
15. Install and lightly tighten the (2) nuts holding the stopper plate.

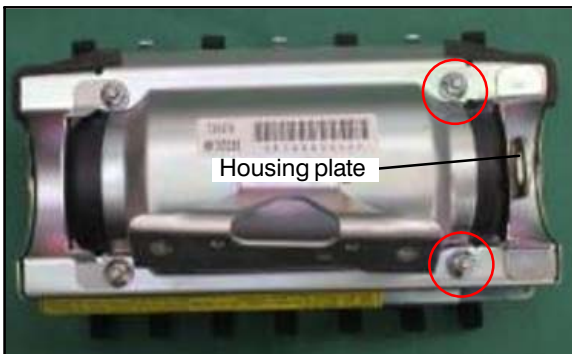
16. Remove and discard (2) nuts near the housing plate side.  
17. Install (2) **new** nuts and lightly tighten them.

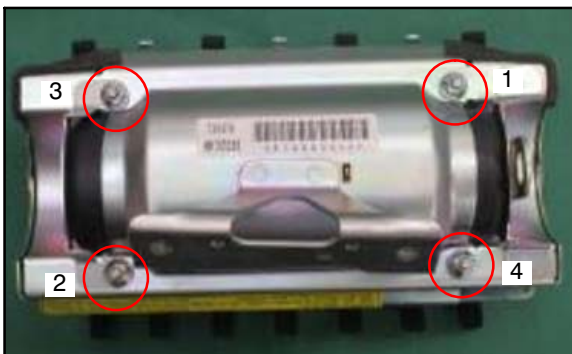
18. In the illustrated order, torque all (4) nuts to  $34.5 \pm 3.5$  in-lb ( $3.9 \pm 0.4$  Nm).

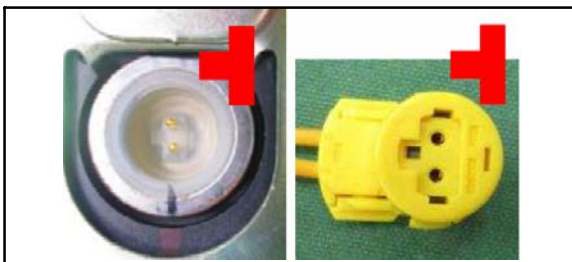
19. Match the wiring harness connector's plug with the shape in the electrical connector socket.

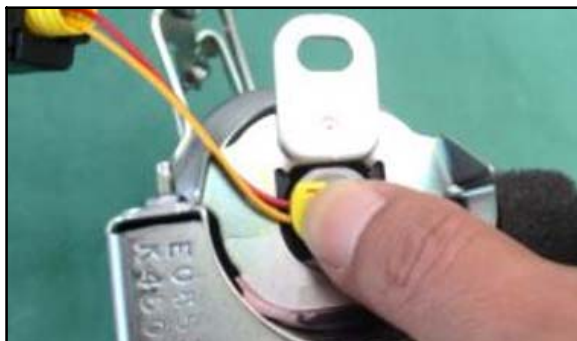
20. Press the wiring harness connector firmly into the electrical connector socket.

**NOTE:** A faint click will be heard when the connector is inserted correctly.

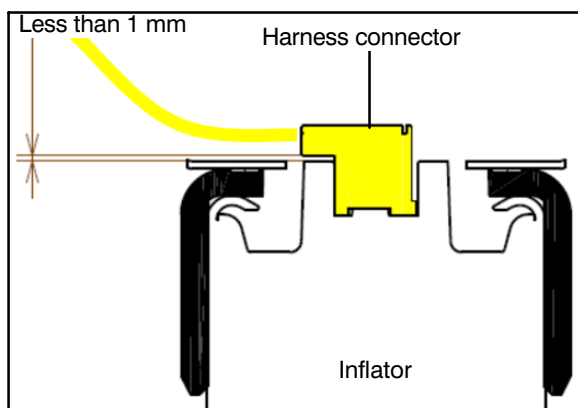
21. Ensure the harness connector is completely inserted into the electrical connector socket by gently pulling on the harness connector.

Measure the distance between the inflator and the harness connector to ensure it is less than 1 mm.

If the distance is more than 1 mm, the connection is NG.

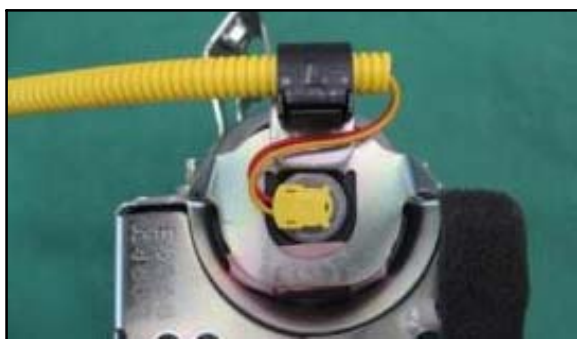
22. Clip the wiring harness to the mounting bracket as shown.

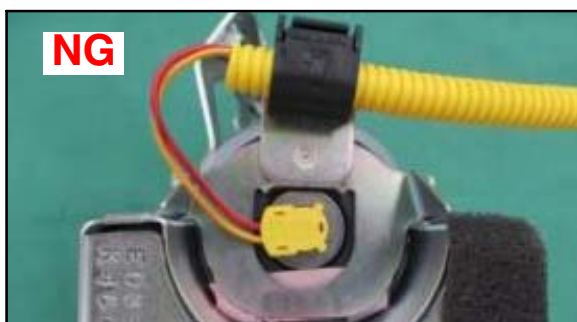
**CAUTION:** Do not connect the wiring harness in the incorrect direction.

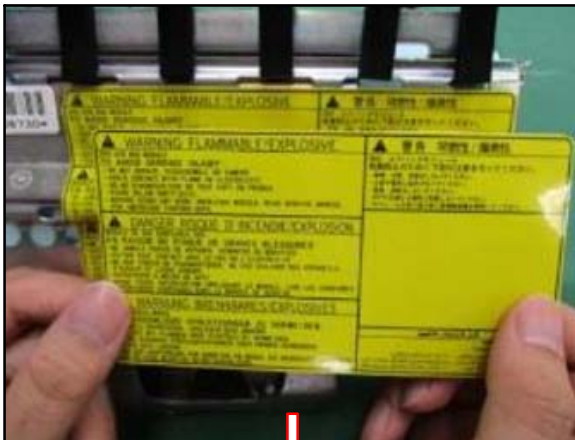
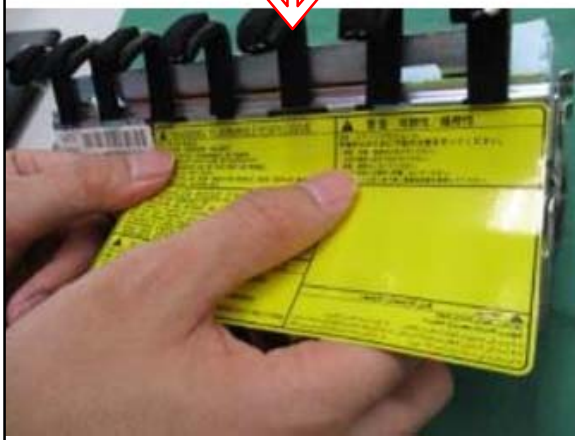
24. Use a clean, dry cloth or towel to wipe the old caution label.

25. Affix the new caution label directly over the old caution label.

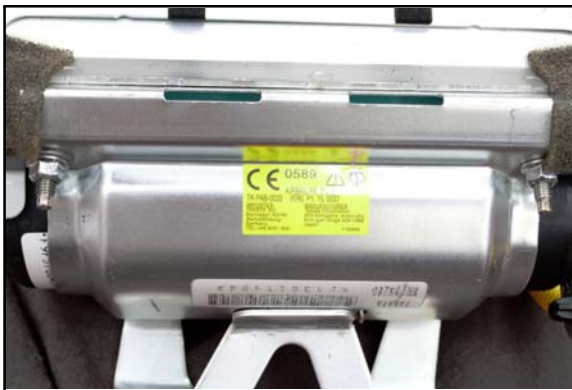
27. Affix the CE certification label on the degreased area.

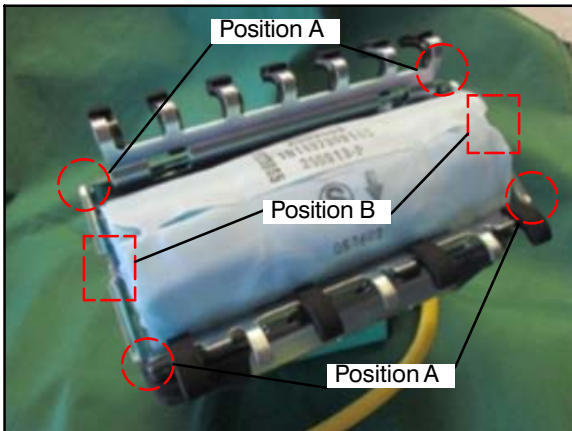
28. Prepare felt tapes for application to the outlined locations.

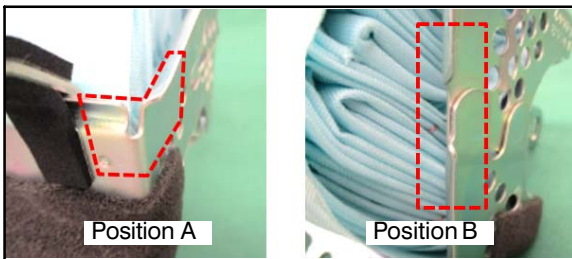
a. Note the taping area for Position A and Position B.
