## Safety Recall: Front Seats Frame Rivets

Supersedes 18-042, dated April 11, 2018, to revise the information highlighted in **yellow**

### AFFECTED VEHICLES

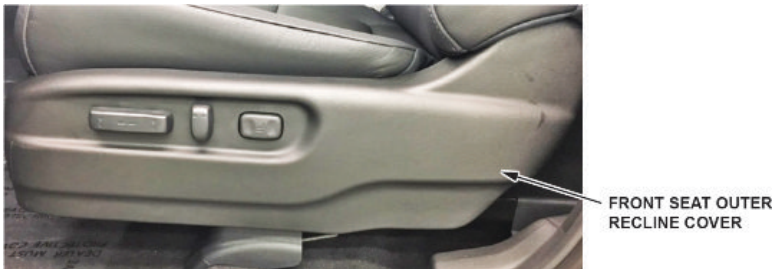
3. Remove the outer seat recline cover.

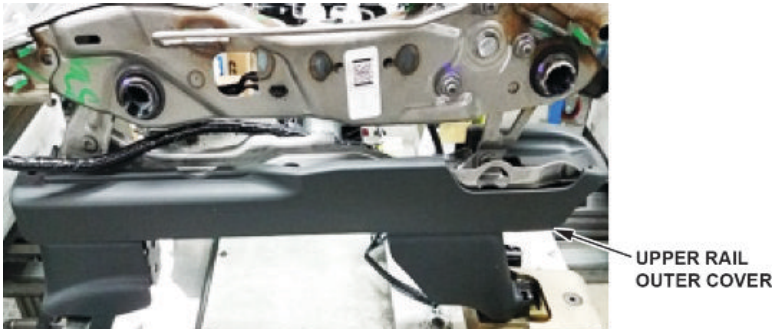
4. Remove the upper rail outer cover.

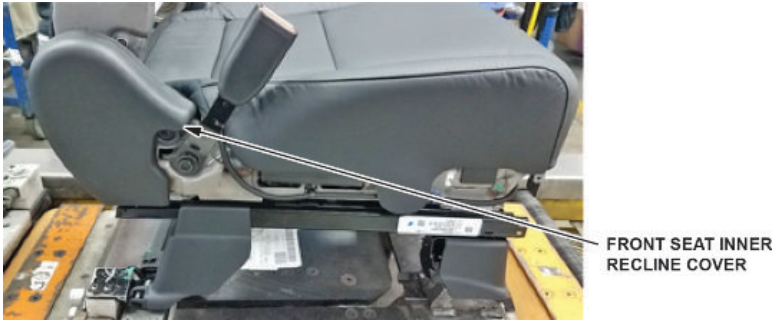
5. Remove the inner recline cover.

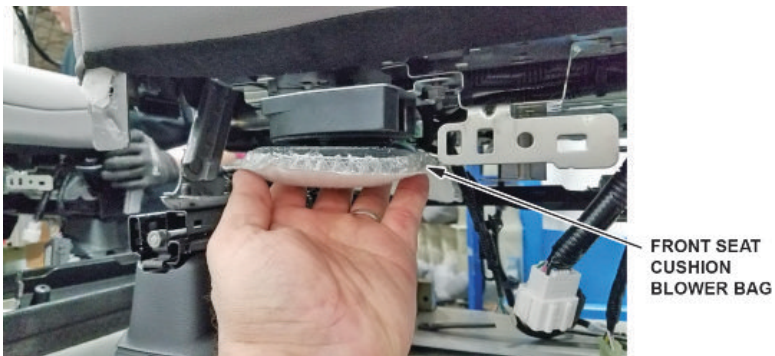
6. Disconnect the seat cushion blower bag. (Pilot Elite trim only)

Leave the blower motor on the seat.

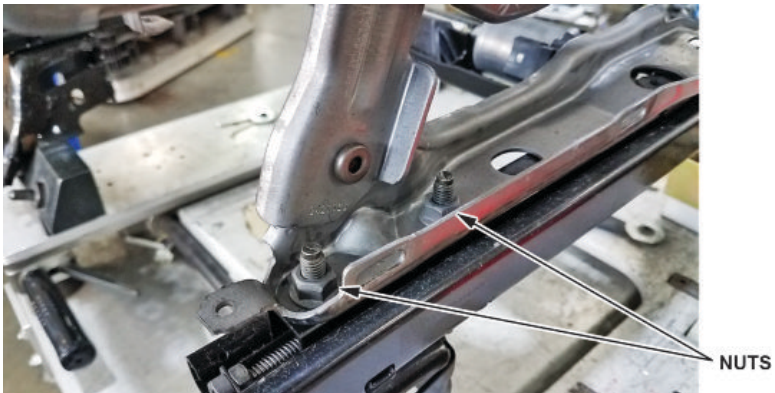
10. Remove 2 nuts at the remaining 3 corners.

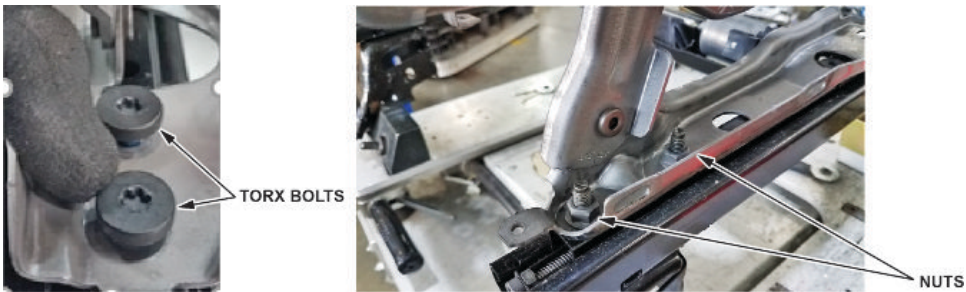
14. Install and hand tighten the 2 torx bolts into the rear-right corner, then the 2 nuts in the remaining 3 corners.

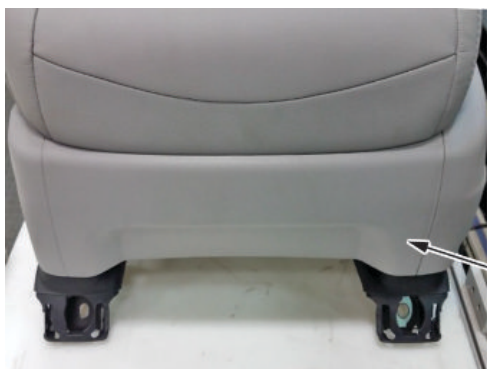
FRONT CUSHION COVER

2. Remove the front cushion cover.

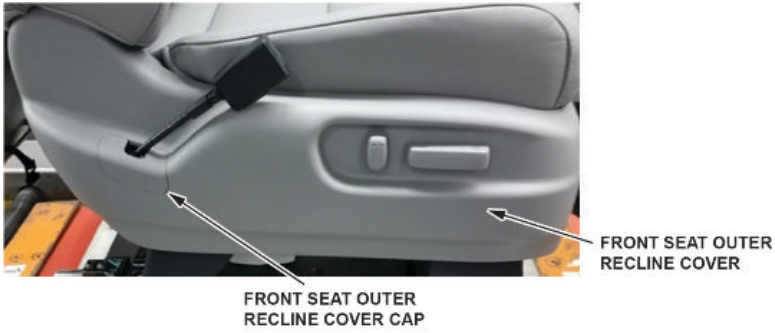
3. Remove the outer recline cover cap, then the outer seat recline cover.

Carefully remove the recline cover cap to avoid damage.

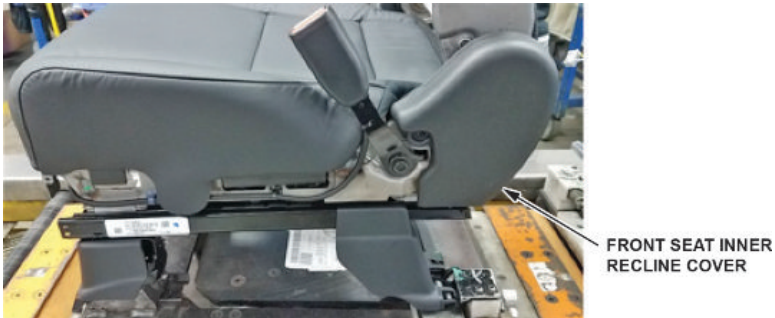
4. Remove the inner recline cover.

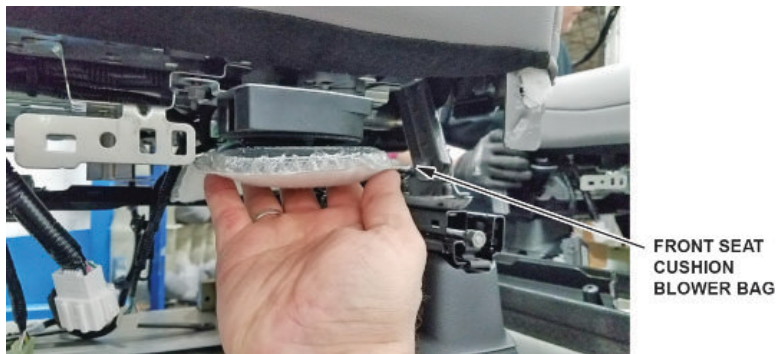
6. Disconnect the seat cushion blower bag. (Pilot Elite trim only)

Leave the blower motor on the seat.

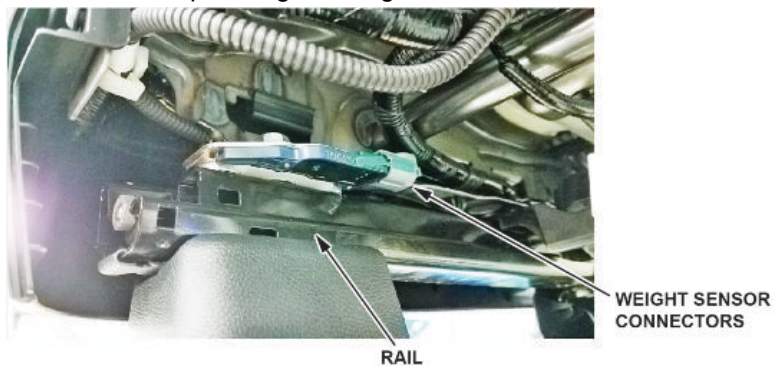
8. Disconnect the passenger's weight sensor connectors.

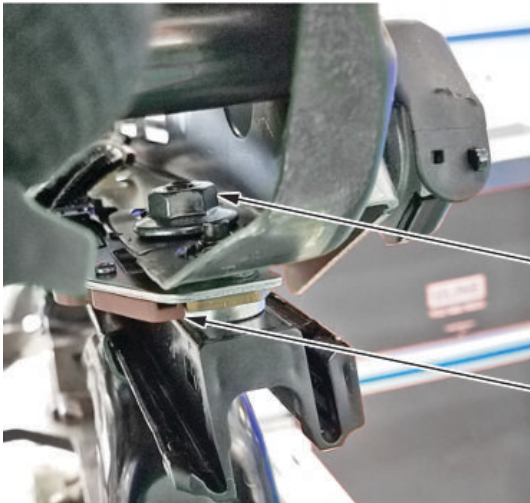
10. Remove the weight sensor nuts on all 4 corners of the seat.

WEIGHT SENSOR NUT

WEIGHT SENSOR

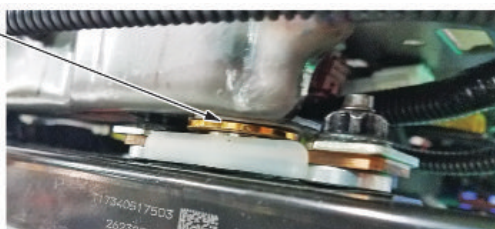
**GOOD**

16. Make sure the collar is centered, and there is no gap between the seat and frame.

COLLAR CENTERED

NO GAP

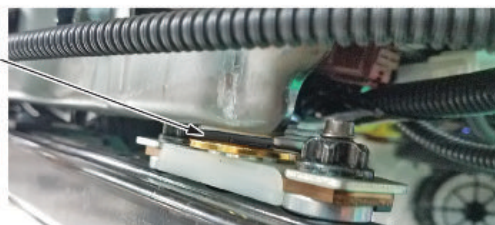
**NO GOOD**

COLLAR OFF-CENTER

GAP

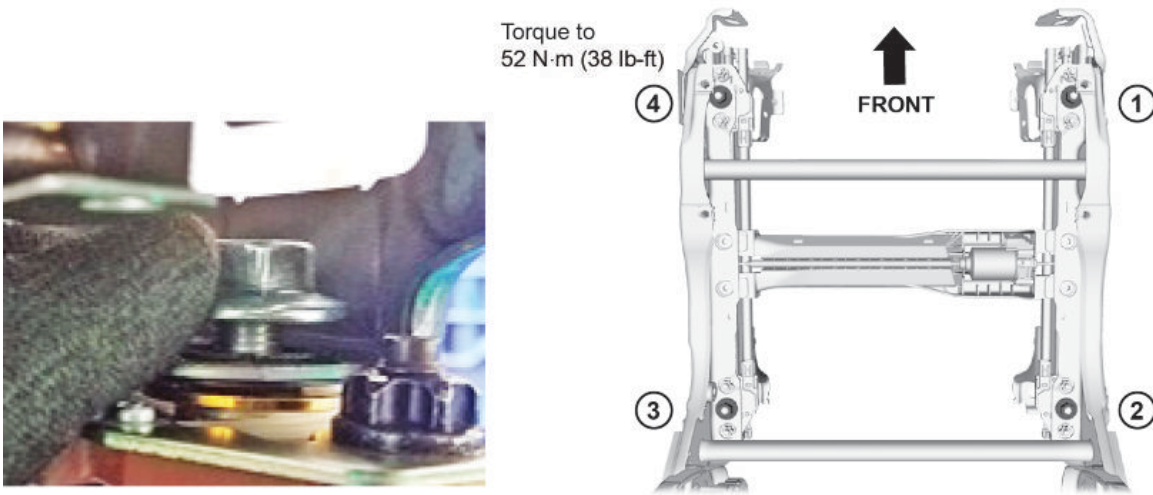
17. Install and hand tighten the nuts, then torque them to **52 N·m (38 lb-ft)** in the sequence shown.
