**April 27, 2018**

## Safety Recall: Driver's Replacement (Service Part) Seat-back Pad

Year	Model	Trim	VIN Range
2017	Civic	5 Door	Check the iN VIN status for eligibility.

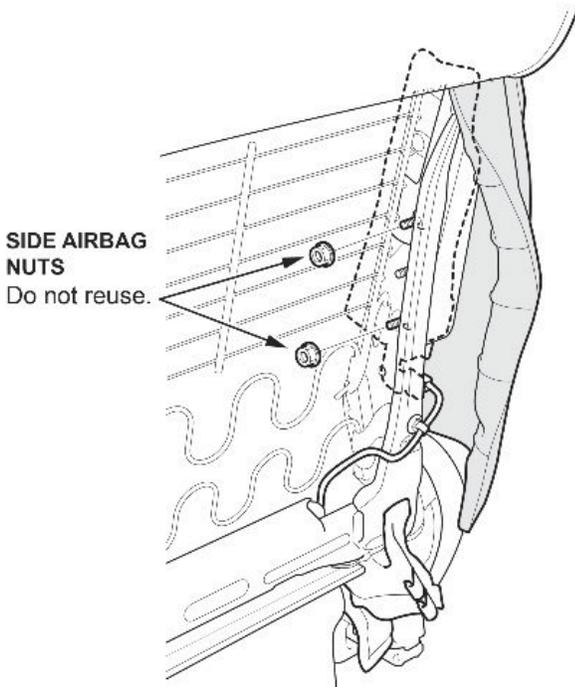
Remove the nuts from the side airbag, but do not remove it. The seat cover is easier to install with the airbag loose.

3. Remove the seat-back cover and pad from the seat frame. Refer to the service information.

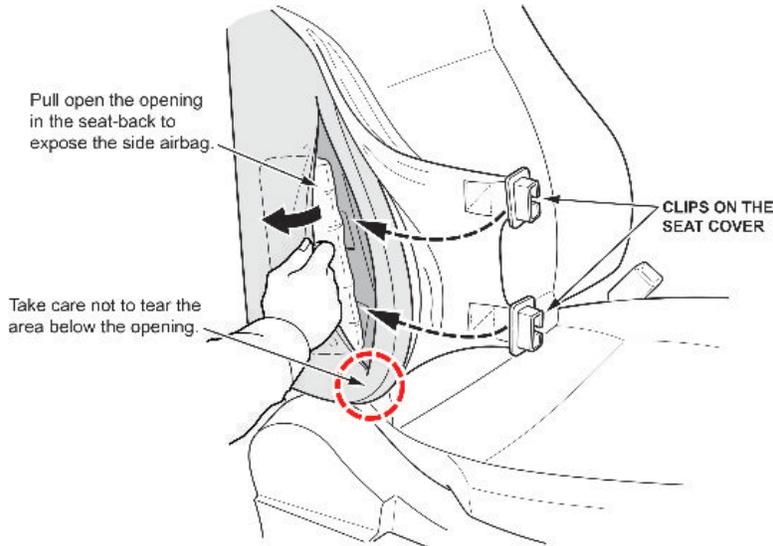
5.1. Carefully open the opening in the seat back and insert the two clips on the seat cover behind the side airbag.

Make sure you don't tear the seat back pad.

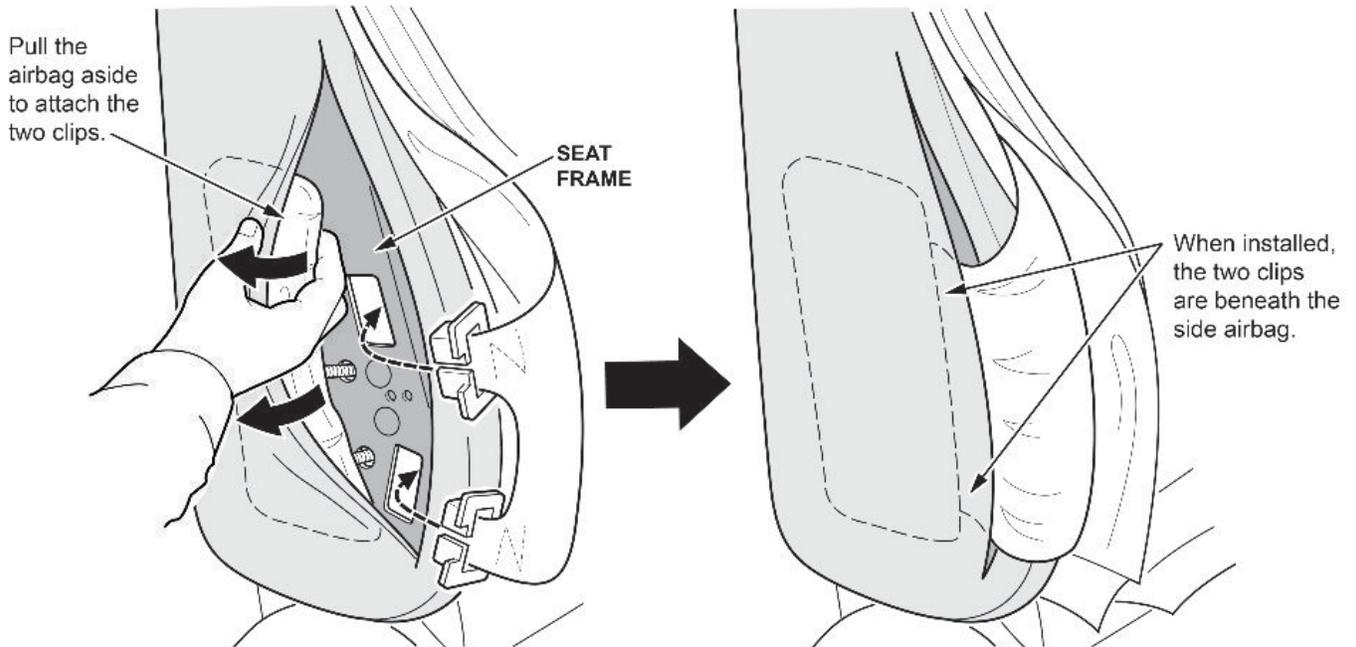
5.2. Pull the side airbag far enough to access the two clips on the seat frame, then attach the clips on the seat cover.

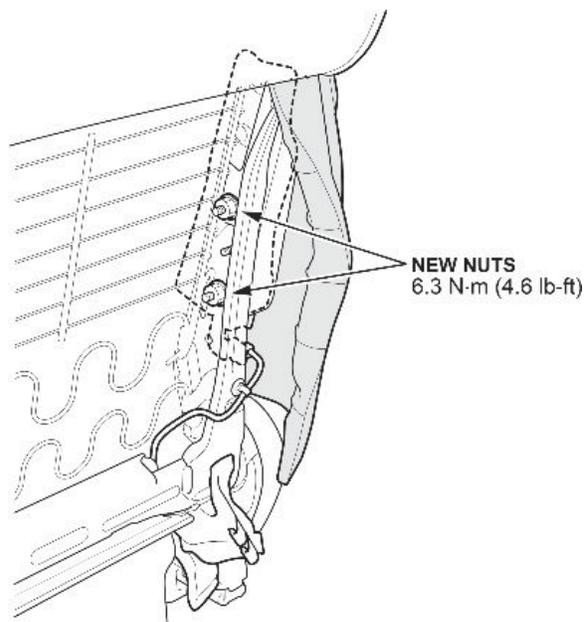
5.3. Torque the new side airbag nuts to **6.3 N·m (4.6 lb-ft)**.
