SP/DR/GN/GZ/LS No. 065

## **SAFETY RECALL CAMPAIGN 2A84**

### **DR-Z400S/SML8 Rear Brake Stop Lamp Switch Replacement**

**Affected Models:** 2018 DR-Z400S/SM

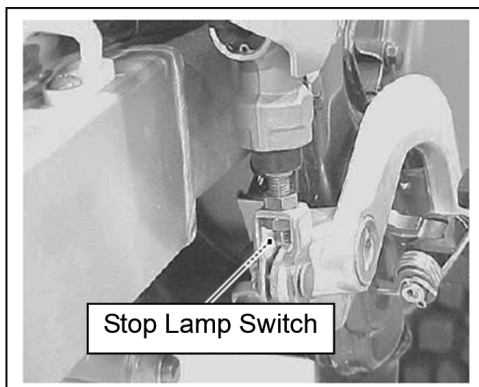
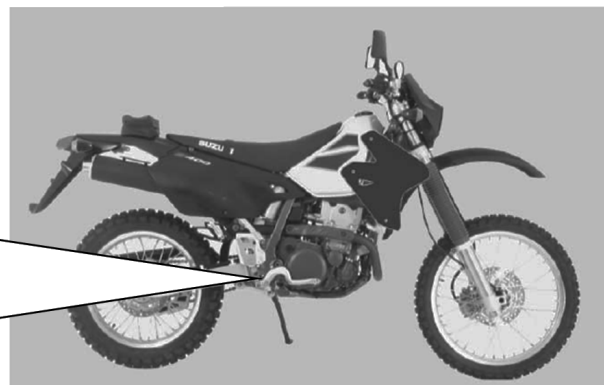
During the manufacturing process, the resin used to fill the rear brake stop lamp switch assembly may have adhered to the internal contacts, resulting in poor conductivity and preventing the stop lamp from illuminating when only the rear brake is applied. Failure of the brake stop lamp to illuminate may increase the risk of a rear crash. To ensure customer safety and satisfaction, Suzuki is replacing the rear brake stop lamp switch assembly.

Install a replacement rear brake stop lamp switch assembly as outlined in this Technical Service Bulletin, and submit a warranty claim for reimbursement.

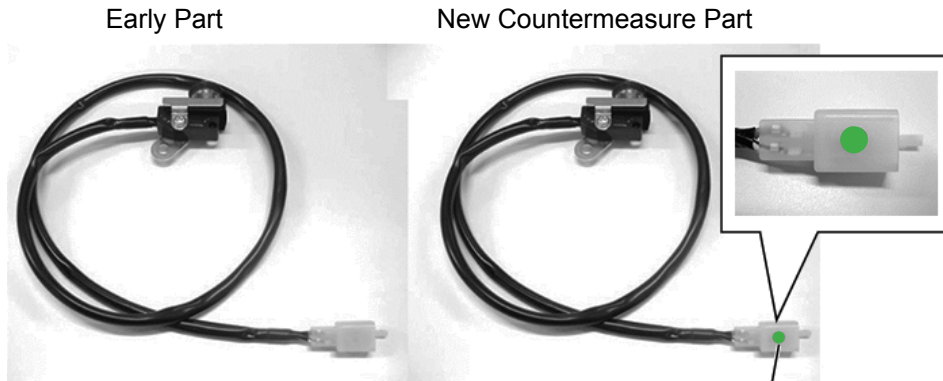
*The new countermeasure part can be identified by the green paint mark on the lead wire coupler.*

Part Name	Part Number	Quantity Required
Switch Assy, Stop Lamp	37740-29F00-RX0	1

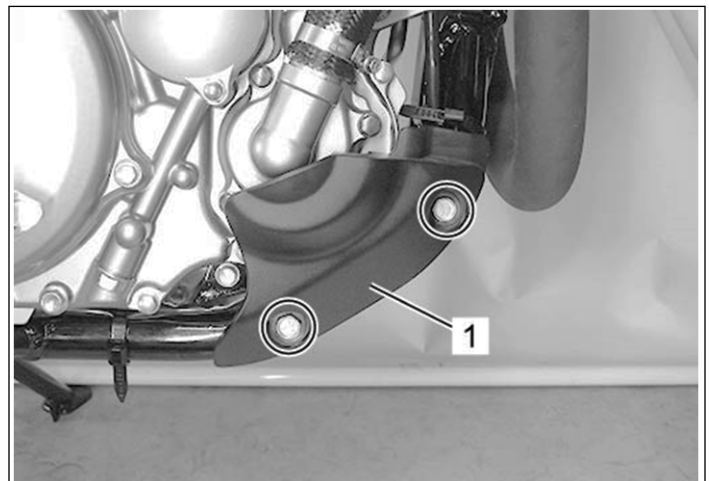
1. Remove the seat. (Refer to *Service Manual Section 6-2, Exterior Parts.*)
2. Remove the left frame cover. (Refer to *Section 6-2, Exterior Parts.*)
3. Disconnect the negative battery (-) lead wire. (Refer to *Section 7-34, Battery.*)
4. Remove the engine plate. (Refer to *Section 3-3, Engine Removal and Remounting.*)
5. Remove the water pump guard (1).

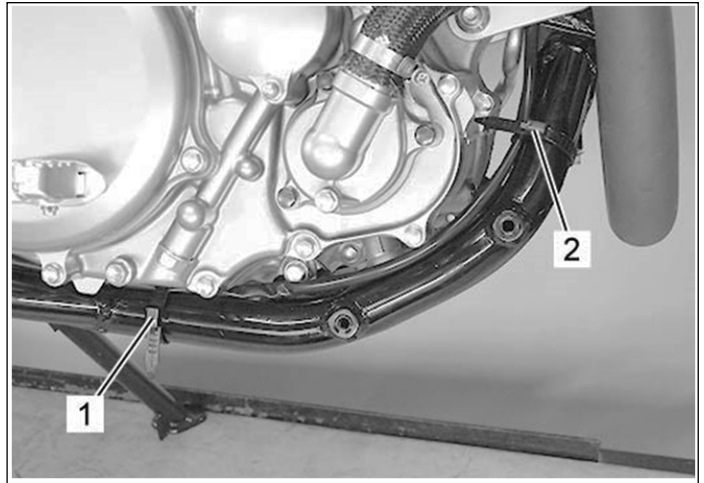
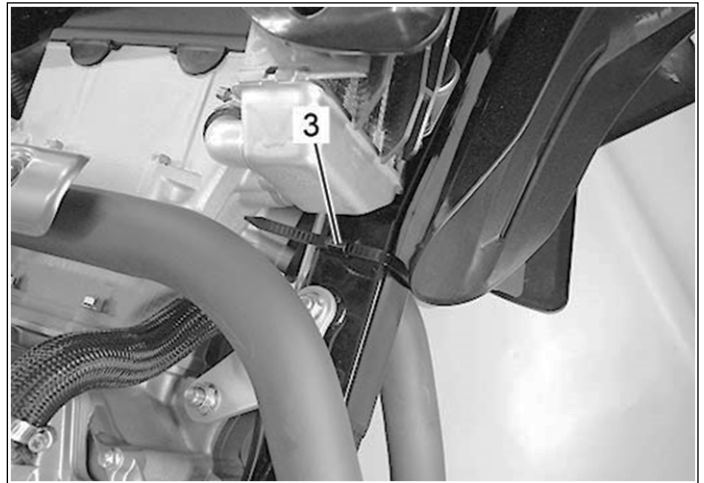
6. Remove clamps (1), (2) and (3).

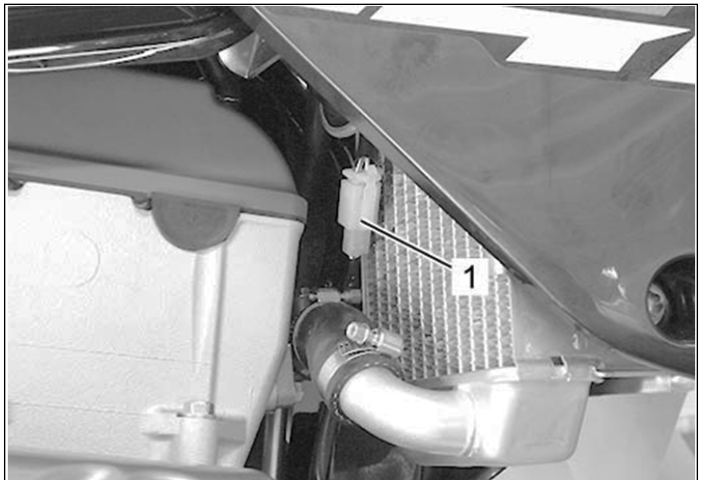
7. Disconnect the rear brake stop lamp switch lead wire coupler (1).

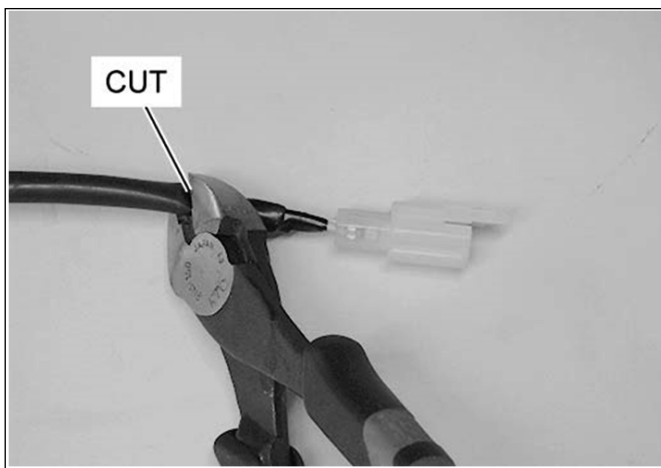
8. Cut the rear brake stop lamp switch lead wire.

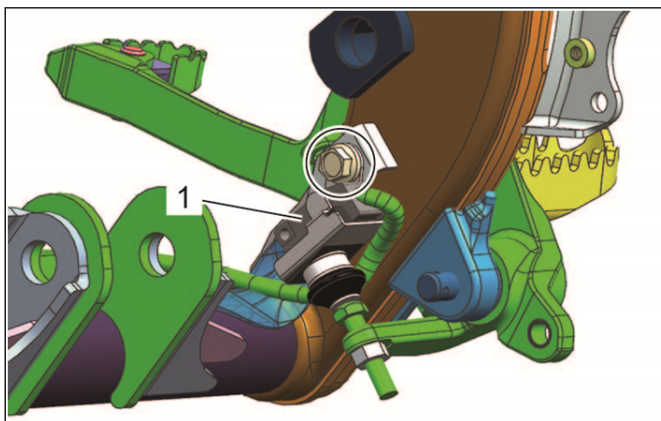
9. Remove the rear brake stop lamp switch (1).

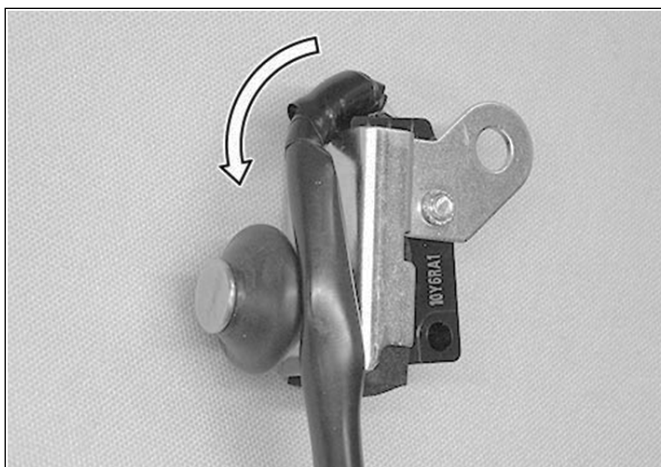
1. Before installing the new rear brake stop lamp switch, position the lead wire as shown.

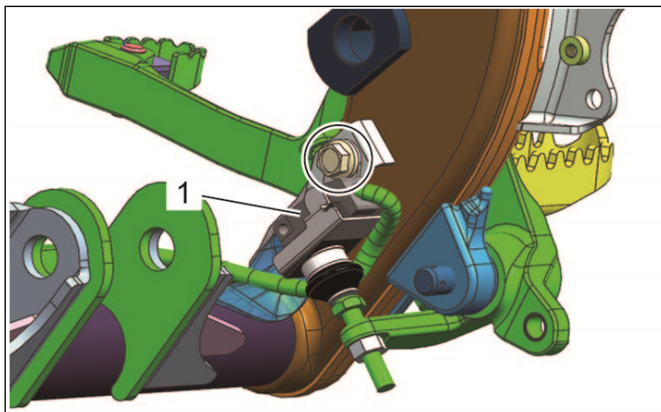
2. Install the new rear brake stop lamp switch (1) on the frame.

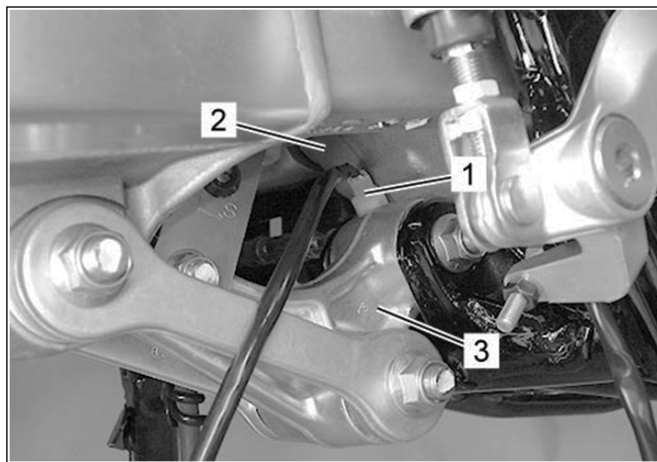
a) Pass the lead wire coupler (1) between the crankcase (2) and cushion lever (3).

3. Pass the rear brake stop lamp switch lead wire according to the following procedure.

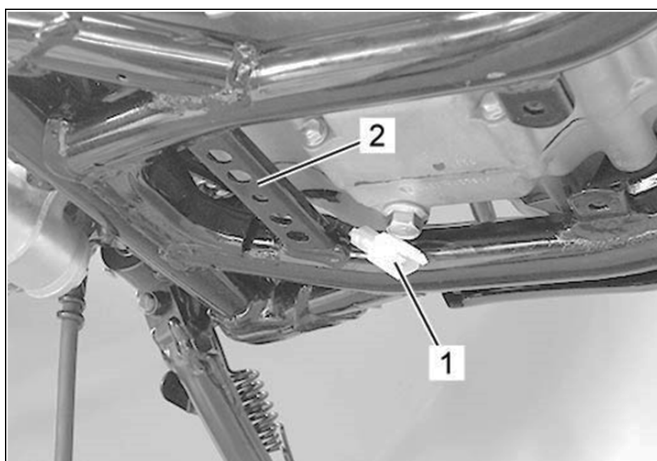
b) Pass the lead wire coupler (1) above the frame bridge left side (2).

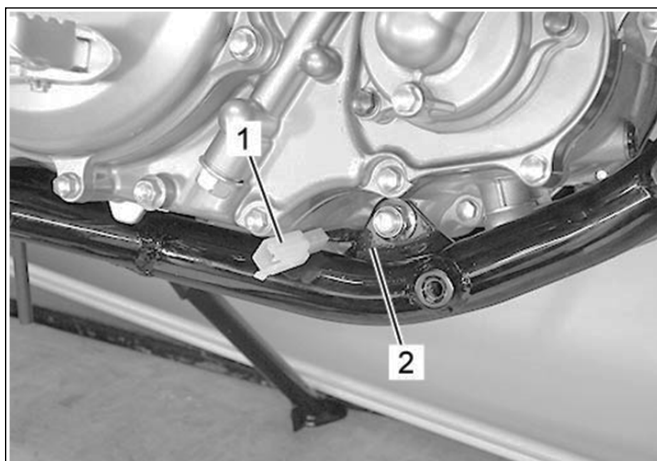
c) Draw the lead wire coupler (1) from behind the engine mounting lower bracket (2).

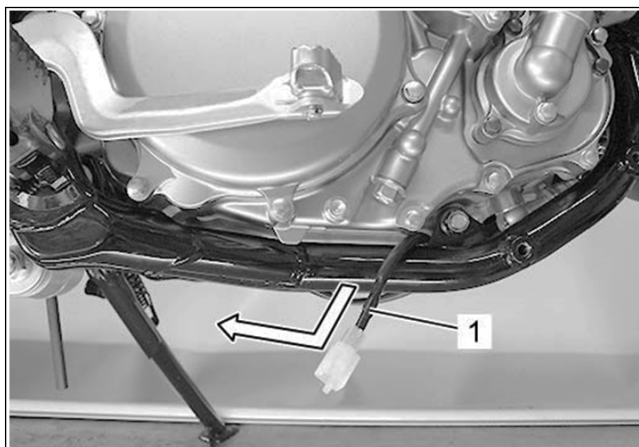
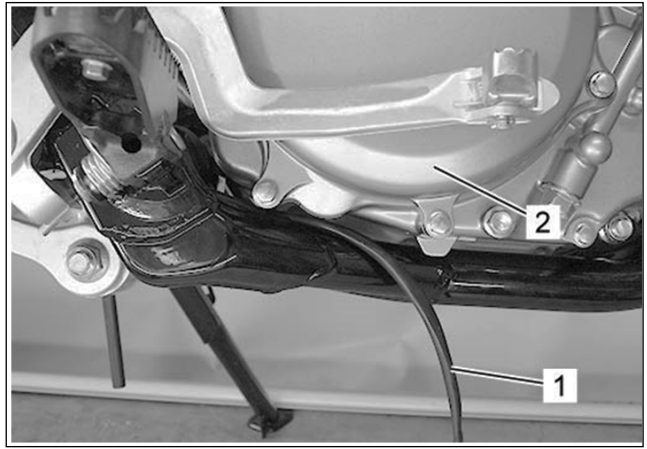
d) Draw the lead wire (1) from under the clutch cover (2).

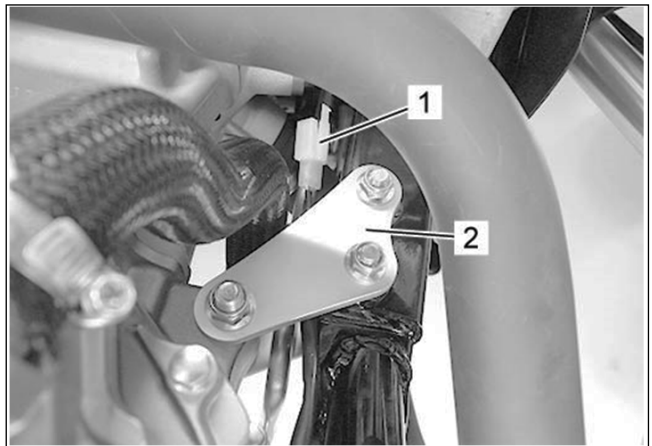
e) Pass the lead wire along the frame upper side, then pass the coupler (1) inside the right engine mounting front plate (2).

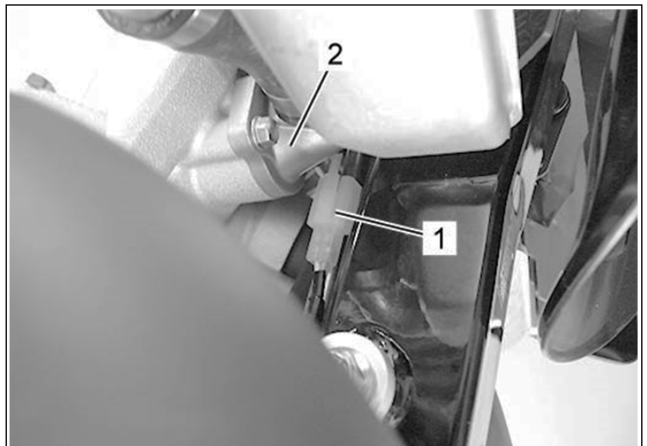
f) Pass the switch lead wire coupler (1) through the left side of the thermostat case (2).

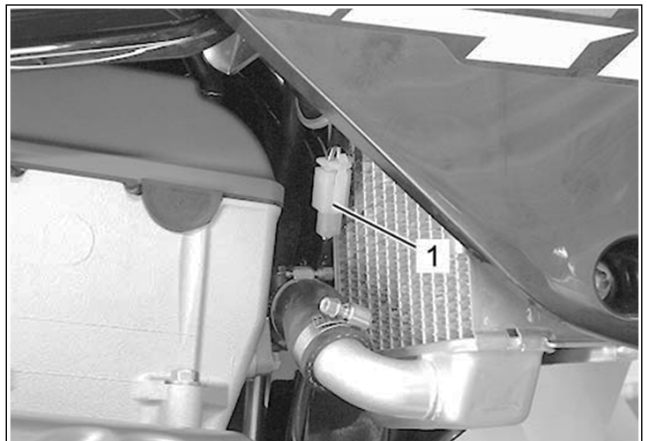
4. Connect the switch lead wire coupler (1).
