September 13, 2018

## Safety Recall: 2017-18 NSX Fuel Tank Product Update: 2017 NSX Thermostat

Supersedes 18-050, dated September 12, 2018, to revise the information highlighted in **yellow**

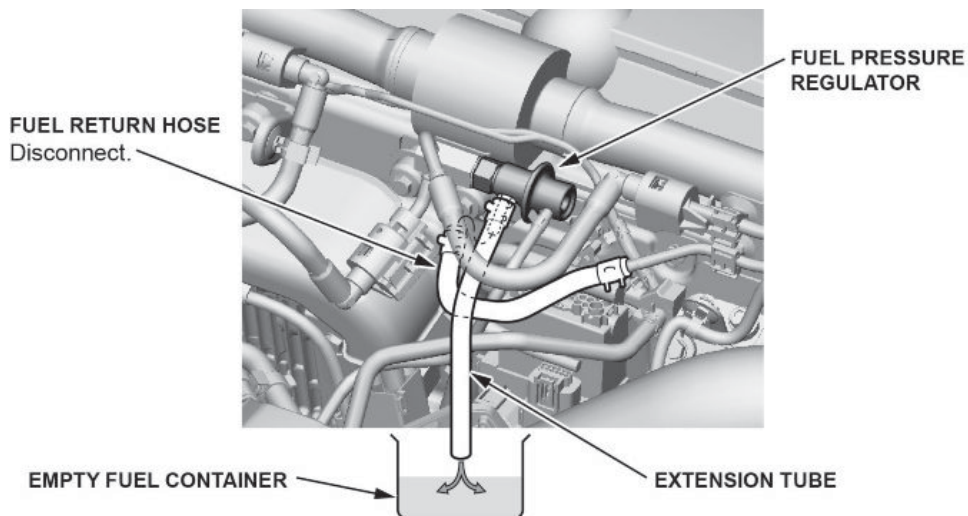
1. Set the vehicle on the lift. Refer to the service information.
2. Protect and cover the body panels surrounding the engine compartment.
3. Remove the engine room covers. Refer to the service information.
4. Remove the driver's side air cleaner assembly. Refer to the service information.
5. Drain the fuel from both fuel tanks.
  - 5.1. Remove the PGM-FI main relay 3 (UNDER HOOD).
  - 5.2. Remove the PGM-FI main relay 2 (CABIN).
  - 5.3. In **Maintenance Mode** do the **Forced PI Idling Mode**, then let the engine idle until it stalls.
  - 5.4. Remove the fuel return hose from the fuel pressure regulator, and add an extension tube to an empty fuel container.

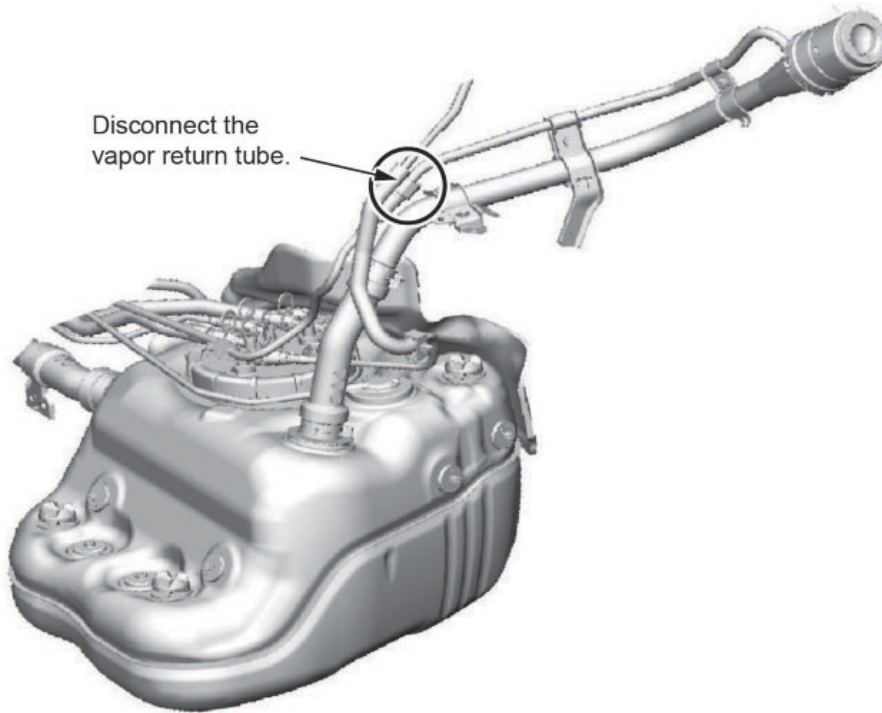
- 5.6. Wait until all the fuel is drained.
6. Disconnect the fuel vapor line (located below the removed driver's air cleaner assembly).

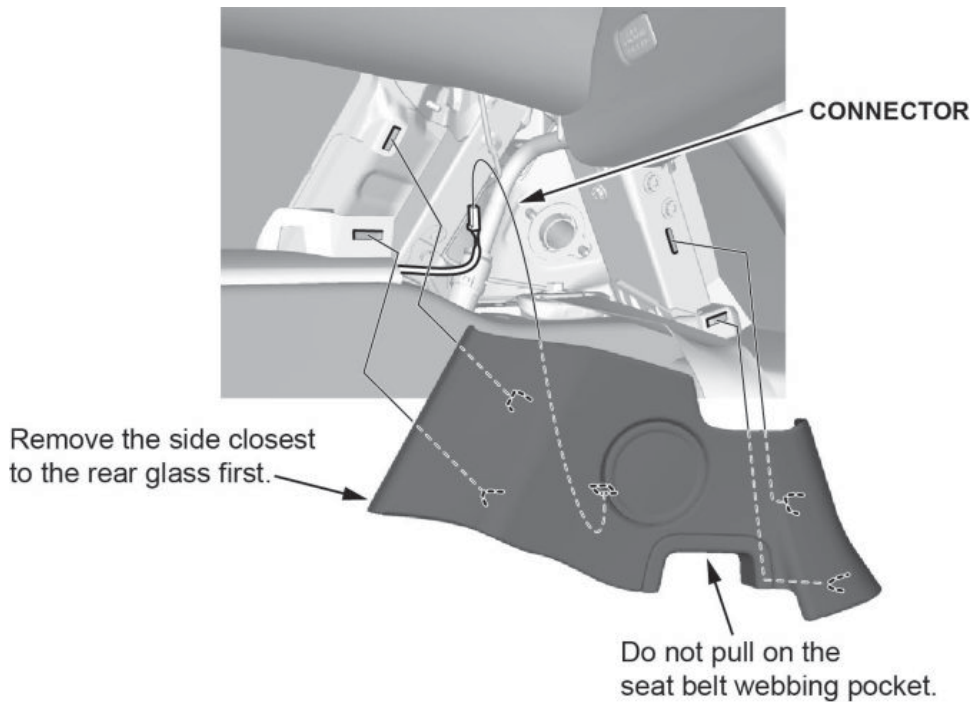
7.3. Remove the driver's C-pillar trim.

To avoid damage when removing the C-pillar trim make sure you detach it from the outer edge near the rear glass and not at the seat belt webbing pocket.

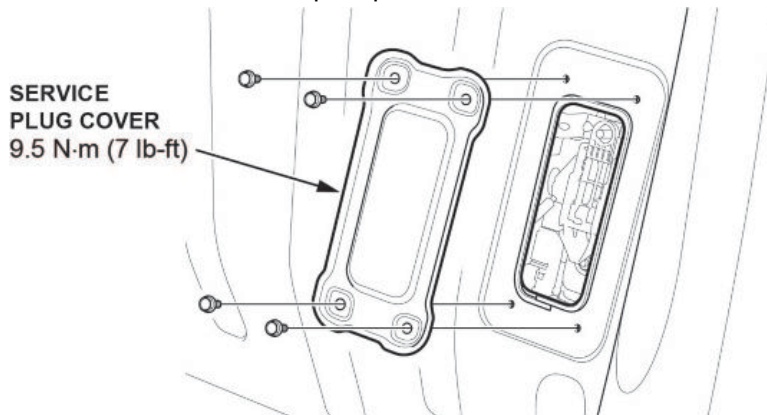
7.5. Pull the rear bulkhead carpet up to access and remove the service plug cover.

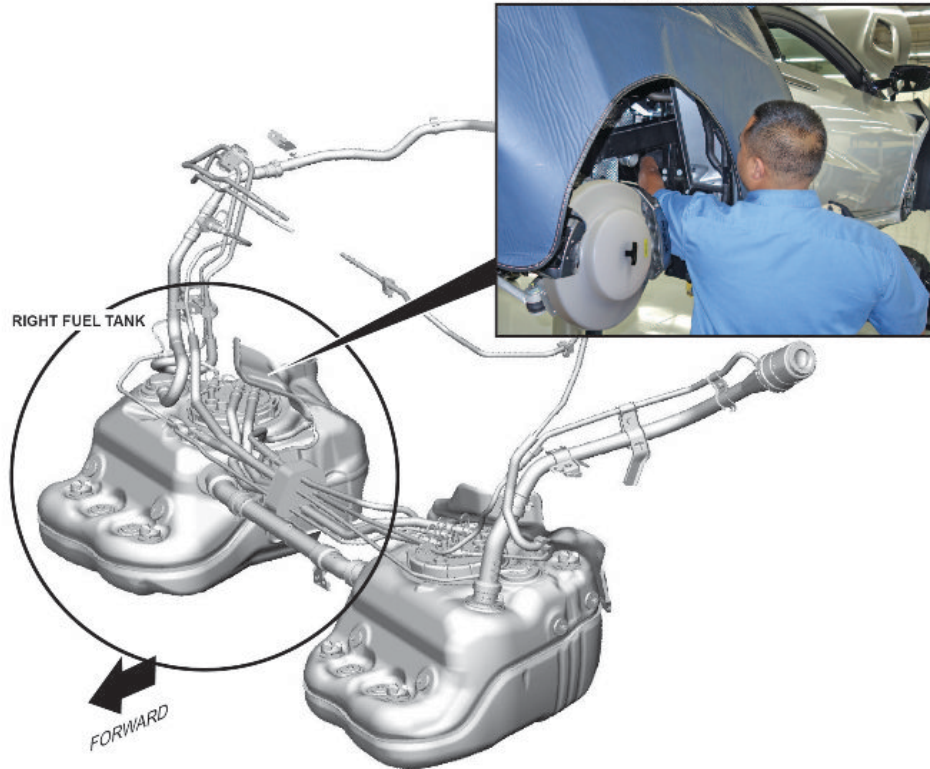
12. On the passenger side rear wheel well, disconnect the following:

Reach through the right rear wheel well to access the right fuel tank connections.

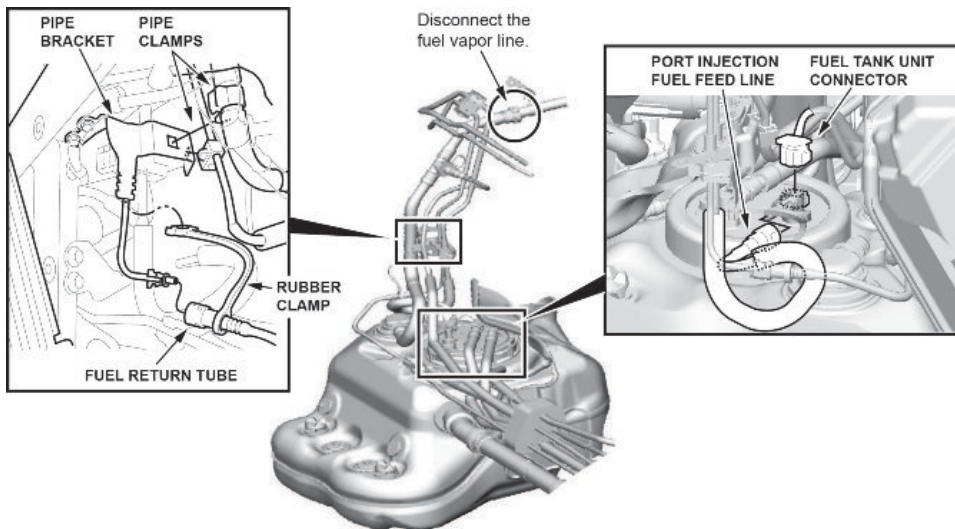
- OVR tube (next to frame beam)
- Lower intercooler hose (Unclamp and move.)
- PI fuel feed pipe
- Fuel tank unit connector
- Clip harness tab for the OVR
- Clip harness tab for the fuel line return

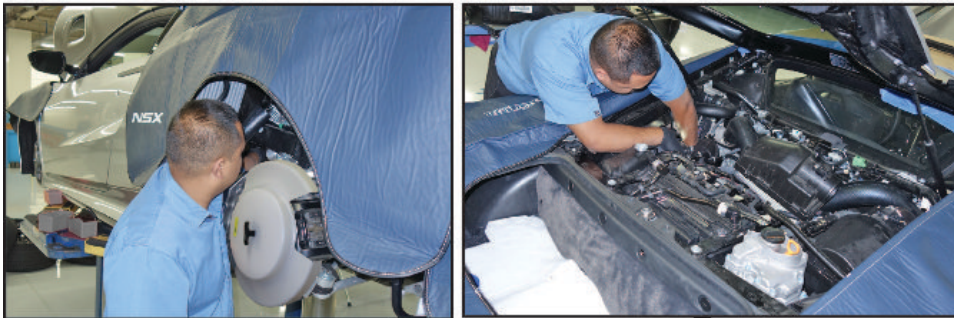
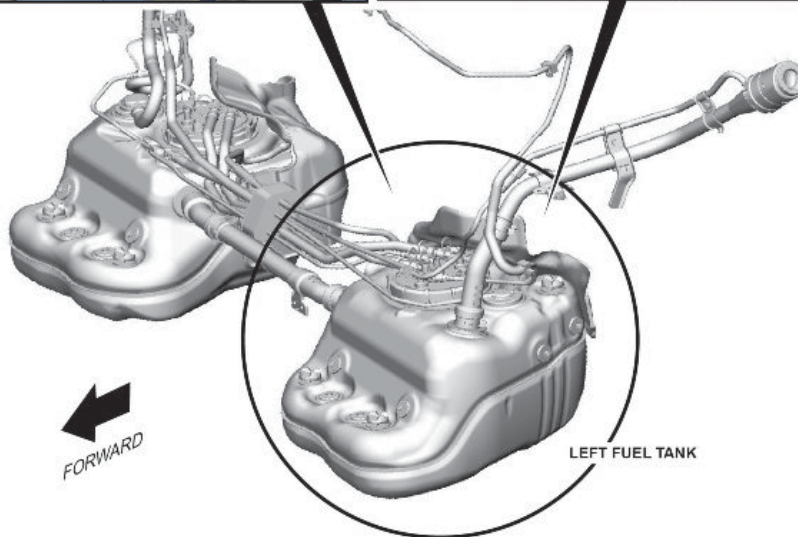
13. On the driver's side rear wheel well, do the following:

Reach through the left rear wheel well and the engine compartment to access the left fuel tank connections.

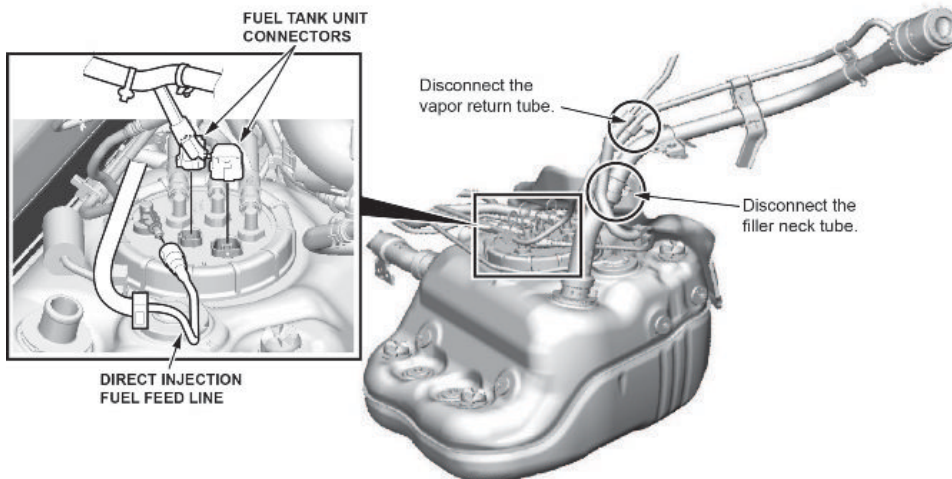
- Unclamp and move the intercooler hose.
- Remove the black bracket holding the fuel tank (top side fasteners).
- Disconnect the two electrical connectors.
- Disconnect the fuel filler neck.
- Disconnect the PI fuel feed pipe to the fuel pump.
- Unhook the tube clamp on the firewall side.

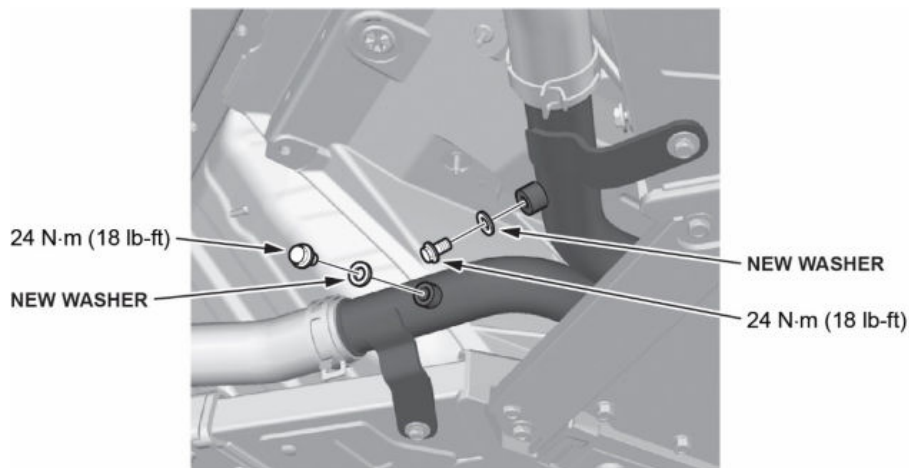
18. Drain the engine coolant only from the water pipe underneath the vehicle.

After the coolant has drained, reinstall the drain bolts with new washers included in the kit.

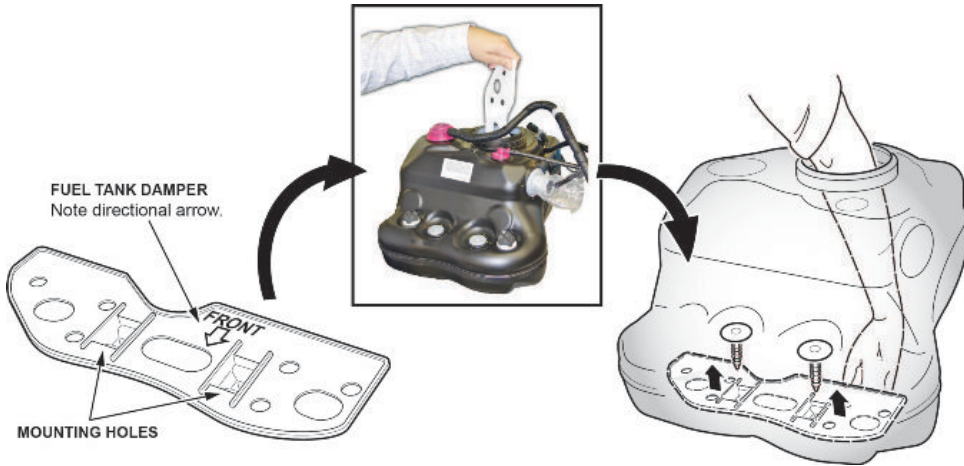
30. Install the fuel tank damper (supplied with the new fuel tanks) as shown.

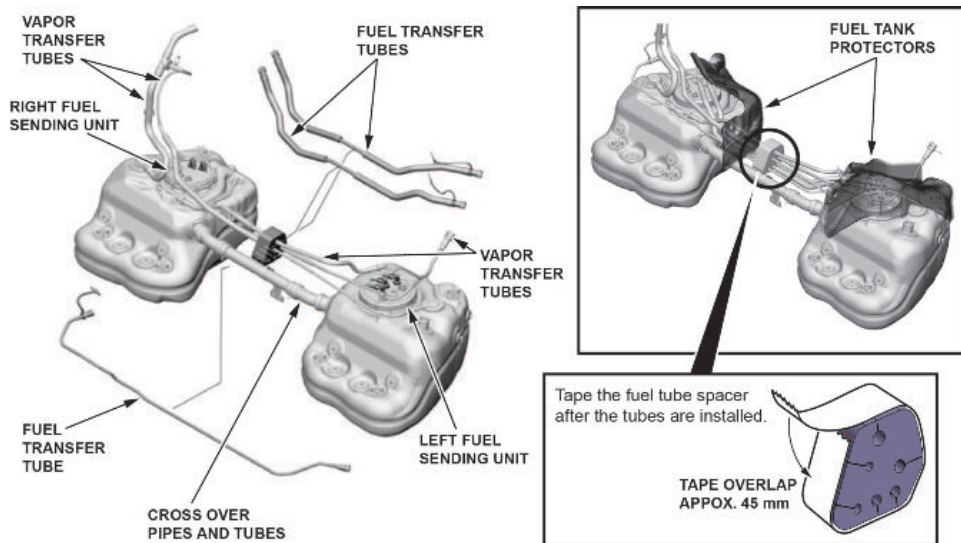
Install the supplied tape around the fuel tube spacer as shown.

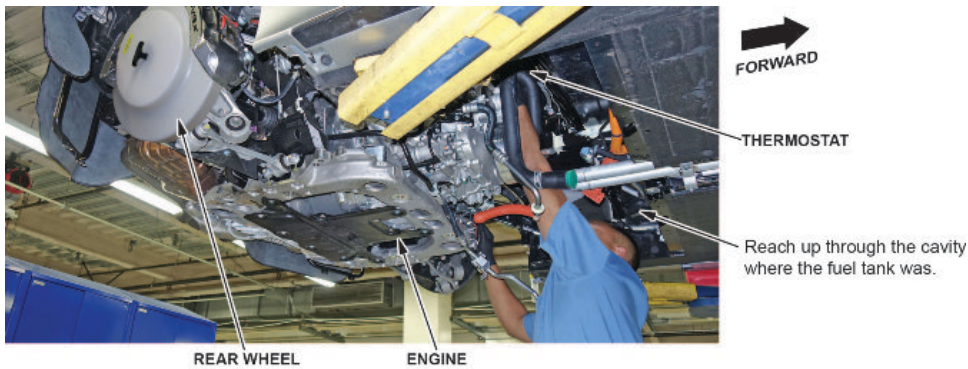
32. Replace the thermostat from underneath the vehicle as shown below.

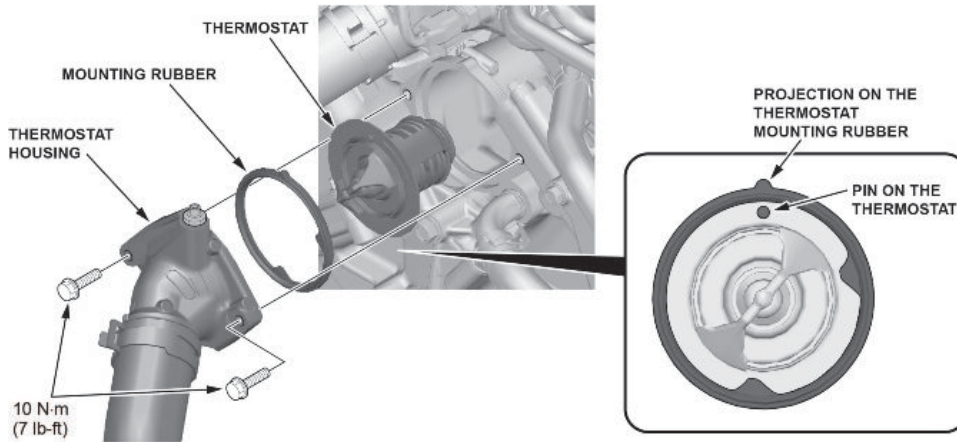
Align the tab on the thermostat mounting rubber with the pin on the thermostat as shown below.
